## Thermographic study of the pathological manifestations due to humidity and of the conservation state of the Santa Maria Basilica's roof

This paper analyzes the current state of the roof of the Basilica of Santa Maria, Alicante, Spain. This building dates back to the 13th century and is catalogued. For the analysis of the efflorescence observed, an analysis of the constructive typology is carried out, as well as a visual analysis of the state of the same, describing the existing pathological manifestations, both in the exterior area of the roofs, as well as in the interior area of the rooms under them. For the technical analysis of the possible leaks from the roof to the interior rooms of the basilica, a watertightness test and the verification through the control of the variation of temperatures by means of thermographic analysis are carried out. It can be concluded the existence and position of leaks that have damaged this listed building.

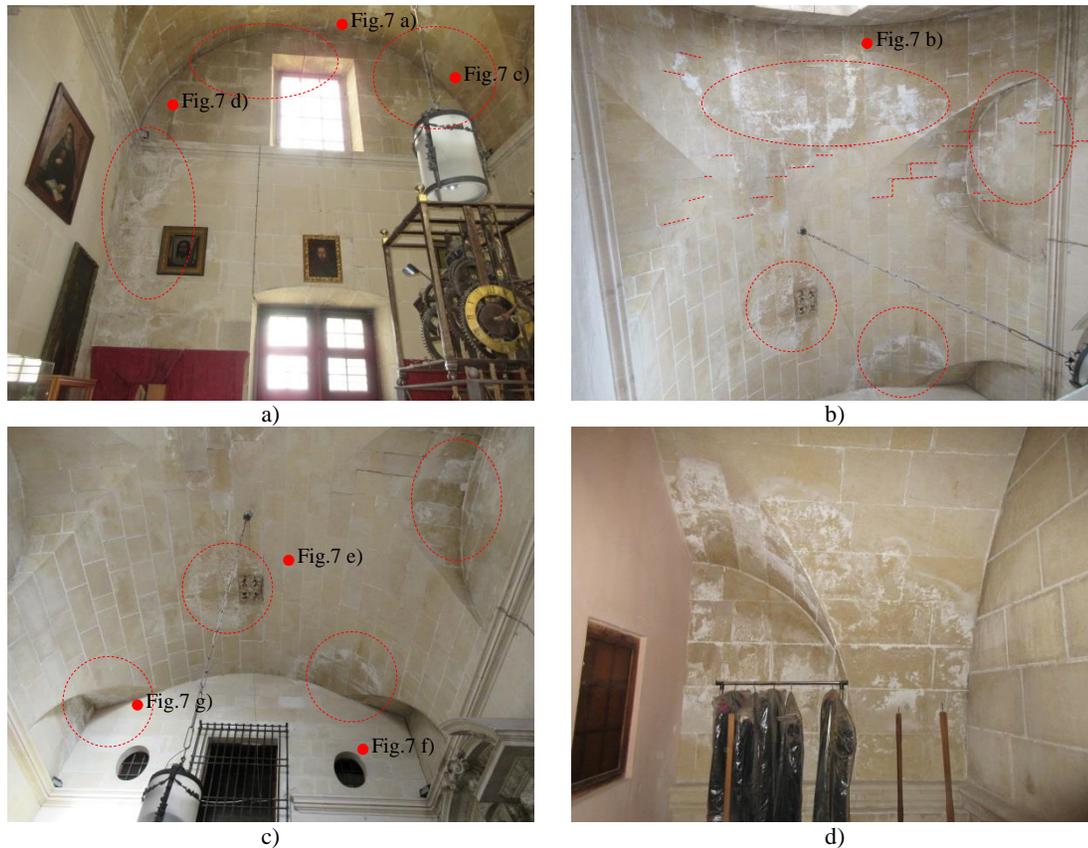
On the other hand, if the accumulation of salts mentioned above corresponded to hygroscopic salts, these would tend to retain water from the air when the relative humidity exceeds a certain limit value, which could generate a false mechanism of the presence of moisture due to hygroscopic condensation, with the possible appearance of stains, but caused simply by the absorption of water vapor from the air due to the effect of the hygroscopicity of the salts and not by the real presence of a source of water by filtration or capillarity. For this reason, a general cause of moisture pathology in historic buildings is the appearance of efflorescence due to local seepage phenomena caused years ago that have subsequently been reactivated. That is to say, the appearance of new moistures on the masonry would not be due to the real presence of a new water seepage, but due to the hygroscopicity of the salts on the surface of the rocks. Grossi and Esbert (Grossi and Esbert, 1994) show a deep bibliographical review on the effects of soluble salts in the deterioration of monumental rocks. In this sense, in the interior of the analyzed church, different efflorescences and stains are observed, which suggest the existence of filtrations, Figure 2.

Figure 2. Photos of rooms under roof 2: a) East facade, b) Lower view of the roof, c) Lower view of the roof with vault partition wall, d) Upper adjoining room after division with partition wall. Photos of rooms under roof 1: e) Lower view of the roof area next to the exterior facade, f) Lower view of the roof in contact with the body of the church. Figures a), b), c) include the tomography points of Figure 7 with a red dot.

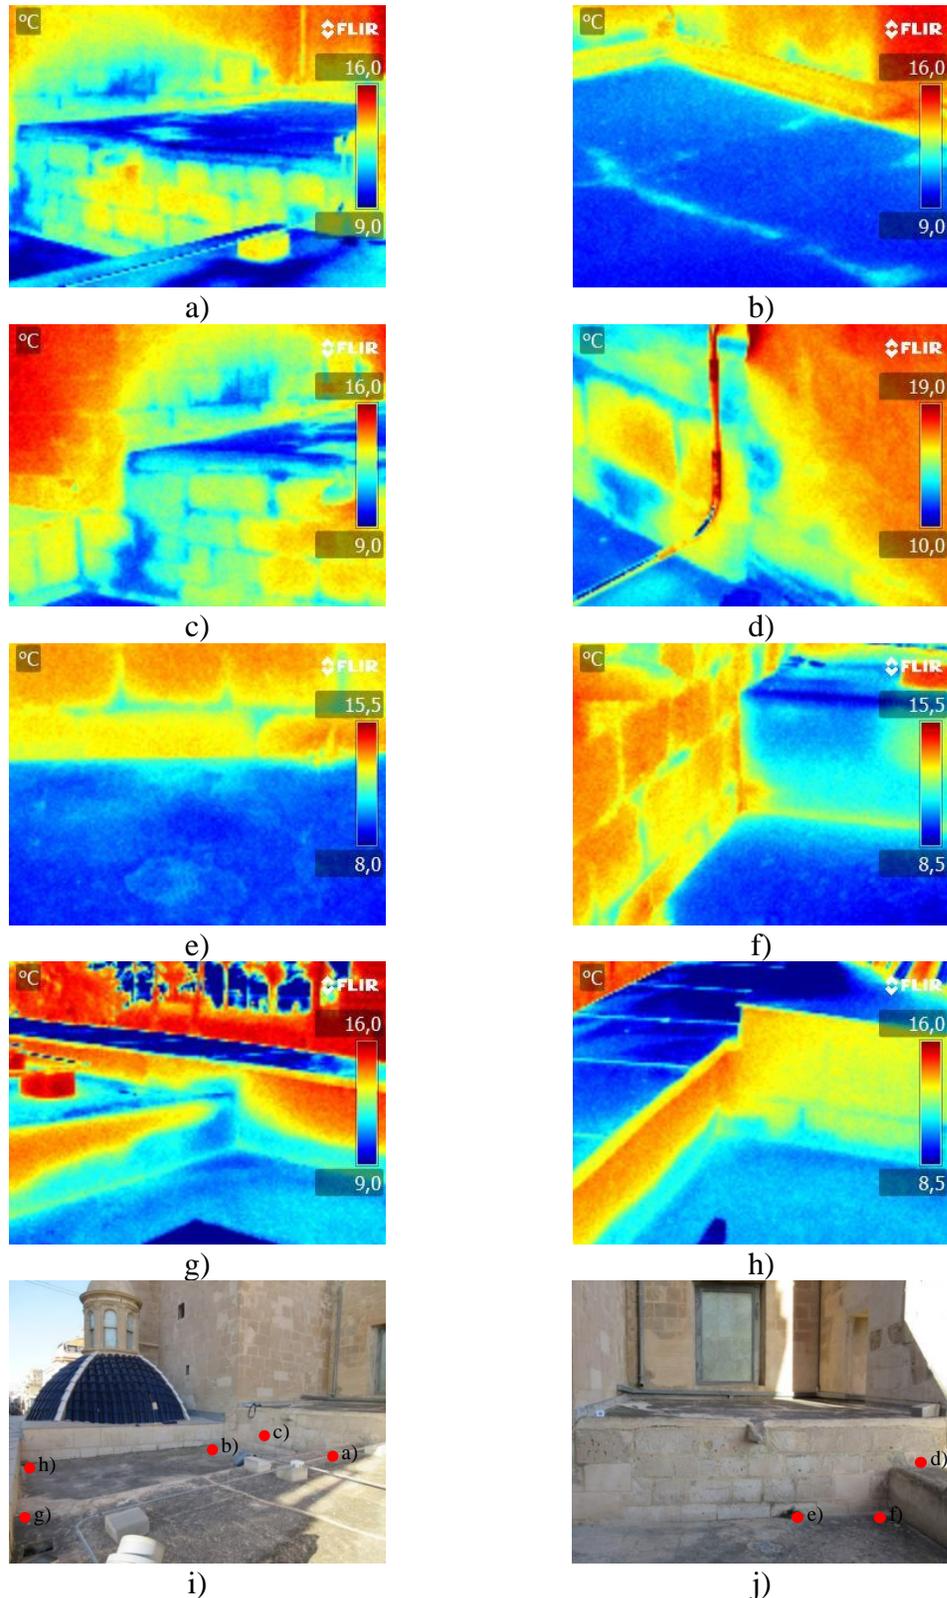
In relation to the analysis of the water flow during the watertightness test, the results show that in the case of roof 1, the upper zone channels the water perimetrically towards the gutter through the established slopes. In the case of roof 1, in the lower zone, it was possible to verify that the slopes converge in the drainage area. The absence of overflows prevents the evacuation of water in the event of saturation of the drain due to the accumulation of solid elements at its entrance. This fact makes it easier for the level of stagnant water to reach the side wall of the Communion chapel, favoring the entry of water at the intersection of the vertical wall-skirt.

Regarding the results of the thermographic analysis of roof 1, Figure 3 shows the images for both the upper and lower areas of the roof. Figure 3 (a) shows an overview of the upper part of the roof. In this image, all the possible pathological manifestations previously mentioned can be identified. In the first place, it can be seen how after the watertightness test and the pouring of the water on part of the vertical façade enclosures and 10 h after the test, part of the humidity is preserved due to the high absorption capacity of the stone in the facing. In this image, it can also be seen how the area of the parapet, the water has accumulated more than in the area located just in the area of the gutter. A detail of this area can be seen in Figure 3c, where it can be observed not only the entry and accumulation of water in the lower area, but also the water filtered through the joints between the masonry pieces. On the other hand, it should also be noted the abrupt change in thermal characteristics at the joint between the parapet and the wall corresponding to the rigid protection of the upper skirt, Figure 3a-3c. The joint between the two materials is clearly observed and it can be seen how part of the water poured from the end of the skirt has dripped down the facing, being stored in the area of the joint, due to the absence of the correct realization of the detail of the end of the skirt. In relation to the gutter, however, no leakage problems have been detected. On the other hand, Figure 3b shows a detail of the gutter for the passage of the installations. In this image, it can be seen in green, the rear area of the gutter, where water has been stored, due to the lack of watertightness of the joint and the absence of a protection device to prevent water from dripping

down the face and leaking behind the gutter. On the other hand, Figure 3d shows a detail of the lack of watertightness of the right end of the parapet, in the area of connection of the end of the skirt, the parapet and the buttress, marking the area that is currently very deteriorated, being an obvious sign of lack of waterproofing. Also in relation to waterproofing problems, it can be seen in Figure 3e, the absence of the waterproofing in the contact area of the lower skirt with the parapet, as well as the presence of vegetation in the rightmost area of the photo, where the temperature is higher. In addition, the current state of waterproofing of the damaged area of the sill can be evaluated by means of this image. The results shown by thermography did not show the presence of watertightness problems. Finally, Figures 3g-3h show the dammed area during the test, where the process of capillary rise through the facing can be clearly observed, clearly exceeding the 5 cm of waterproofing strip currently in place at the junction of the skirt with the vertical facing, in the areas where it has been placed, since there is an absence of this construction detail in various parts of the lower skirt.

Figure 3. Thermography of roof 1: a) General view of the upper area, b) Detail of the installations gutter, c) Moisture in vertical facing and corner of parapet, filtration through masonry joints, d) Lack of watertightness in parapet and buttress, e) Lower skirt and vertical facing, f) Lateral connection of parapet skirt, g) and h) Capillarity, i) and j) location of the thermographs. The red dots indicate the location of the thermography in the associated image.

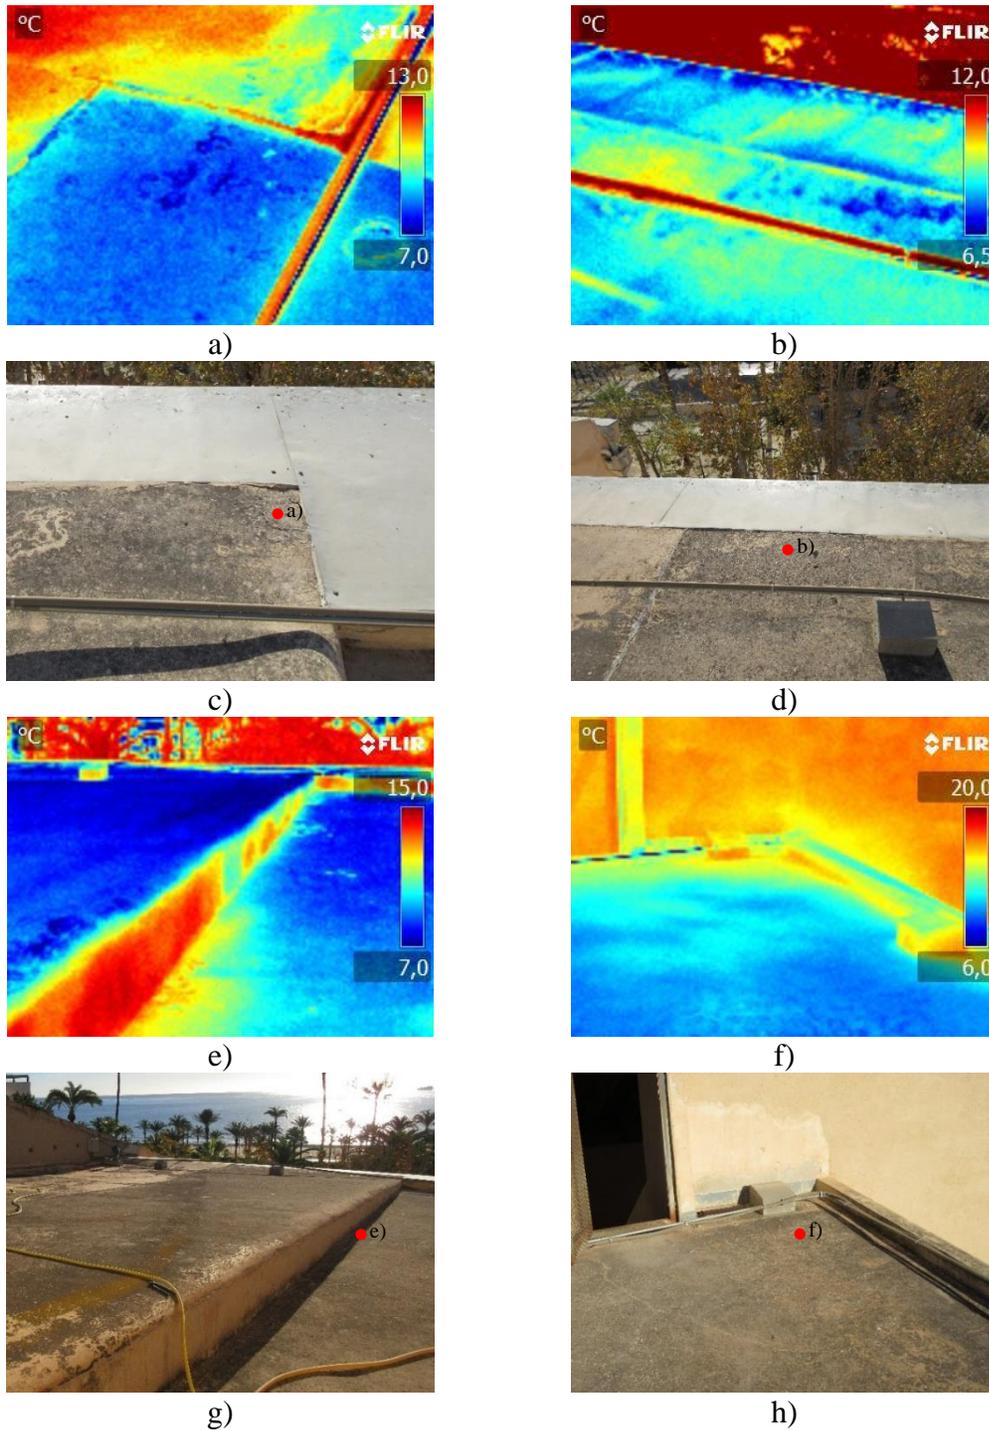
In relation to the results of the analysis of roof 2, Figure 4a and 4b show the detail of the absence of the perimeter joint, showing the difference in temperatures in the areas where the mortar is totally deteriorated, and the joint is without mortar between the end of the skirt and the facing. It is important not to confuse this with the red line associated with the passage of an installation pipe, since the area analyzed is the one associated with the end of the connection with the vertical face of the facade. These images show the lack of thermal insulation in the sections of the vertical facing, as well as areas with a colder tone, due to the water spilled during the load test. Figures 4c and 4d show a detail of this area without thermal camera application. On the other hand, Figure 4e shows the side skirt end zone. In this image it can be seen how the lack of thermal insulation in the vertical facing sections, as well as areas of colder tone, due to the water poured during the load test. This area is shown in a more greenish tone in the middle area of the photo. Also noteworthy is the contrast at the skirt end joint, clearly showing the position of the horizontal joint between the upper material and the support material. This joint, represented as a yellow line with cyan tones, presents an important state of deterioration, as could be observed during the visual analysis of the roof, Figure 4g. Finally, Figure 4f shows a detail of the perimeter end of the skirt, in the area near the access door to the roof. Figure 4 also includes digital camera images of the areas analyzed by thermal imaging. The comparison of these images allows observing the benefits of the use of thermography in the detection of pathologies, being this a support technique to the visual inspection.

Figure 4. Thermography roof 2: a) Deterioration of perimeter joint, b) Detail of failure in perimeter joint in contact of the skirt with the facade, c) and d) Image a) and b) with digital camera, e) Detail of the lateral end of the skirt and connection with the roof, f) Perimeter zone of the skirt in the access area to the roof; g) and h) Image e) and f) with digital camera. The red dots indicate the location of the thermography in the associated image.

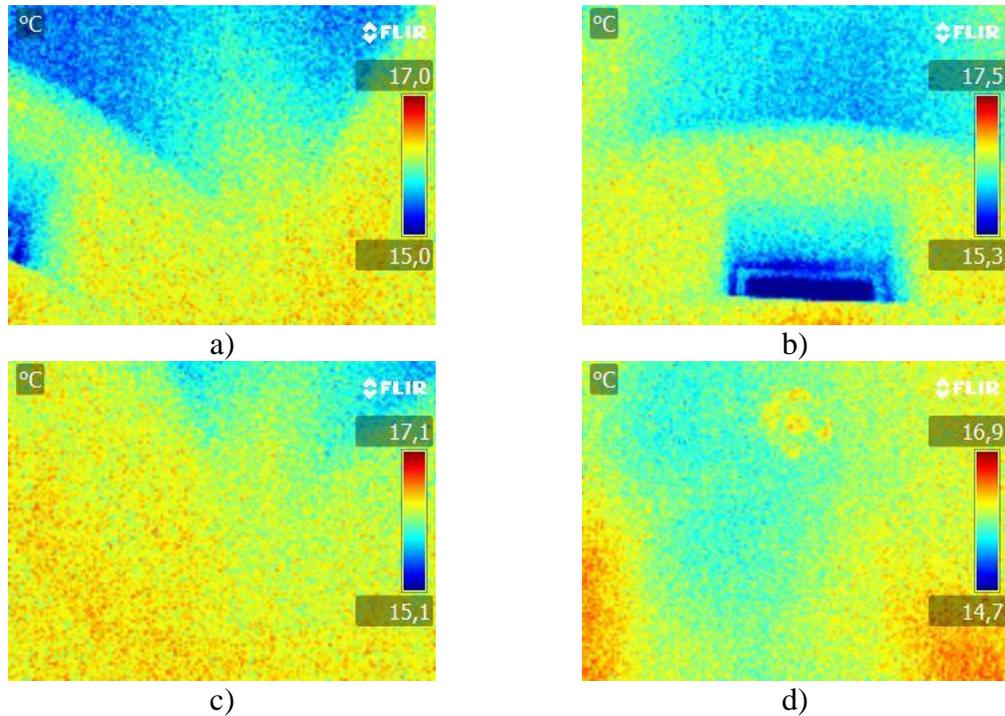
Analyzing the thermal behavior of the room under the lower area of roof 1, Figure 5, referred to throughout the study as the room adjacent to the Communion Chapel, it can be seen in Figure 5a, corresponding to the corner of connection between the exterior facade and the main arch that gives access to the Communion Chapel and, arranged in the area near the presence of the drain in the roof at the top, that the thermal difference between the part corresponding to the facade and the roof of the vault is clearly defined. However, with the climatic conditions recorded during the test, the presence of specific thermal irregularities in the potentially damaged areas associated with the connection between the facade and the toral arch of the groin vault analyzed were not detected. Also, part of the exterior window is observed, which serves as a reference in order to be able to frame the photo. Figure 5b shows a detail of the window area. In this image, the cold spot effect is clearly visible due to the higher thermal transparency of the glass compared to the high thicknesses of the facade. In addition, the lack of thermal insulation in the connection areas between the facade and the roof can be observed, clearly marking the junction edge between the two, and showing a temperature gradient from the beginning to the central area of the vault. In Figure 5c, the thermography of the other corner of the exterior facade is shown, similar to that described in Figure 5a. As can be seen, in this image there are no relevant signs of pathology, being detected only the thermal gap between the vertical faces and the roof of the vault. Finally, Figure 5d shows a general image of the roof. This image shows the presence of a part of the roof slightly colder than the other, mainly due to the effect of the accumulation of water during the test.

Figure 5. Thermography of rooms under roof 1, adjacent to the Communion Chapel: a) Connection of the main arch with the exterior facade, in the area of access to the Communion Chapel, b) Connection of the facade with the roof in the window area, c) Second corner of the facade wall, equivalent to image (a), d) General view of the roof from below.

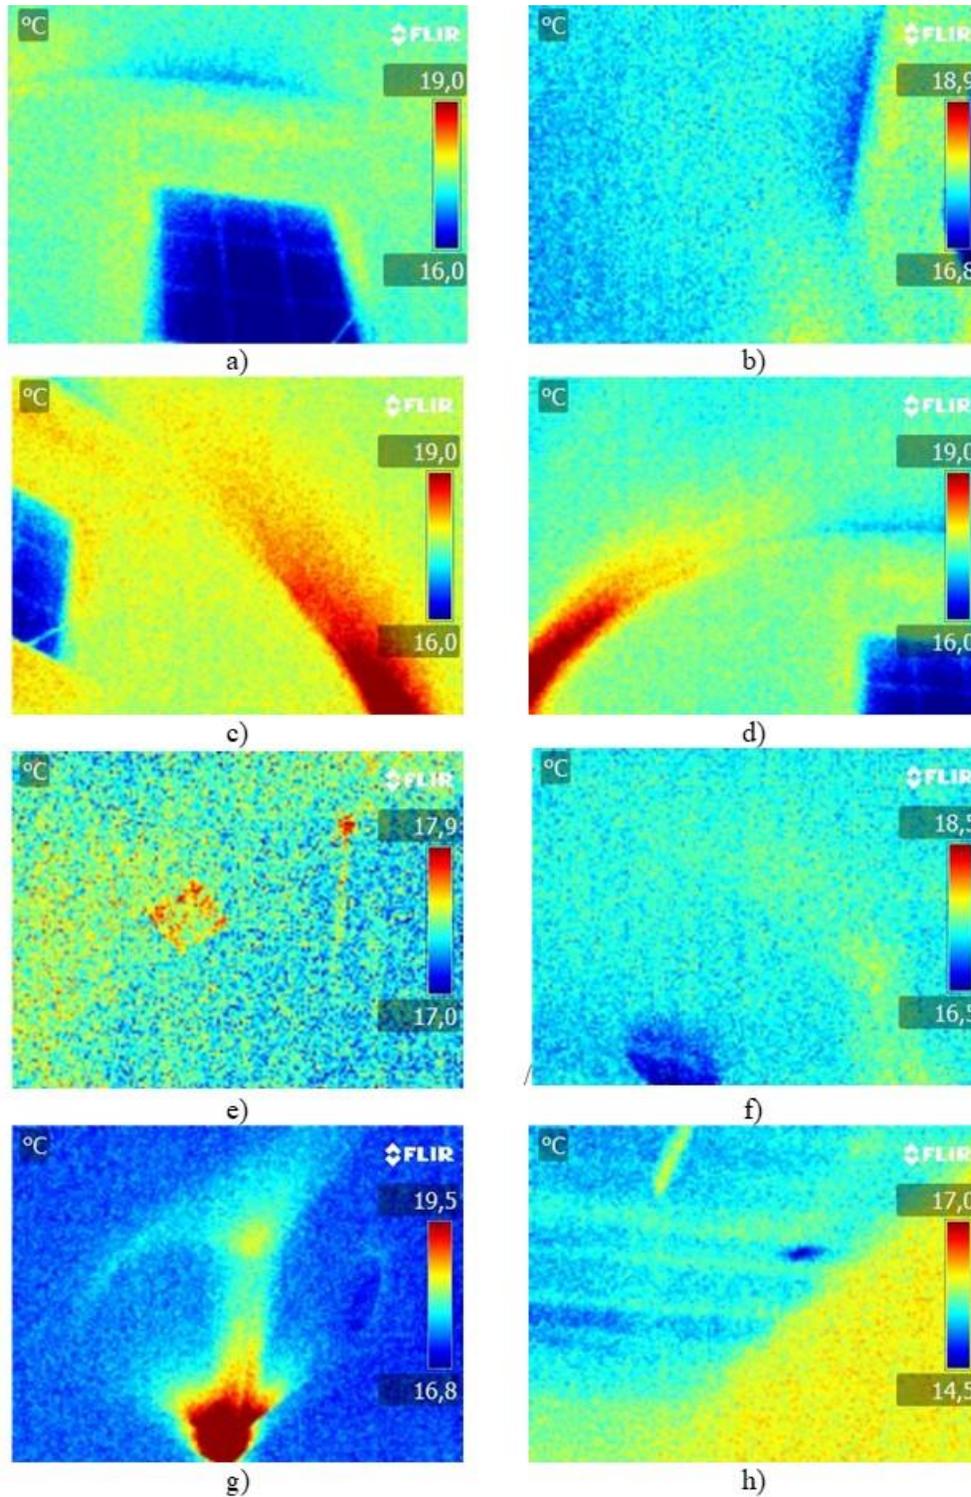
Finally, in relation to the thermography analysis carried out for the room under deck 2, Figure 7 shows the distribution of temperatures in the different critical points analyzed in the previous sections. In general, the thermal behavior is very similar to those detected in the previous rooms, except that in this case a high thermal difference between the points of the interior facade and the roof has not been observed. That is, Figures 7a, 7b, 7c and 7d show the detail of the contact between the facade and the roof, showing the thermal leaks in the upper part of the window area, as well as in the window itself. Figure 7e shows a thermography of the part of the roof corresponding to the anchorage of the chandelier, where a uniform distribution of temperatures is observed without the presence of detected damage. In Figures 7f and 7g, the thermographies associated to Figures 7c and 7d are observed, but in this case, in the facade opposite to the exterior one. In this case, the thermal variations can be observed in the areas affected by the heating of the light sources. This is due to the presence of cold spots in the contact zones between the side wall and the facade. These cold spots, especially those detected in Figure 7g, are related to the detected moisture stains. In these images, the coldest circular hole is shown as a reference to locate the position of the photos. It is important to point out that such humidity stains, besides being related to the presence of a cold zone, are also related to the presence of a water accumulation zone in the upper part of deck 2, close to the dome. In this area the water collected in the dome is discharged, and the lack of lateral sealing at the end of the skirt, together with the low level of ventilation in the room shown, cause the increase in humidity, and thus the appearance of such efflorescence.

Finally, it should be noted the presence of a leak detected in the annex building with access to room 2. This leak is on the roof of the upper floor. It has not been possible to detect whether the presence of moisture is due to an error in the tile roof, or in the roof 2 itself. However, due to its geometric position, it is very close to the position of the roof drain, which could be a sign of a lack of watertightness of the roof.

Figure 7. Thermography of room under roof 2: a) window and slab area, b) lower view of roof, c) connection view of slab side wall, d) connection view of slab side wall, e) central area of roof, f) view of rear dividing wall, g) connection view of side wall and rear wall, h) leak in outbuilding area.
