Non-destructive evaluation of the wooden beams from the Narciso López building in the Historic Center of Havana for reuse in its restoration

A. Hernández Oroza^{1*}

DOI: <https://doi.org/10.21041/ra.v12i2.585>

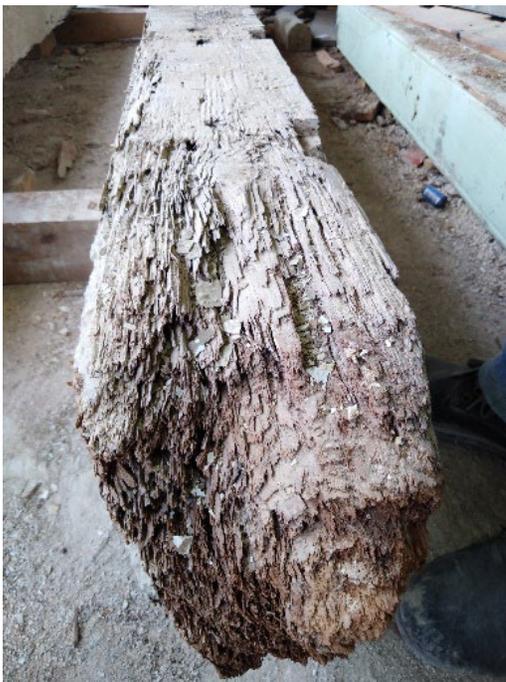
The study began with the removal of the floor and the dismantling of all the beams. This enables detailed inspection on all sides (Figures 3 y 4), fundamentally in the area of the heads, which, being embedded in the walls, show greater deterioration due to rot by increase of moisture inside the joints (Figures 5 y 6). This first stage makes it possible to record the position, length, direction and sense of each fissure, crack, rot and/or defibration present in the beams, for which the distance of the lesion with respect to the head was taken as a reference (Figure 7). Additionally, the test areas that have the ideal conditions for carrying out the measurements were identified. In areas where there are cracks or deterioration due to different forms of rot (brown, soft, etc.) it is not possible to carry out measurements because a correct transmission or confinement of the signal is not achieved from the emitter to the receiver, or the results obtained are altered by the presence of microbial films that affect the physical-chemical composition of the wood, degrading its structure and density. On the other hand, impact or penetration techniques have the drawback that they should not be applied on irregular surfaces that influence the moment of impact of the drill bit, either due to its deformation, alteration in the angle of entry or lack of wood to offer a density value representative of the real properties of the structural element. For the preparation of the test areas, two sections were selected for each beam, free of surface lesions.

Figure 5. State of the beam heads

The most recurrent injuries found during the visual inspection were the deterioration of the heads due to excess moisture in the joints, by the development of rotting fungi, as well as fissures and discontinuous cracks on the faces and edges. Among the most common restoration and reinforcement techniques for these types of deterioration are the use of metal caps and brackets to guarantee the fastening of the beams at the support points. Pickling or brushing of the faces and edges until reaching a surface with the fewest possible number of injuries. The fissures, on the other hand, can be sealed using resins, or from the preparation of a paste of carpenter's glue mixed with sawdust. Fumigation and treatment with biocide products, and finally the structural recalculation for the new dimensions of the beams.

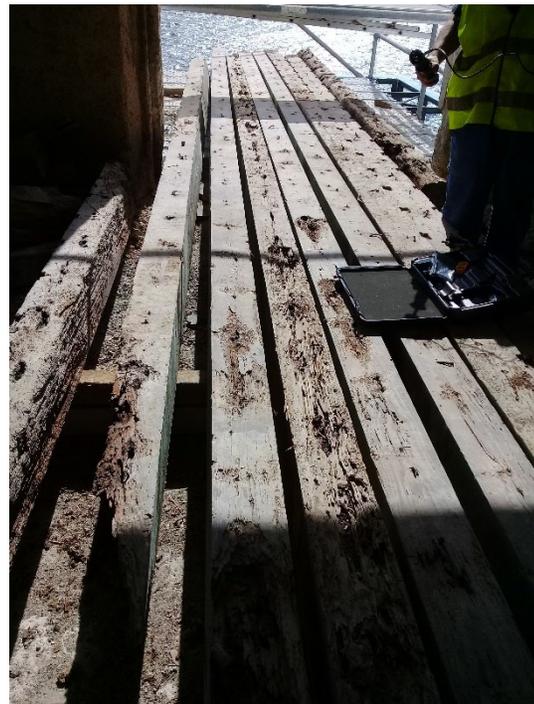
Figure 6. Disassembled beams with different pathological manifestations

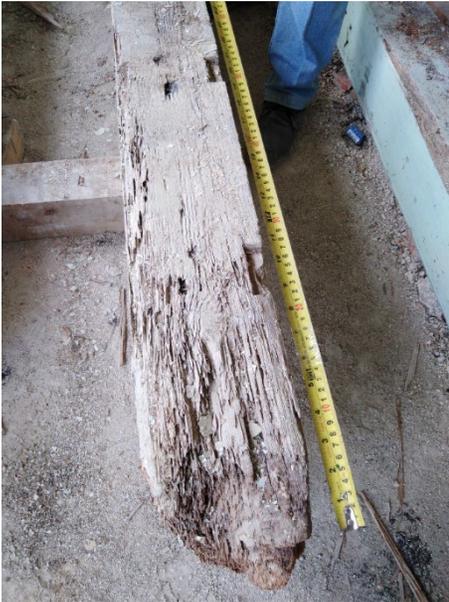
Figure 7. Measure of the affected beam section with Steel tape

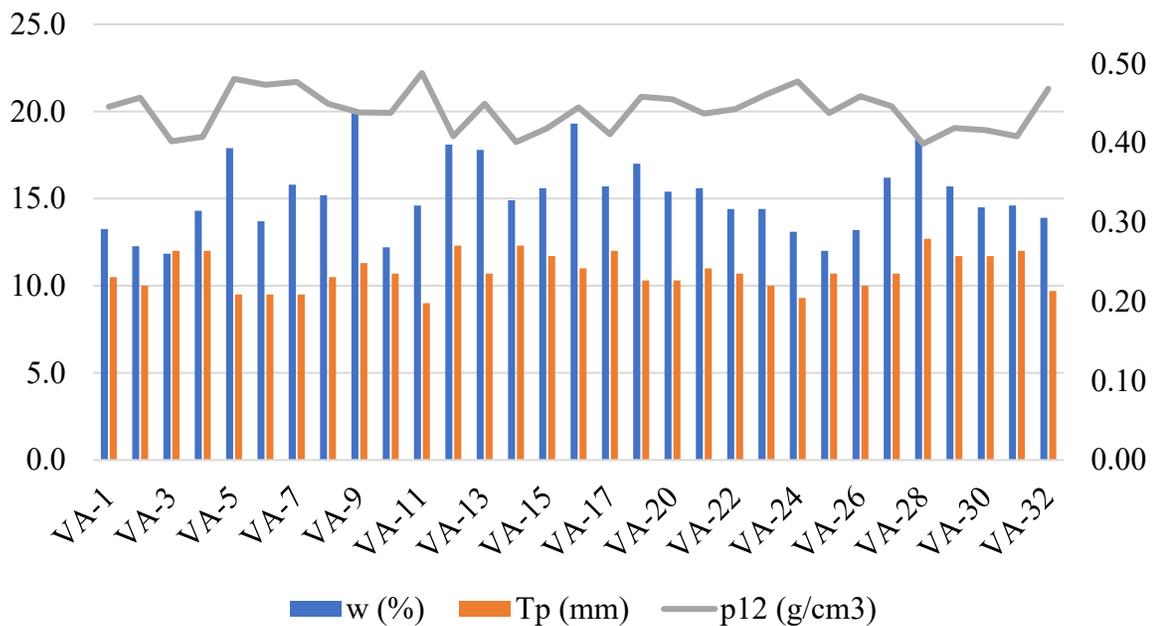
This shows that the estimation of the state of conservation of wood based on the density calculated by penetrometer, can lead to false positives if it is not combined with other measurement techniques. The hardness of the wood at the point of impact of the needle can result in a high value that does not reflect the deterioration inside the material. Figure 13 shows the general analysis of results that correlate the moisture content/penetration/calculated density. In the cases of VA-9 and

VA-16, it is identified how they reach a penetration value ≥ 11.0 mm for humidity close to 20%, in which a softening of the wood would be expected that result in greater penetration, as happens with the VA-28. The moisture content comparison between these beams is very similar but with opposite results. In the case of VA-9 and VA-16 they do not present any lesions and they maintained a UPV higher than 2000 m/s, while in VA-28 the progression of the damages towards the interior of the beam was confirmed with UPV results less than 1400m/s.

Figure 13. Relationship of results of moisture content, penetrometer and density calculated at 12% for all the wooden beams studied

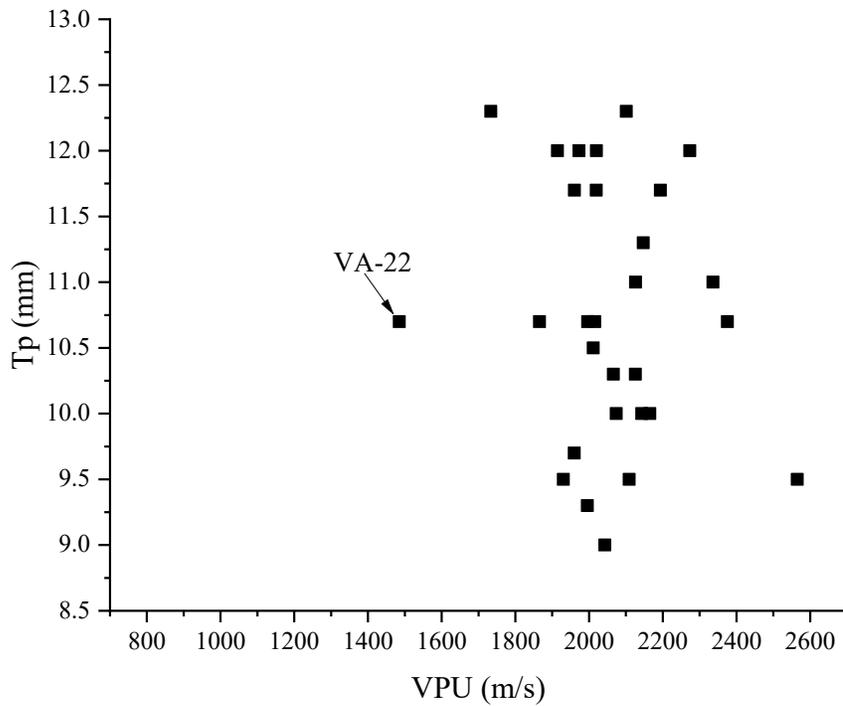
Of the total UPV measurements made, 82% fluctuated in a penetration depth between 9.0 mm and 12.0 mm. In the graphical analysis (Figure 14) it can be seen how the majority set of results occupies the range between 1800 m/s and 2400 m/s for the aforementioned interval. The graph allowed to identify beam VA-22 as a variable distant from the population mean with a result of UPV= 1485.10 m/s. If the calculated standard deviation and the damages present in the beam are taken into account, it would be reasonable for structural safety reasons to replace it with a new one. The values obtained from the proposed equations for estimating the f_k and the MOE show a high correlation between them (Figure 15), characterizing the beams in structural class ME-2 (UNE 56544, 2011), on which they must apply all the restoration and consolidation actions necessary for its reuse.

Figure 14. Relationship of results of UPV vs Tp for the beams evaluated as Sound Wood
