Restoration of the facade of the church of San Pedro Apostol in Agost, Spain

This work describes the studies and the intervention carried out for the restoration of the facade of San Pedro Apostol in the parish church of Agost. This facade was made at the end of the 18th century in limestone. After an initial inspection and graphic survey of the facade, the lesions, their origin, and the solution to them were identified by using advanced restoration techniques. The stone elements damaged or destroyed by the passage of time are composed of calcite, dolomite and silica, with plaster joints, and have been reconstructed either through the use of new elements or, for the most part, through systems of recovery of the initial volume with the use of a light core of polystyrene, lime mortars, expanded clay, fiberglass and carbon together with infiltrations of resins in the disintegrated areas. After a delicate intervention process using innovative techniques, the facade was completed in June 2023.

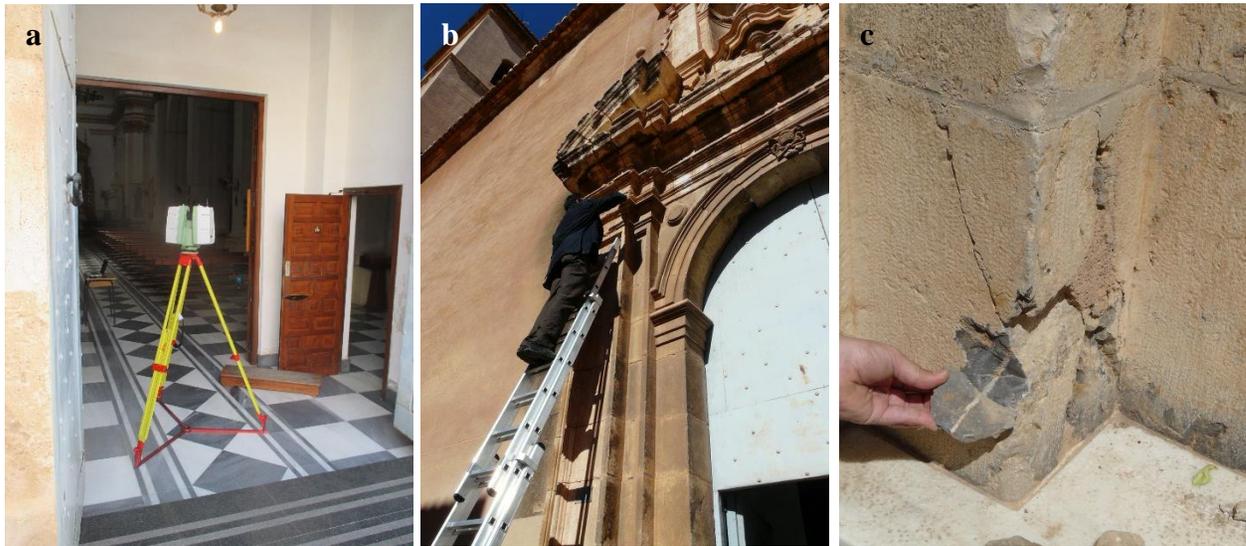
Figure 4. Different aspects of data and sample collection. a) Detail of geometric recording with laser scanner. b) Collection of samples of loose fragments on the cornice. c) Black stone flake in lower corner for observation.

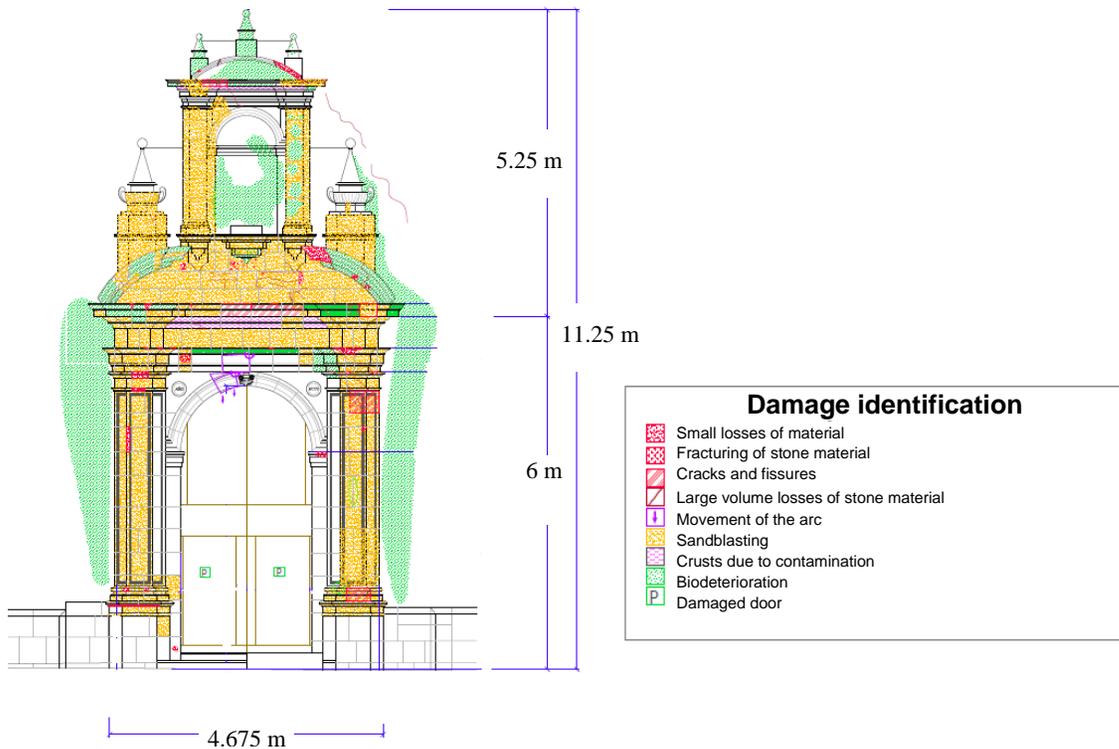
Based on the geometric information obtained, as well as the lesions observed, Figure 5 shows the situation of the doorway.

Figure 5. General geometry of the doorway. Damages observed.

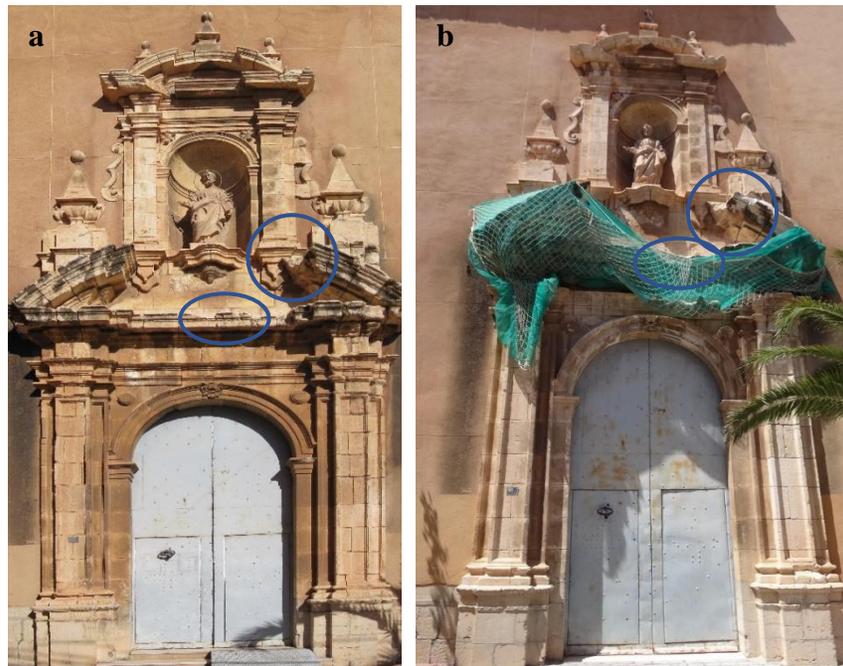
The facade of San Pedro Apóstol was much deteriorated, with stone elements missing, such as several fragments of the cornice that have come loose in recent years. If we compare the images of the facade in 2014 with those of 2021 (Figure 6), we can appreciate the increase in deterioration it has suffered. In 2014, it was recommended that protective nets be installed, as the facade was already showing a high degree of deterioration.

In January 2020, several large fragments fell off and were caught in the protective netting (Figure 6b). In other exposed areas of the portal, where water can be retained, further deterioration has also been observed.

Figure 6. a) Aspect of the doorway in 2014 (Author Javier García Galán; 2014) and b) 2021 (author Yolanda Spairani; own elaboration). The areas with the largest landslides are indicated.

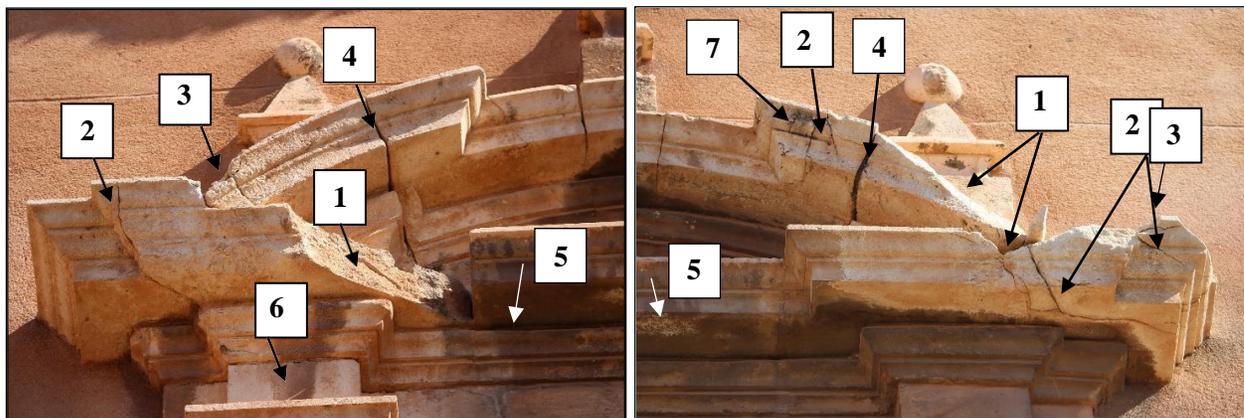
The different lesions observed on the doorway are listed below (Figure 7) in order of severity of the problem and photographs are attached to illustrate each of the different lesions:

1. Detachments of stone fragments
2. Fractures in the stone
3. Small losses of stone material.
4. Widespread loss of grouting material
5. Crusts due to contamination
6. Dirt deposits
7. Bio deterioration
8. Alteration of surface patina

Figure 7. Detail of the lesions in the upper area. Deposits of dirt can be seen in the areas protected from rain.

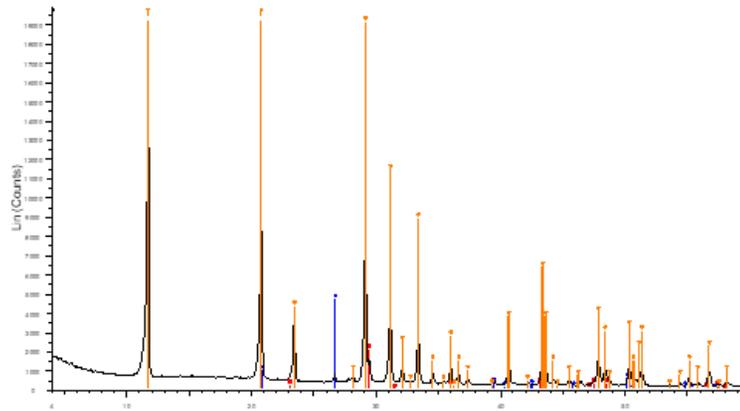
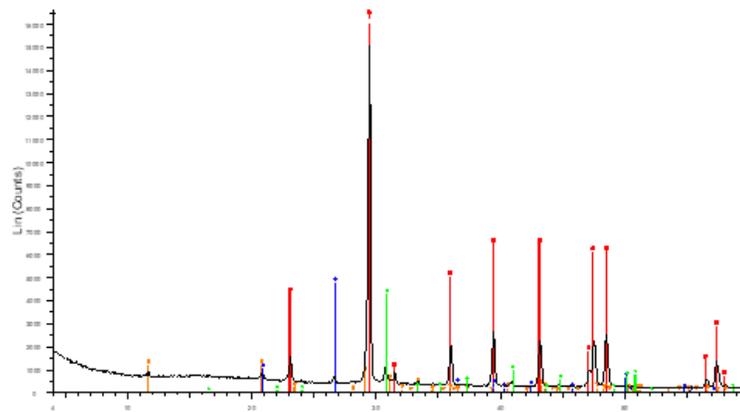
Figura 8. Diffractograms

The grout mortar, the calcarenitic stone and the grey limestone of the plinth have been analysed. The mortar was found to be gypsum as shown by the XRD results (Figures 8a and 8b). The stone is mainly composed of calcite (calcium carbonate CaCO_3), with some dolomite (Calcium magnesium carbonate $\text{CaMg}(\text{CO}_3)_2$), quartz (mineral composed of silica SiO_2) and gypsum (Calcium sulphate CaSO_4) as can be seen in the following diffractograms in their composition, where the orange peaks in the graph correspond to gypsum, limestone to red, siliceous to blue and dolomite to green.

a) Diffractogram of the mortar from the doorway of San Pedro in Agost.

b) Diffractogram of the calcarenite stone from the doorway of San Pedro in Agost.

These results indicate a significant presence of calcium sulphate (orange peaks) in existing mortars that are exposed to atmospheric agents (rainwater), and therefore its weakness and deterioration as a hygroscopic material (gains and losses of water in its molecular composition $\text{CaSO}_4 \cdot n(\text{H}_2\text{O})$) which makes it not very stable; but also this presence of sulphates can accelerate stone degradation as the stone contains the magnesium of the dolomite and very harmful salts such as magnesium sulphates can be produced (Grossi and Esbert, 1994), (Benavente, 2002, 2021). (Figure 9).

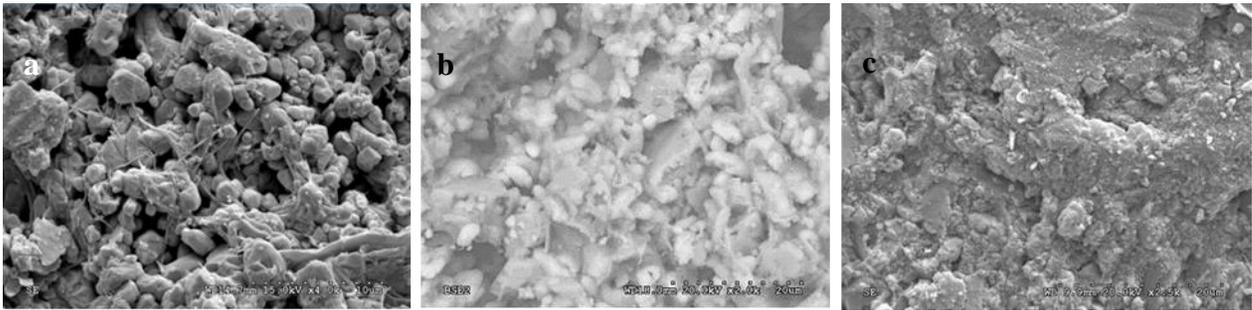
Figure 9. Microphotographs of the materials that make up the doorway of San Pedro de Agost. a) Calcarenitic stone, showing clays and abundant porosity. b) Gypsum mortar with signs of recrystallisation. c) Black limestone with occasional salts..

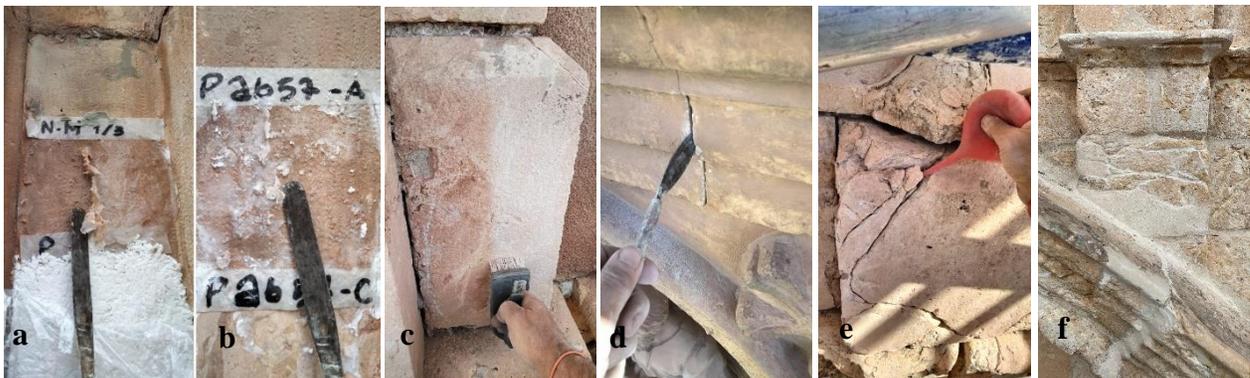
Figure 11. Different aspects of pre-testing of crack cleaning and crack sealing.

The following product has been applied: *Arbocel* (cellulose pulp) with different products such as distilled water and AB57 on an inconspicuous area of the doorway. In both cases it was protected with plastic film to prevent the liquid from evaporating too quickly. It was first left to act for 2 hours, then for 4 hours, and it was observed that in both cases more time was needed, so it was left to act for 24 hours until it was cleaned (figure 11). The result obtained with water was not satisfactory, as hardly any adhering dirt had been removed. With AB57 it worked well. A technique has also been tested which is applied in liquid form and once applied solidifies, trapping the surface dirt in a period ranging from 1 to 3 days. In our case, it was decided to apply a 33% proportion of strong product with 67% of weak product on the entire front doorway with "Clean Galena" heritage cleaner (figure 11a), in those areas where the soft bristle brush did not remove the dirt.

In the cracks (>1mm), lime grout was injected after previously cleaning them with air (figure 11e) and wetting them with water, in this case "Mape Antique I" of the Mapei brand was used. The joints between ashlar have been cleaned with a spatula (figure 11d) since, as we have seen above, they were made of plaster and were disaggregated. Air is applied to clean internally before injecting lime grout. Once the entire portal was cleaned, the cracks and fissures were sealed with lime grout. The large areas have been reintegrated with a lightweight system designed for this case, as the base stone is very degraded, and the aim has been to subject the supporting stone to as little external stress as possible.

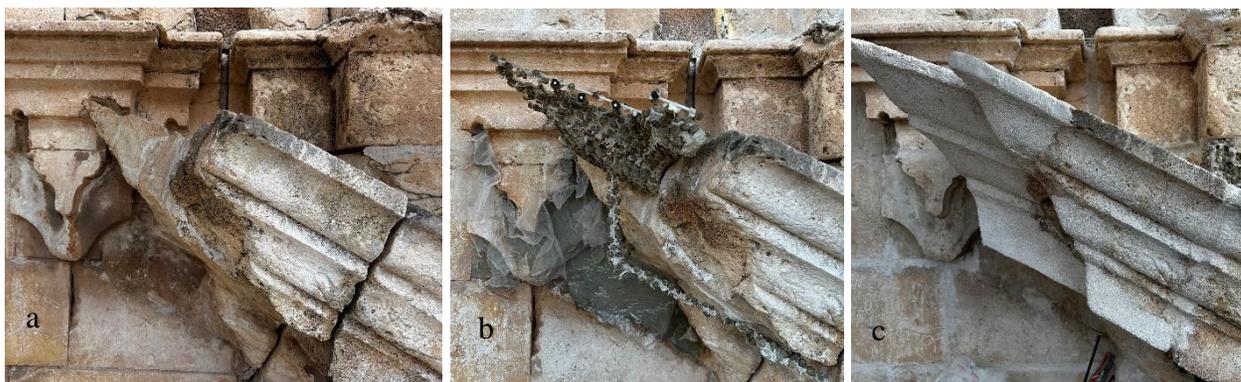
Figure 12. Different aspects of the restitution of volume using mortar with lightened core and light mortar. a) Missing area already consolidated while waiting to drill holes for anchoring. b) Appearance of the lightened core prepared to add mortar externally. c) Appearance with mortar already reintegrated, pending the application of glazing with lime water and pigments to blend the added area with the rest of the facade.

possible damage. All of this is what has led the drafting team and the restoration technician to take the decision not to use similar stone, the density of which is $2,1\text{g/cm}^3$. (Figure 12).

The system designed consists of an extruded polystyrene core that is carved to the shape of the stone leaving at least 3 cm to reintegrate with lime mortar. The polystyrene is wrapped with fibre mesh, epoxy resins are applied and lightened aggregates are adhered to increase the surface area of adhesion to the mortar. It is anchored, no less than 20 cm inside the stone of the doorway, with carbon fibre and glass rods, depending on the volume to be reintegrated. Once finished, the pigmented lime mortar is applied in mass and with a percentage of 25% of eps beads, to lighten the mortar. In this way, the weight of the material used has been reduced by approximately 75%.
