Evaluation of concrete flaw detection capability by means of ultrasonic tests

A. Lorenzi^{1*}, J. A. Chies¹, D. S. Adamatti¹, L. C. P. Silva Filho¹

Citation: A. Lorenzi, J. A. Chies, D. S. Adamatti, L. C. P. Silva Filho (2017), “*Evaluation of concrete flaw detection capability by means of ultrasonic tests*”, Revista ALCONPAT, 7 (3), pp. 286-301, DOI: <http://dx.doi.org/10.21041/ra.v7i3.127>

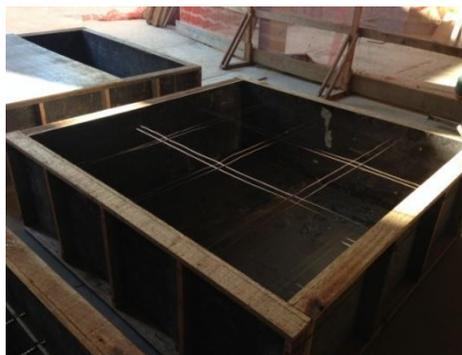
Figure 1. Molds for the concrete pouring of the wall

For the preparation of the test elements were generated molds using plasticised plywood and frame in eucalyptus wood, trying to approach the way of making a real concrete structure. The shapes were assembled in such a way as to obtain two square faces with a 1.70 m edge, with distinct roughnesses, one smooth (bottom of mold) and one rough (top of the mold - non - contact with the plywood). Figure 1 shows one of the molds used to make the walls.

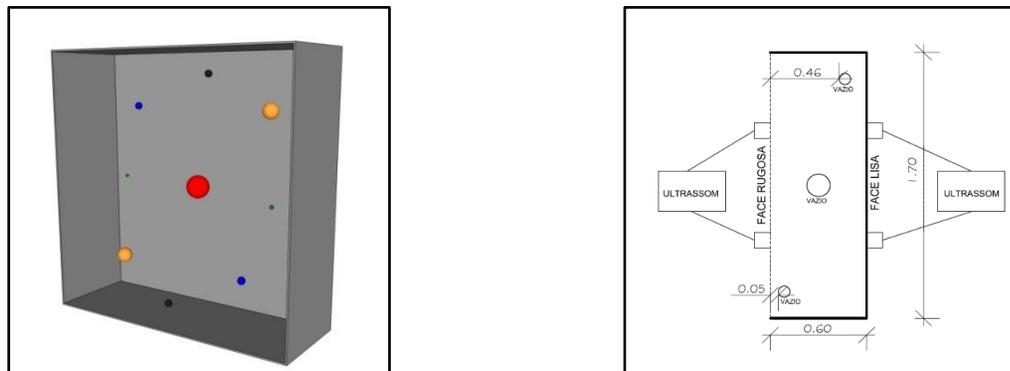
Figure 2. Positioning and depth of voids.

The positioning and the depth of the voids were thought in a way that could have equal combinations for both faces. Thus, it was possible to evaluate the capacity of detecting voids with diameters of 2.5cm, 5cm and 10cm at depths between 5cm and 50cm for both a rough and smooth surface (Figure 2).

Due to the dimension of the void of 15cm in diameter being relatively large in comparison to the others, its positioning was limited to the center of the wall, to a depth of 30cm of both faces.

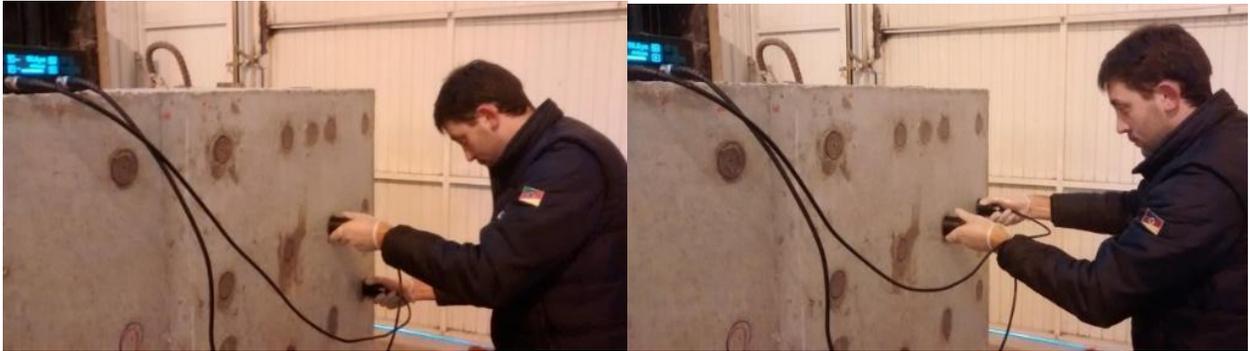
Figure 3. Sequence of readings

Figures 3 and 4 show the sequence and reading mode within a segment of the wall. With the values of UPV obtained, the velocity variations were mapped graphically. The results of the first stage provided good indications that the parameters armature, roughness, grid size and operator experience were shown to have greater potential in relation to the quality of interpretation and execution of the test. However, the applied methodology could not accurately define the ability to detect defects at different depths.

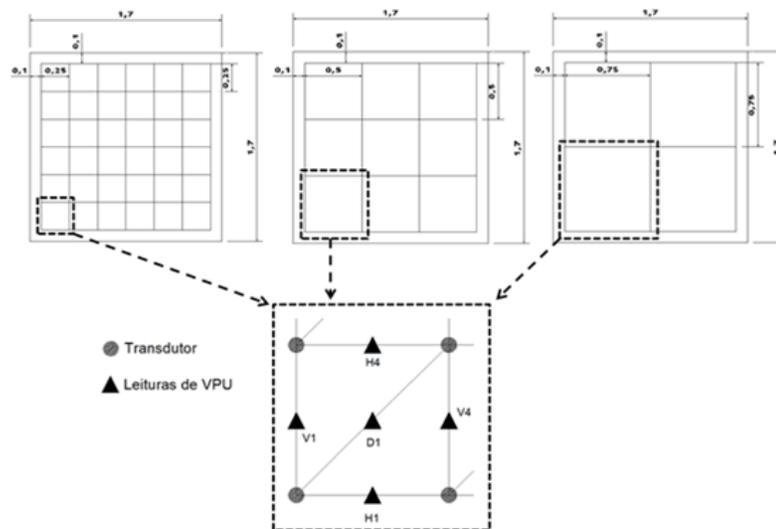
Figure 4. Reading design for each grid

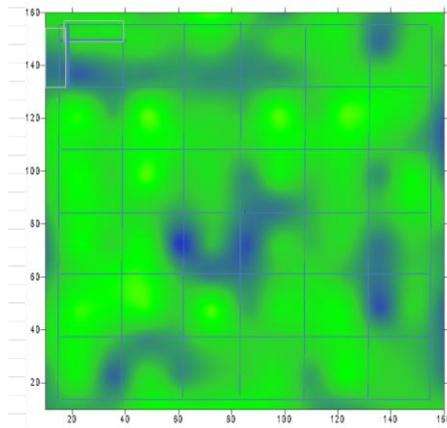
Figure 5. Image generated from the combination of parameters to identify gaps

Figure 5 shows the image obtained through the combination of parameters that presented greater capacity of detection of voids. The image presented is the result of the analysis of a wall without armature, tested by an experienced operator, in a grid of 25cmx25cm on the smooth face of the element. As can be seen in the figure, even with the best combination of parameters, no artificially introduced voids could be accurately located.

Apparently, the natural variability of the readings along a real-scale concrete piece had similar or greater magnitude to the reading deviations caused by the presence of the induced defects (with the dimensions and materials used, and positioned at the depths of that test). It is believed that the presence of the defects was not significant due to their small size in relation to the grid, associated with the compactness of the material used to simulate them (Styrofoam).

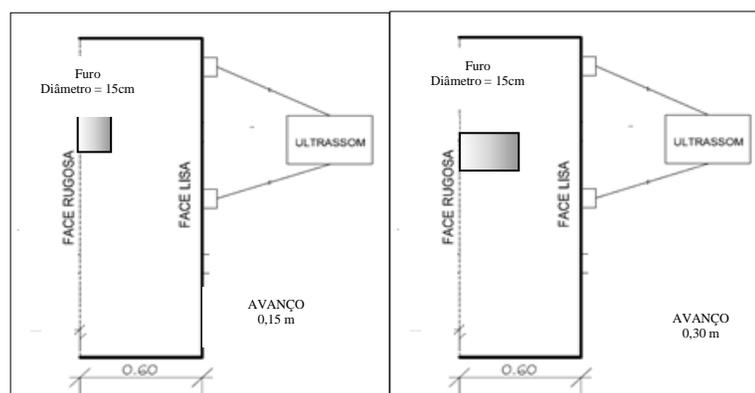
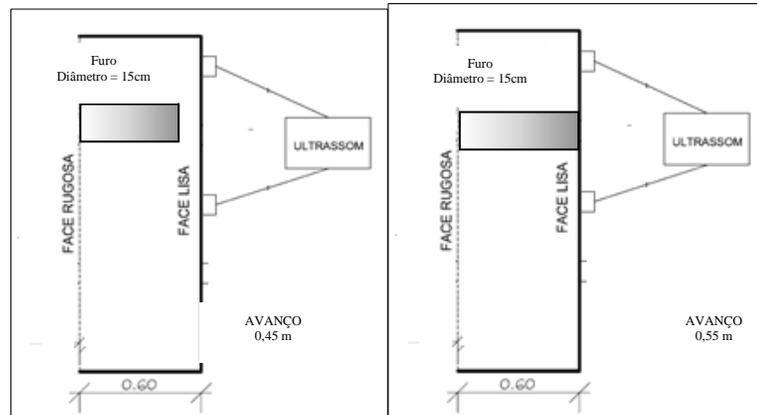
Figure 6. Drill advance diagram

This step was intended to accurately identify to what depth an artificially triggered fault could be located through the test. Figure 6 shows the sequence of some successive perforations and readings that were performed. For this step a region of the block without artificial defects was chosen so as not to interfere with the results.

As can be seen in Figure 6, the drilling was performed in several steps. A velocity reading was performed just before the first drilling. With the use of a 150mm inner diameter diamond drilling machine, 15cm was drilled from the rough face towards the smooth face (read face), where the internal material was removed from the hole, avoiding any interference that this could cause in the results. Then, readings of UPV were made on the opposite side.

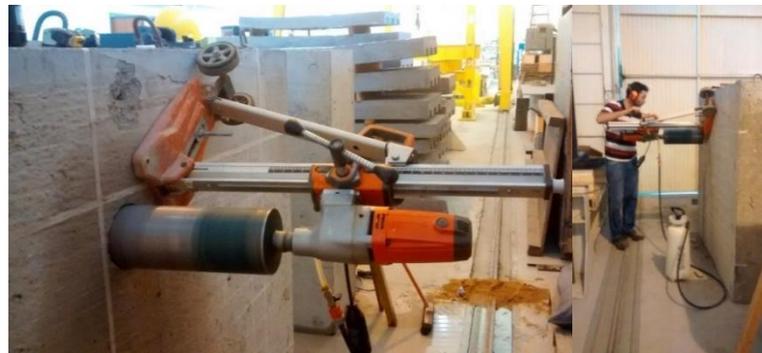
Figure 7. Drill advancement steps

This procedure was identical and strictly respected in the depths of advance of 15cm, 20cm, 25cm, 30cm, 35cm, 40cm, 50cm, 55cm and 60cm. Figure 7 shows the drilling equipment positioned and starting the job. After the closure of the perforations, UPV measurements were again made, even with the hole already apparent on the test face. As a last procedure, the hole was filled with mortar with a compressive strength of 4 MPa, which corresponds to approximately 10% of the compressive strength of the concrete used, simulating alternatively a void of concrete or non-resistant material trapped inside the structure. As in the other stages, UPV readings were acquired after 28 days of filling the hole with the mortar. Figure 8 shows one of the readings acquired at 60cm depth.

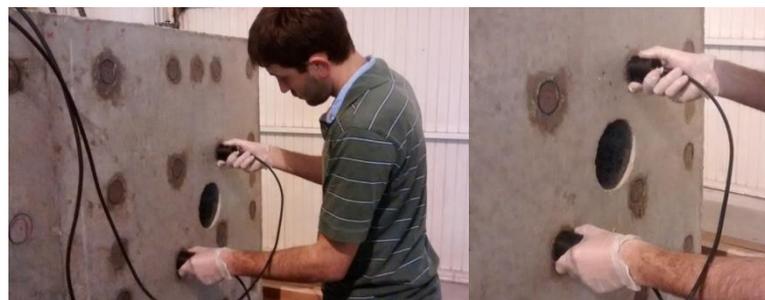
Figure 8. Measurements performed at 60 cm depth

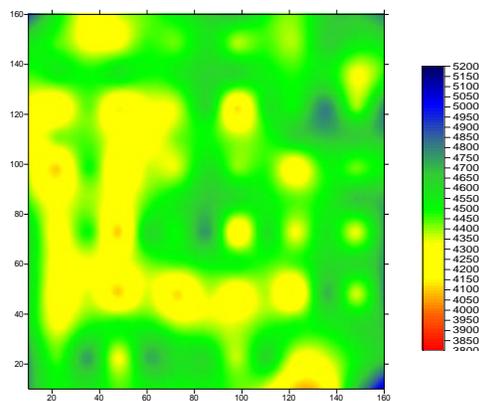
Figure 9. Measurements made for calibration

Figure 9 shows the generated image. After the validation of the measurements, the procedures described above were started with the drilling of a section, UPV measurements, image generation, new drilling and so on until the other side of the element was reached.

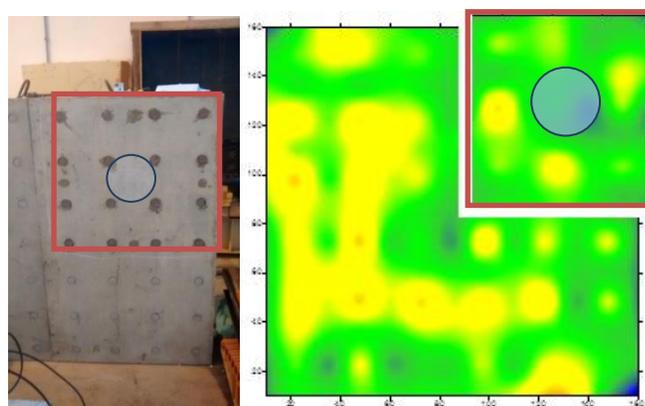
Figure 10. Delimited region and respective image generated.

In this phase an area for the UPV measurements corresponding to $\frac{1}{4}$ of the total surface was delimited. This decision was made by covering only the region of possible interference that the hole could cause, thus allowing a greater number of successive readings. Figure 10 shows the section of the wall used in the measurements of UPV and respective segment of image generated.

The images presented from this moment on are always relative to the area delimited in red. Initial tests were conducted to decide which region to limit without any harmful effects to a correct interpretation. For a comparison, a minimum speed of 3800 m / s representing regions under suspicion and a maximum speed of 5200 m / s were used for all images, symbolizing

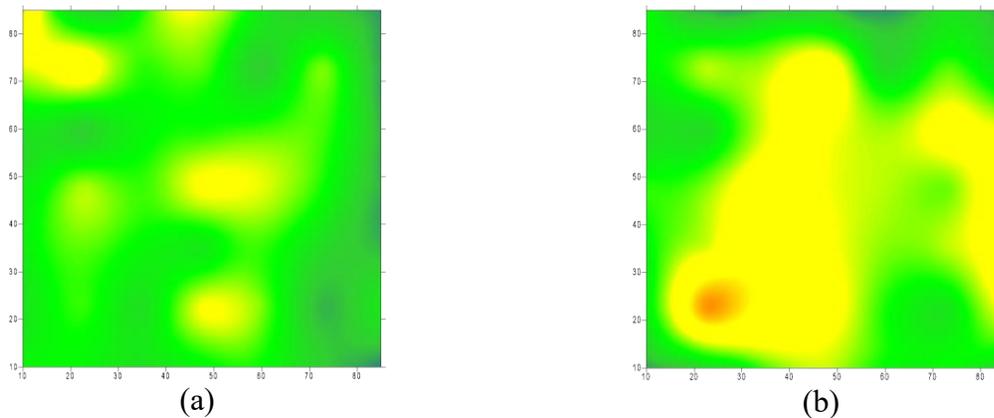
Figure 11. Image corresponding to the depth of: (a) 0,0 m and (b) 0,15 m

We can observe in the images that up to the depth of advance of 35cm no significant changes occur in the analyzed region. We can conclude that for the study situation, it was not possible to detect signs of the presence of the hole. The differences observed are only derived from small variations and test noise.

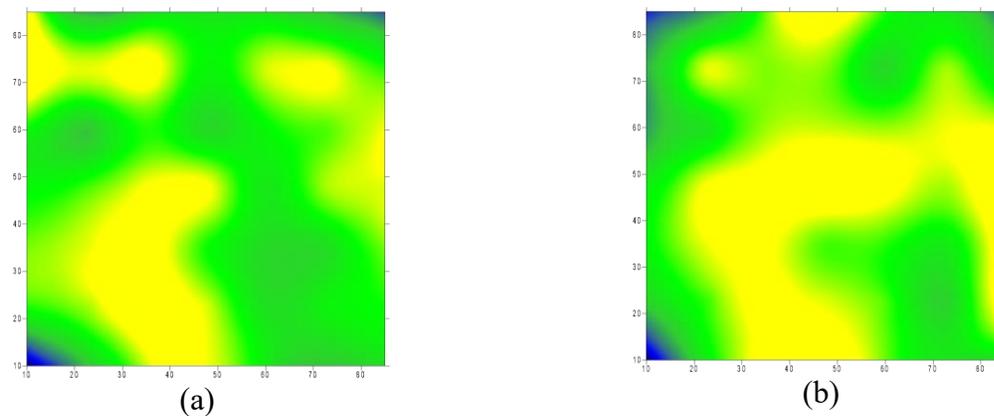
Figure 12. Image corresponding to the depth of: (a) 0,20 m and (b) 0,25 m

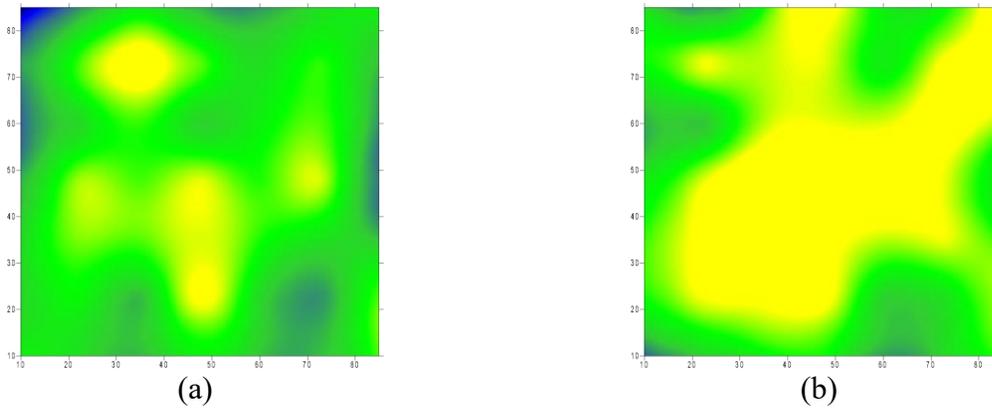
Figure 13. Image corresponding to the depth of: (a) 0,30 m and (b) 0,35 m

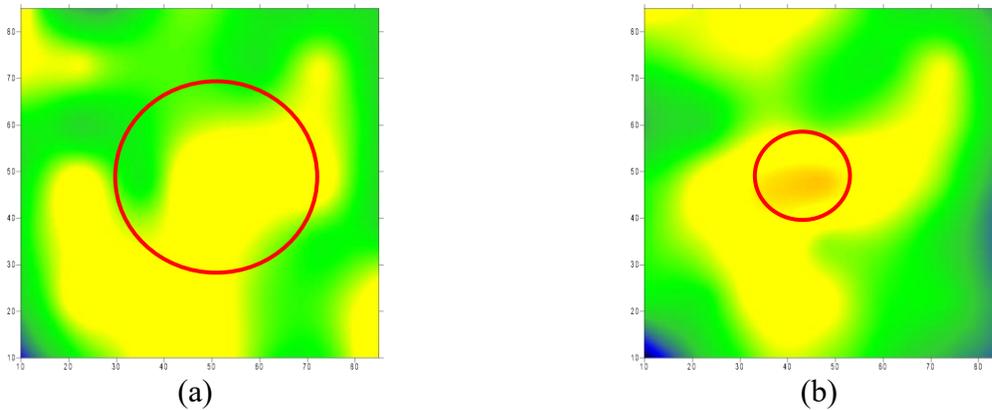
Figure 14. Image corresponding to the depth of: (a) 0,40 m and (b) 0,50 m

Figure 14 shows the sequence of images obtained and the respective depth of the hole for depths between 40 and 50 cm. Based on the results obtained in the images, a significant reduction in velocity averages was observed, especially in the central region, exactly in the area where the hole is located. From the analysis of these results it is possible to visualize evidence of the presence of the defect.

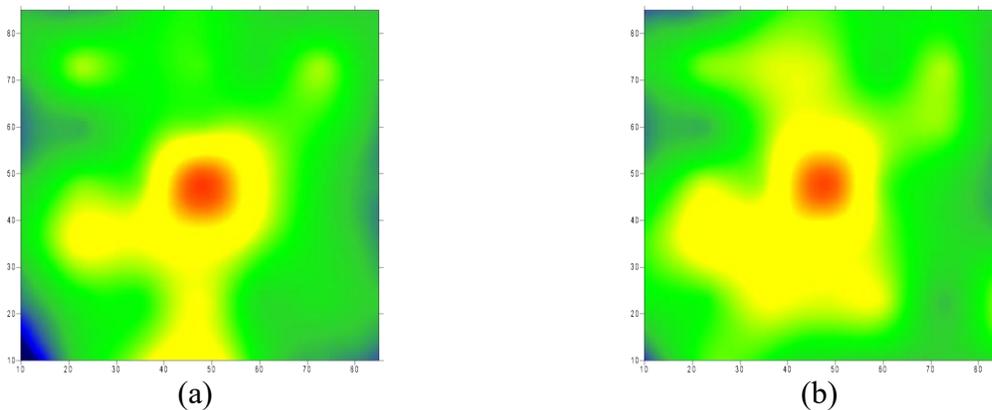
Figure 15. Image corresponding to the depth of: (a) 0.55 m and (b) 0.60 m

Figure 15 shows the obtained images and the respective depth of the hole for depths between 55 and 60cm. From the images generated for the last 10cm of advance, it is clearly observed the presence of the hole, which demonstrates the ability to detect defects to a depth of approximately 10cm.

As can be seen, the generated image was also able to represent with relative precision the size of this void. After completing the drilling step, a complete reading of the wall was again performed, thus verifying if the behavior presented in the specific images of the perforated region would also be verified in a global interpolation of the element.

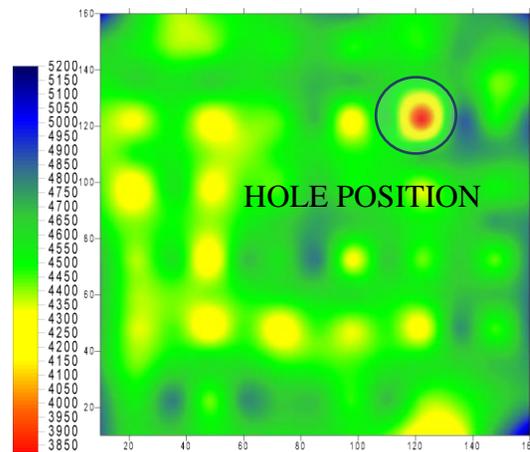
Figure 16. Image corresponding to the depth of 60 cm - full face

Figure 16 shows the result of this interpolation and generation of the respective image. Analyzing the generated image can be observed with ease the connection between the actual position of the hole with a considerably lower speed region shown in the image.
