ALCONPAT International

Revista ALCONPAT

This V9N2 issue begins with a work from **Brazil**, where Graziela Pereira da Silva and colleagues present a review about the influence of infrared thermography on masonry walls to detect pathological manifestations. A systematic review was carried out through research with automatic search and snowballing, selection and sifting of articles to restrict them to the desired theme. After that, infrared thermography in the pathological manifestations was studied along with the thermal properties and their behavior, thermal bridges, temperature difference and air infiltrations. Some care must be taken during the execution of experiments and measurements. It has also been shown that infrared thermography is a complex technique.

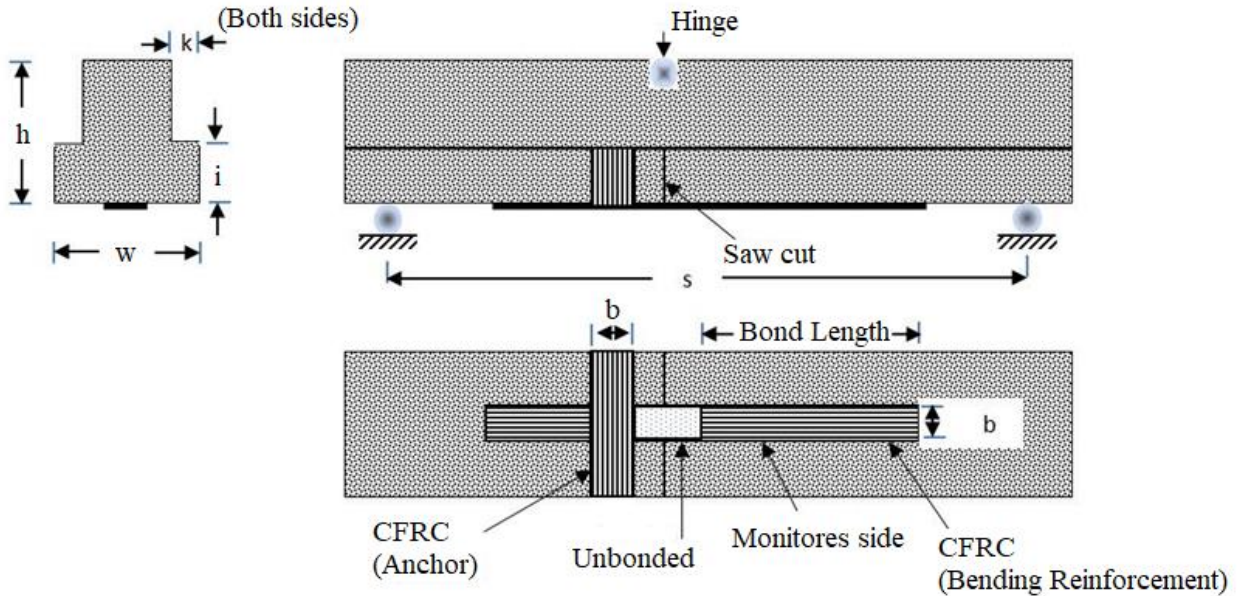
Figure 1. Test specimen showing dimensions of the concrete beam and the position and dimensions of the CFRC bending reinforcing as well as the CFRP anchor. (After De Lorenzis, L. 2001)

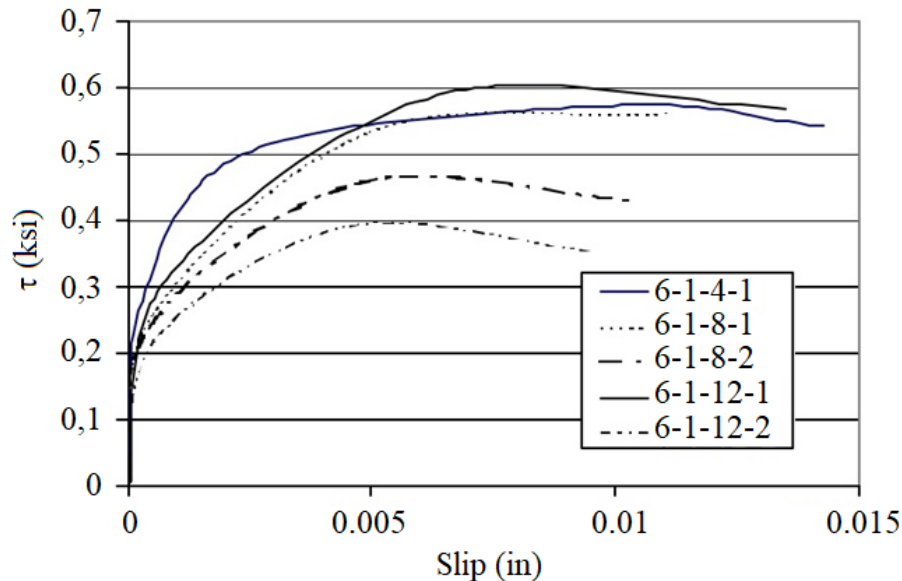
Figure 2. Local τ -slip relationships for specimens with different CFRP bond lengths (4, 8 and 12 in) bonded on the tension side of a concrete beam. Note: 1 in= 25.4 mm; 1 psi= 7.03 kPa (De Lorenzis et al (2001)).

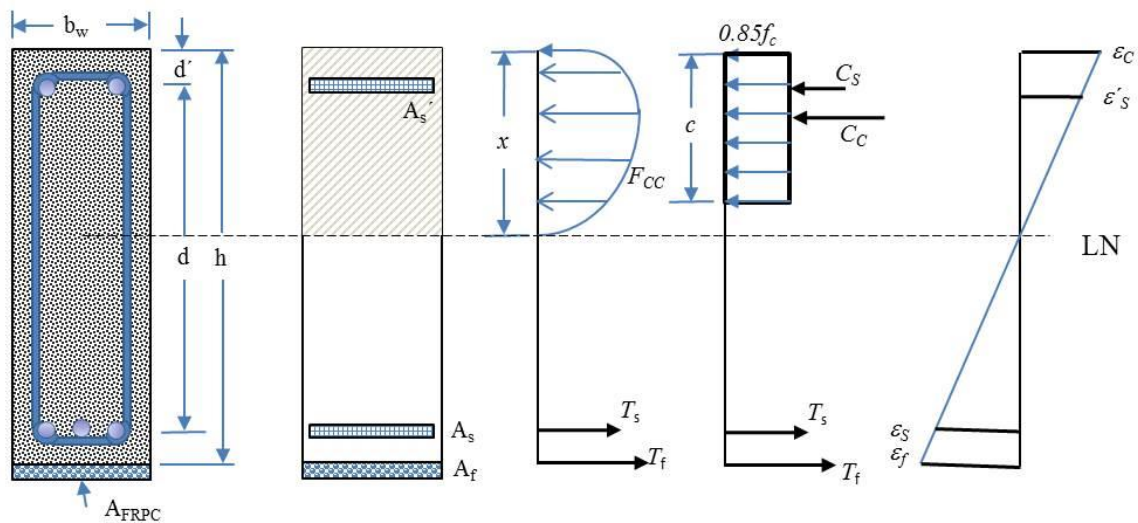
Figure 3. Stress-strain diagram of a steel-reinforced concrete beam strengthened with CFRP (After Ferreira et al 2018)

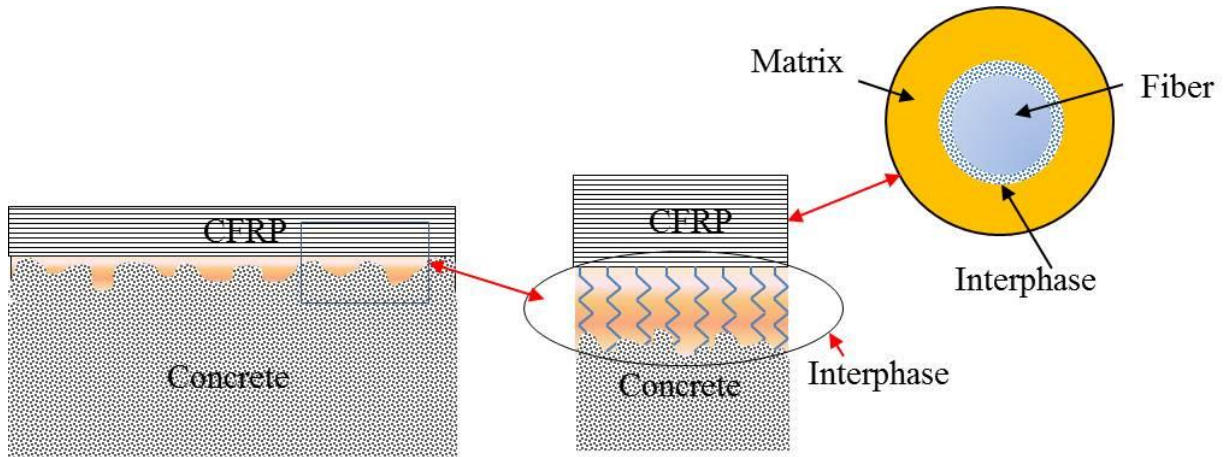
Figure 4. Schematic representation of the formation of dual interphases formed by the use of laminates or fabrics to retrofit steel reinforced concrete beams. One concrete-resin interphase and one fiber-matrix interphase.

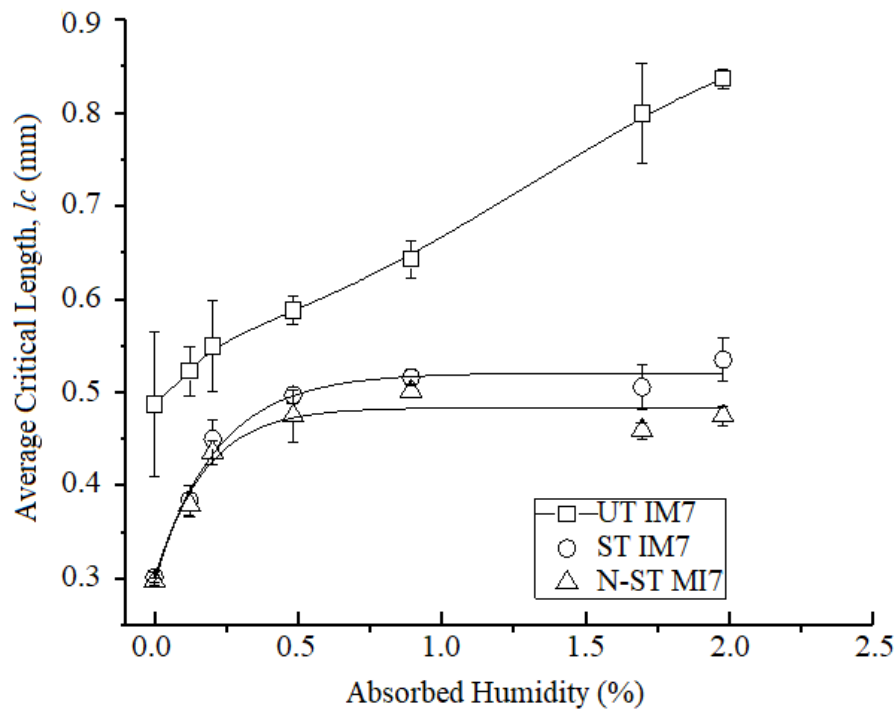
Figure 5. Fiber fragment length a function of matrix-interphase absorbed humidity in the composite, for untreated surface carbon fibers (UT IM7); silane coupling agent treated surface IM7 carbon fibers (ST IM7) and, nitric acid and silane coupling agent treated surface IM7 carbon fibers (N-ST IM7), (J. I. Cauich-Cupul et al, (2011))

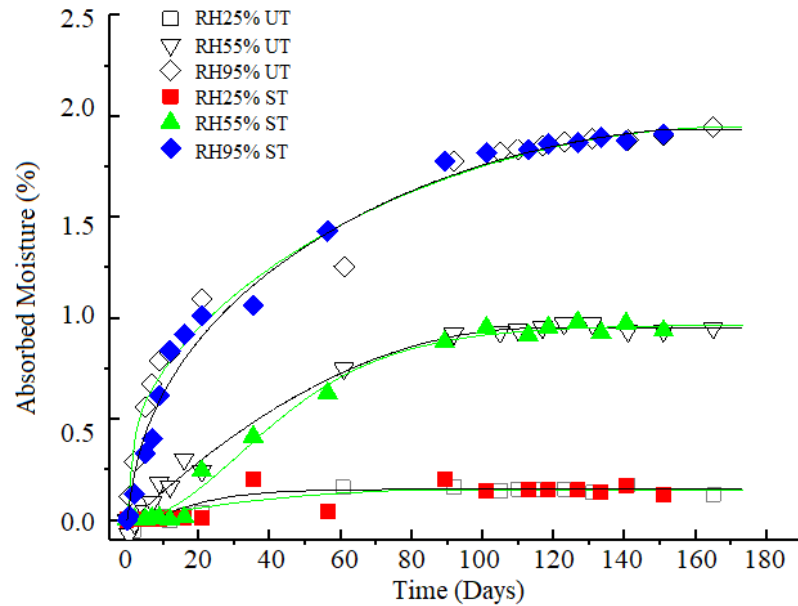
Figure 6. Absorption of moisture in the composite material laminate for different relative humidity environments. Without treatment: (UT) silane surface treatment (ST). RH25% UT, RH55% UT, and RH95% UT, and with silane surface treated fibers RH25% ST, RH55% ST and RH95% ST. (Perez-Pacheco, *et al* (2013))

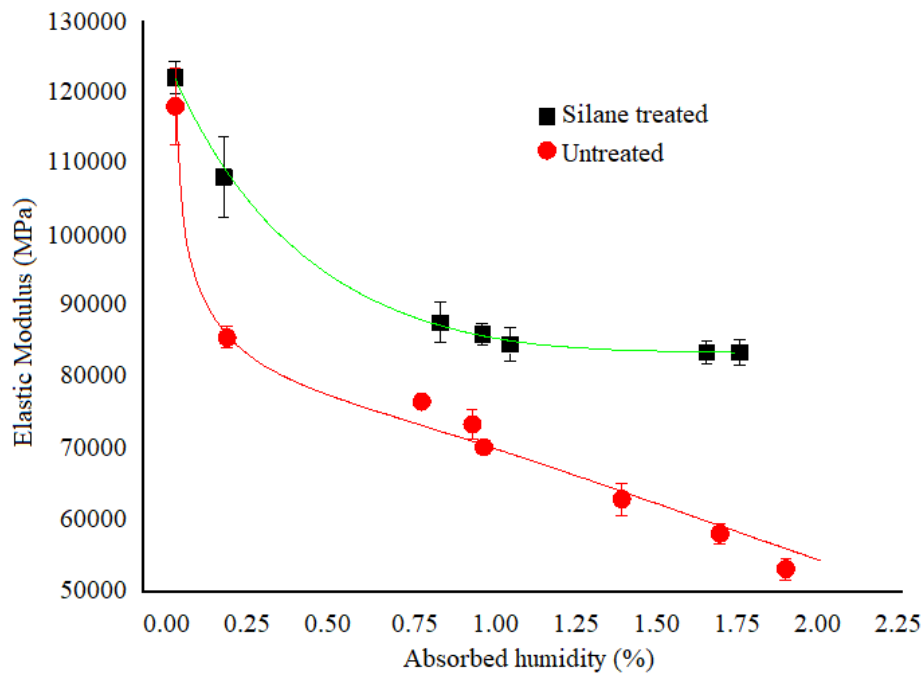
Figure 7. Behavior of the elastic modulus with respect to the moisture absorbed for the composite material with the treated and untreated fiber, respectively. (Perez-Pacheco, *et al* (2013))

Plasticization of the epoxy matrix by moisture lead to the change in its glass-transition temperature (T_g) thus affecting the mechanical response of the composite. It was observed that the tensile strength of laminates made with the silane coupling agent showed a decrease but after a moisture uptake of approximately 0.45 %, the tensile strength remained constant. Then, the use of a proper silane coupling agent to enhance adhesion resulted in improved mechanical properties and reduced the dependence of the properties on humidity under tensile loading (see figures 7 and 8).

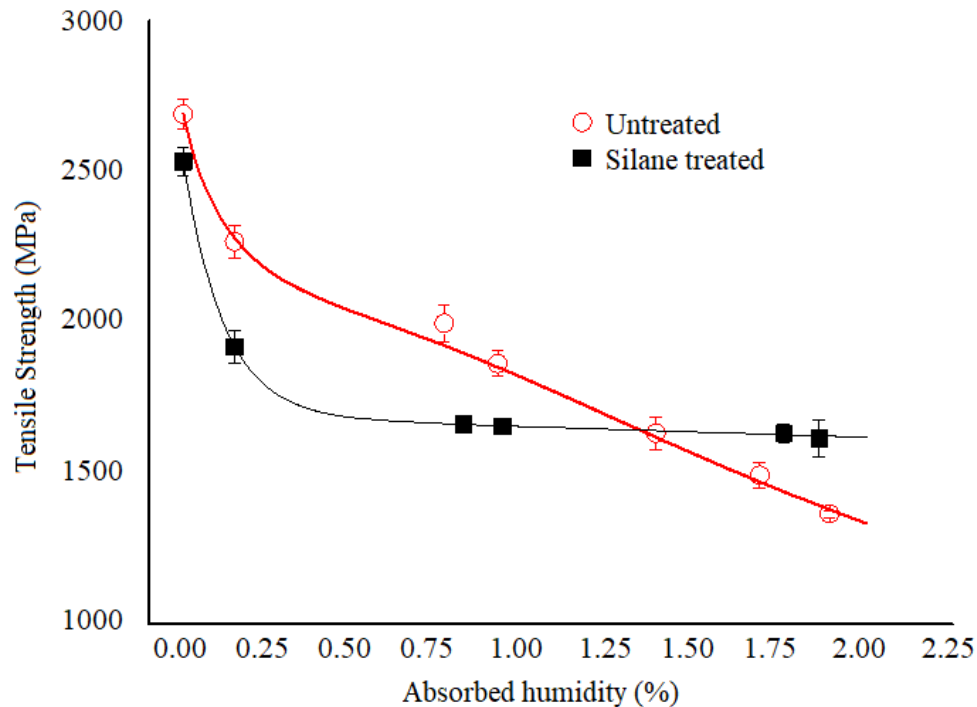
Figure 8. Tensile strength of a CFRP material made on the composite material after suffering hygroscopic degradation, for two different fiber-matrix interface conditions, that is, for treated and untreated fibers, respectively (Perez-Pacheco, *et al* (2013))

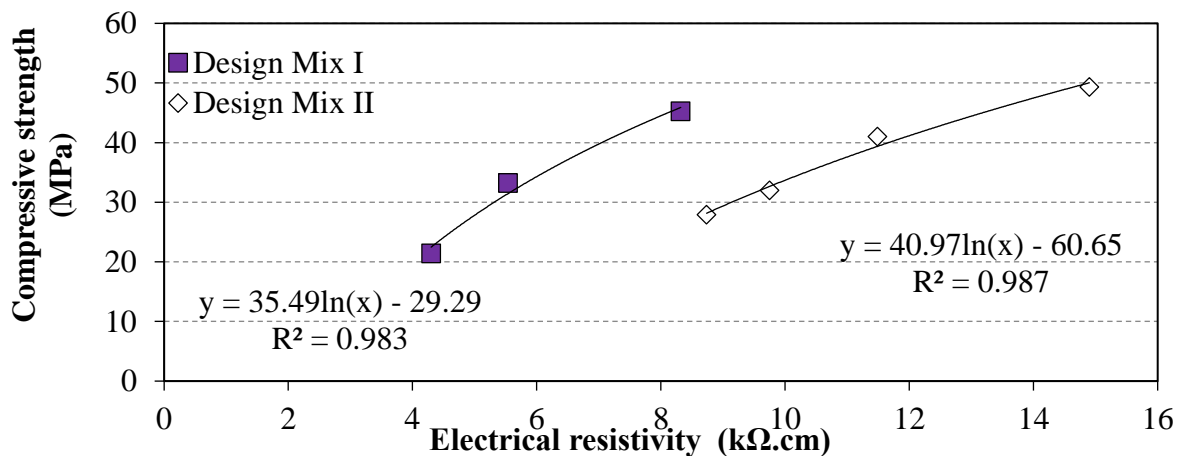
Figure 1. Correlation between electrical resistivity and compressive strength.

In Figure 1, both parameters are directly proportional, i.e., the greater the compressive strength, the greater the electrical resistivity. This behavior was also noted by Dinakar et al. (2007) and Lubeck et al. (2012), and it is related with the clear influence that the porosity has over both properties. Moreover, the good graphical correlation shown in Figure 1 (both R-Squared over 0.98) reaffirms this relation.

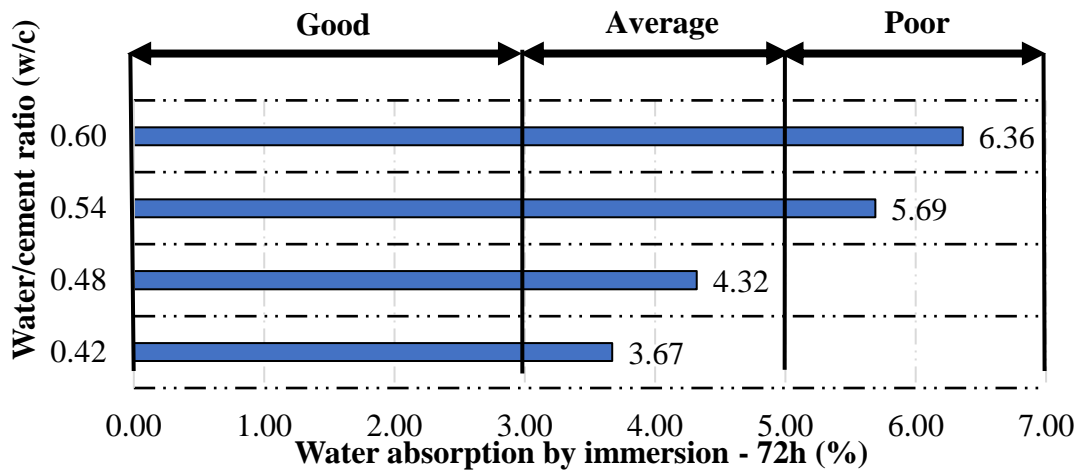
Figure 2. Water absorption by immersion and the concrete quality according with the criteria proposed by the CEB192 (1989).

In addition, according with the Comité Euro-International du Béton (CEB 192, 1989), the concrete may be qualitatively classified as good, average or poor, according to its absorption by immersion level. Figure 2 correlates the results obtained through the experiments with these levels. In Figure 2, while the higher water/cement ratios (0.60 and 0.54) are associated with poor quality concrete, the lower values of this parameter (0.42 and 0.48) classified the concrete with an average quality.

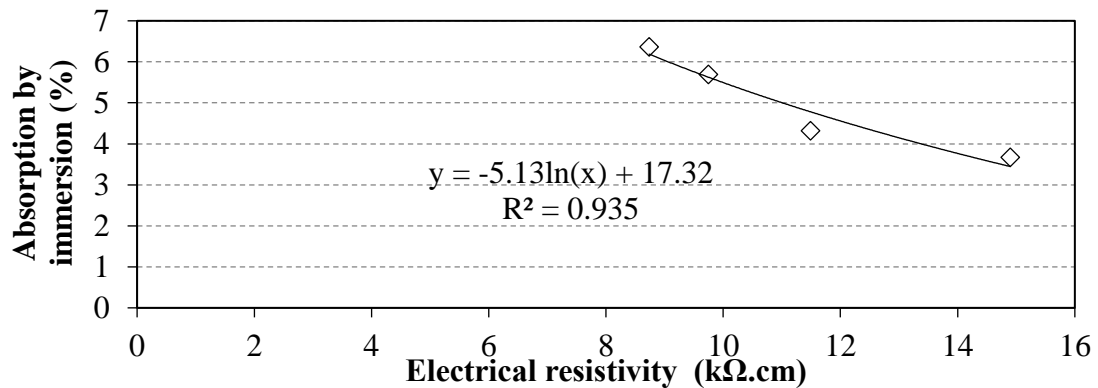
Figure 3. Correlation between electrical resistivity and absorption by immersion.

The good correlation obtained in Figure 3 portrays the inversely behavior between the water absorption by immersion and the electrical resistivity. Thus, the water absorbed into the concrete microstructure enhances its electrical conductivity and, consequently, reduces its electrical resistivity. Figure 4 correlates the water absorption by immersion and the compressive strength, using a logarithmical approach.

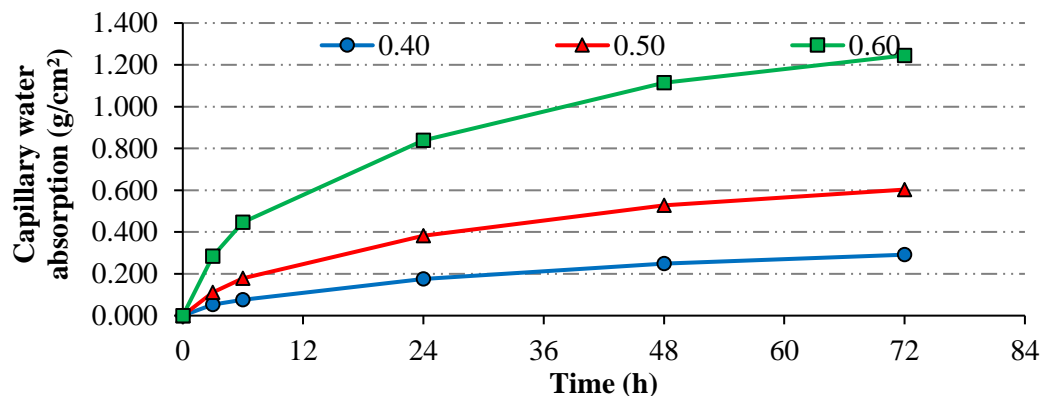
Figure 5. Absorption by capillarity over time - Design Mix I.

Figures 5 and 6 show the variation of the water absorbed by capillarity over time for Design Mixes I and II, respectively. Water absorption by capillarity increased over the 72-hour exposure, in both mixtures. However, as the specimen approached its maximum absorption capacity, a stabilization tendency was identified. This behavior could be observed by different slopes in the curves over time. Usually, the increase in the absorption level was greater during the first 12 hours of the experiment.

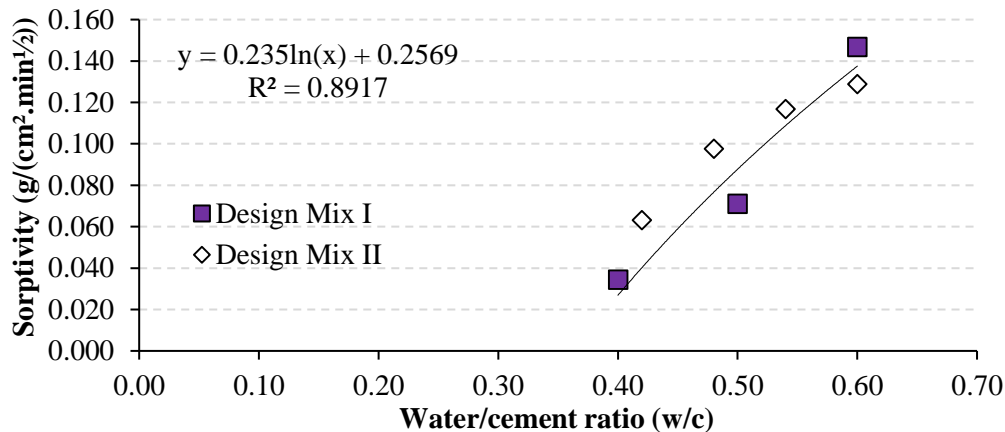
Figure 7. Sorptivity variation with different water/cement ratios.

Furthermore, in order to determine the sorptivity of the concrete, the results obtained with the absorption by capillarity experiment was used in Eq. (1). The sorptivity of the specimens ranged from 0.034 to 0.147 $\text{g}/(\text{cm}^2 \cdot \text{min}^{1/2})$. Figure 7 illustrates the correlation and the variation of this parameter according with the water/cement ratio.

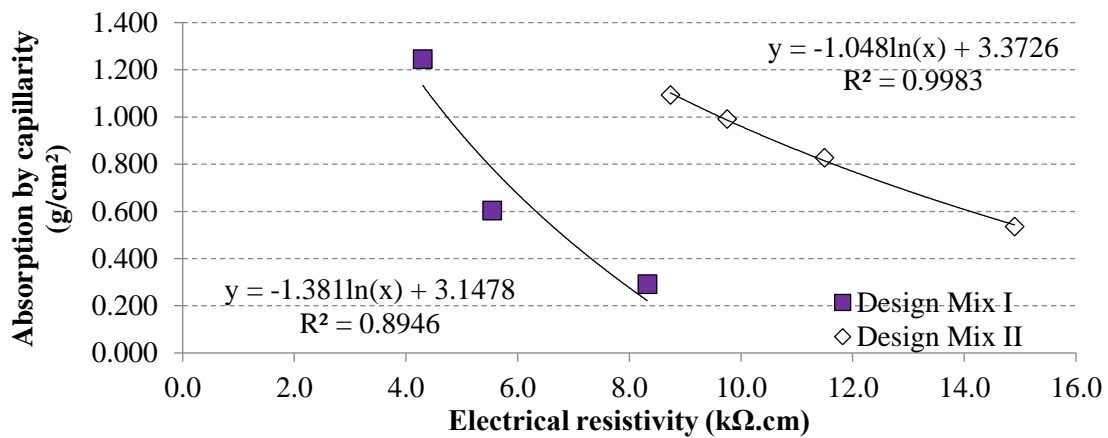
Figure 8. Correlation between electrical resistivity and water absorption by capillarity.

In addition, the water absorption by capillarity was correlated with other properties of the concrete. Figure 8 shows the capillary absorption after 72 hours and the electrical resistivity correlation. Figure 9 presents the behavior of the capillary absorption versus the compressive strength.

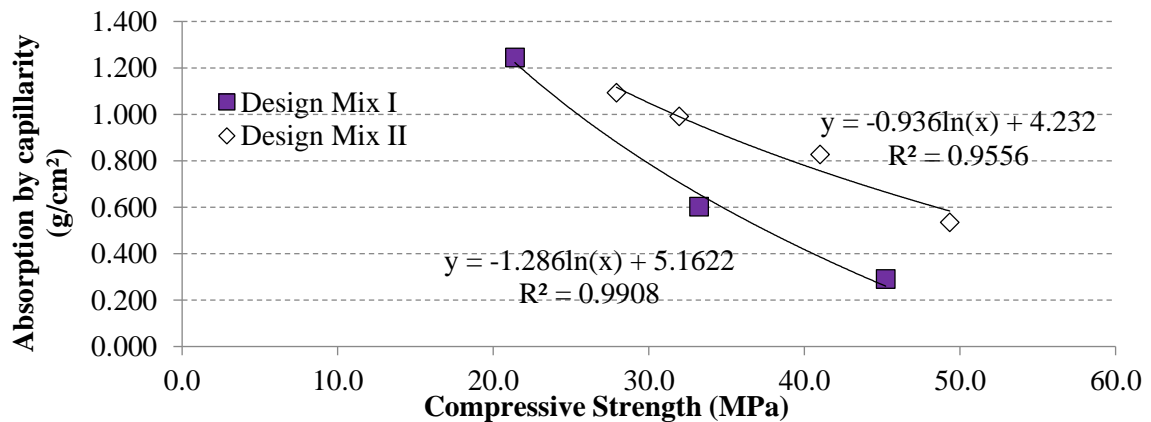
Figure 9. Correlation between the compressive strength and the water absorption by capillarity.

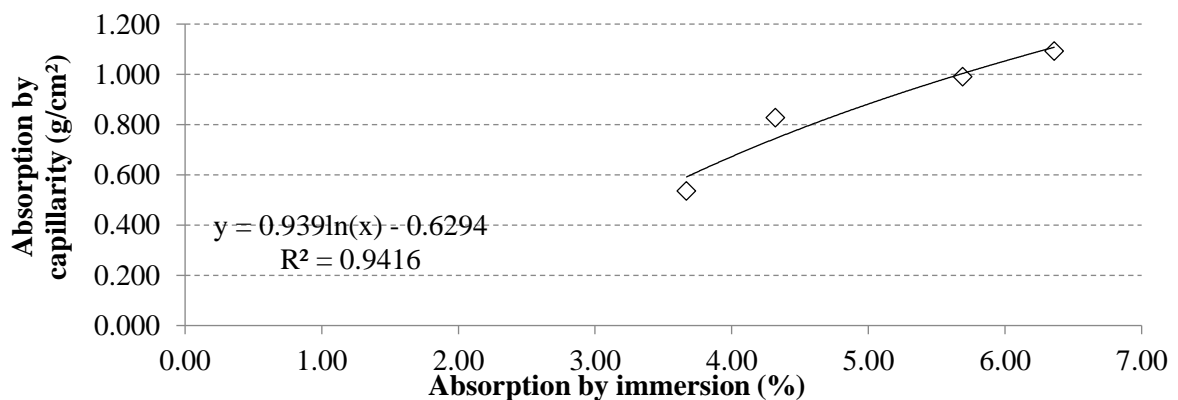
Figure 10. Correlation between water absorptions by immersion and by capillarity.

Furthermore, Figure 10 shows the correlation between the water absorption by immersion versus capillarity. Both absorption measurements are directly-related and according to Figure 10, a high dependence can be identified among them, consolidating the influence of both properties in the water absorption and percolation in the concrete microstructure.

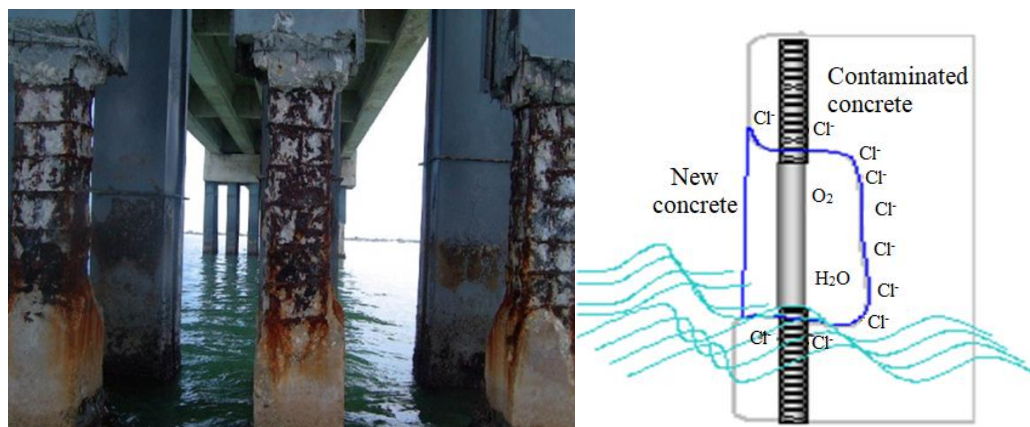
Figure 1. Repairing concrete structures using stainless steel proposed by Pérez Quiroz, (2009)

Perez Quiroz (2016) pointed out that to avoid carbon diffusion into the stainless steel and to minimize the damage risk due to corrosion during welding, buttering using Inconel 182 is a good option. Thus, it is desirable to investigate the metallurgy of dissimilar welded joints and the corrosion behavior of such welded unions. Today, there are few studies that evaluate the corrosion behavior of joints between carbon and stainless steel with and without buttering using Inconel. Therefore, in this work the corrosion resistance of welded joints between carbon and stainless-steel bars with and without buttering using Inconel 182 was tested to evaluate this methodology for refurbishing the concrete structures of maritime piers (Figure 1).

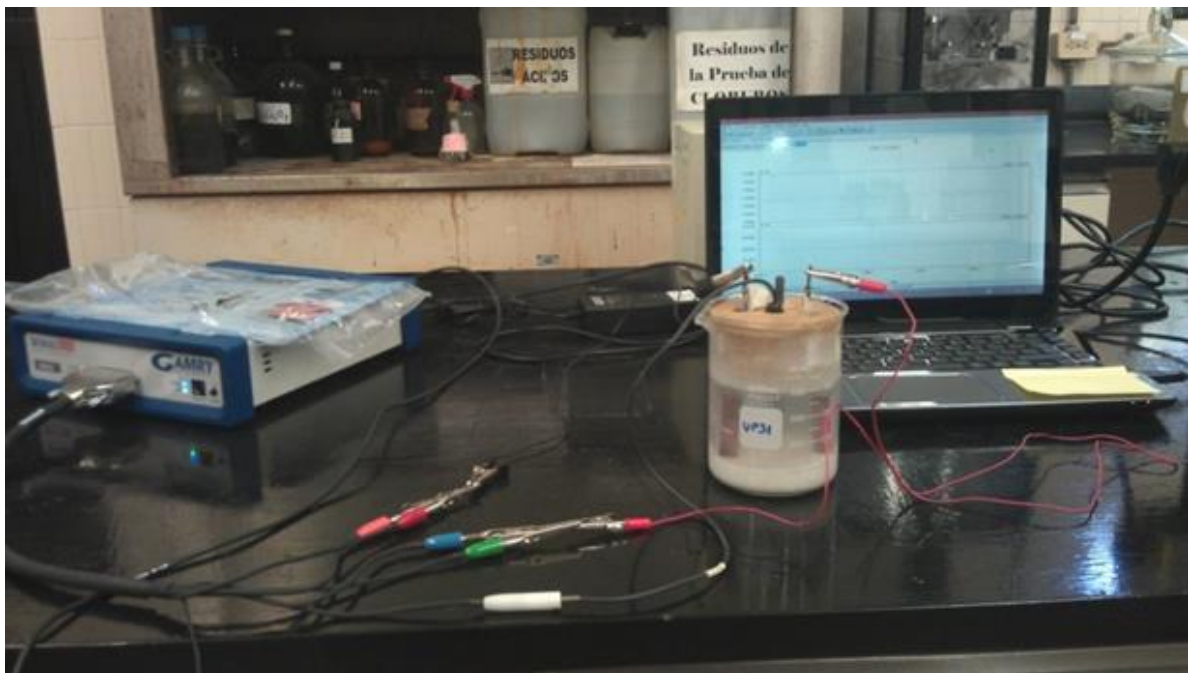
Figure 3. Electrochemical cell setup for corrosion tests.

The EN technique was performed with the help of a Gamry Interface 1000 potentiostat. This equipment is capable of measuring in real time the oxide-reduction phenomena that occur in the electrodes. The number of readings per test piece was 2048, with stabilization time of 10 seconds; the test time was 45 min. This test requires three electrodes, two are identical steel electrodes, and a silver / silver chloride (Ag / AgCl), as reference electrode.

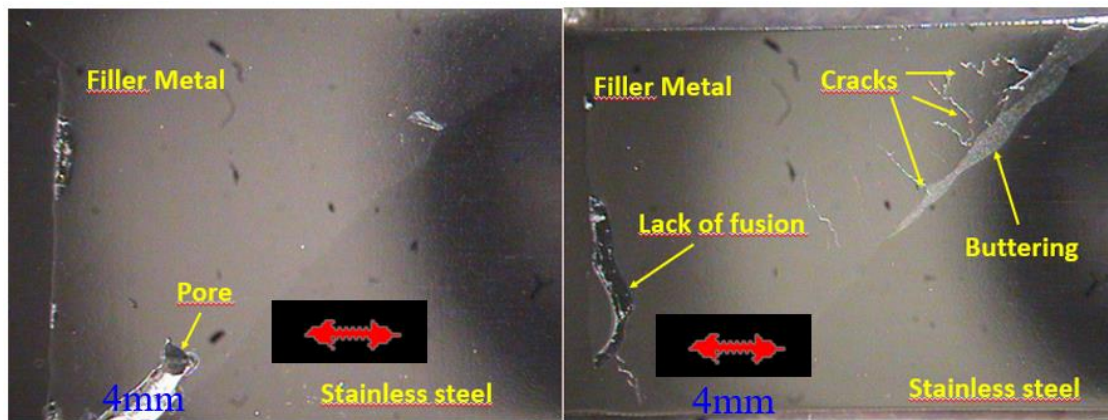
Figure 4. Samples at 7x magnification showing cracks and lack of fusion of the dissimilar welded joints.

Before electrochemical testing, the samples were observed using a stereoscopic microscope, and cracks were observed in the samples where buttering was carried out (Figure 4); those cracks (approximately 2 mm in length) are associated with hot cracking owing to the nickel content in the Inconel 182 used for buttering. Recall that buttering is applied to dissimilar welded joints in order to prevent carbon diffusion, phase segregation, and chromium carbides precipitation, as these phenomena influence corrosion behavior in stainless steel. The results match those of Evans (1962), who reported that nickel alloys welded to stainless steel are susceptible to hot cracking. The macrographs in Figure 4 show some lack of fusion near the carbon steel/filler metal/buttering interface. Such defects should not influence the corrosion behavior of the welded joint because they are in the interior of the metal, but if the electrolyte were to make contact with them, they would become an anode and would allow localized corrosion. On the other hand, they have a strong impact on the mechanical properties because they act as stress risers / concentrators.

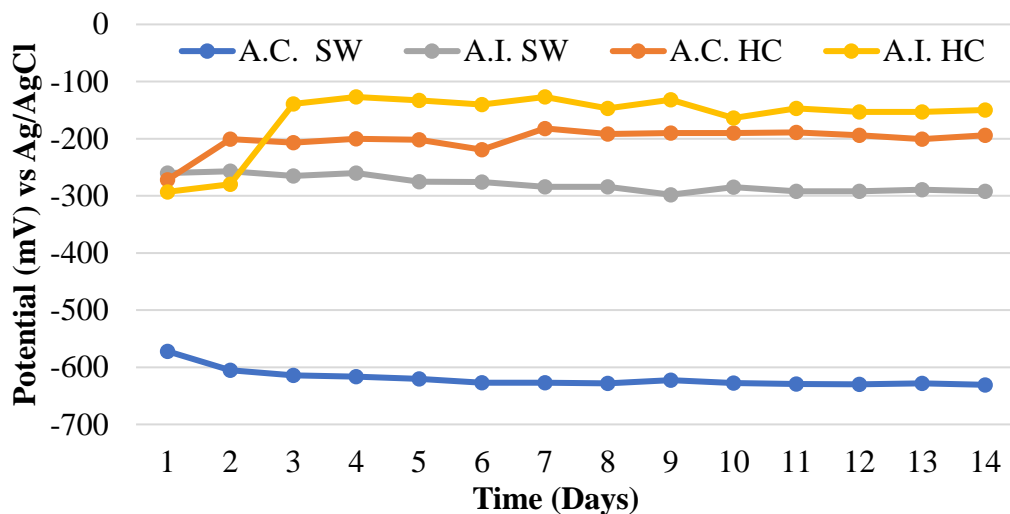
Figure 5. Corrosion potentials of the base metals in sea water and calcium hydroxide.

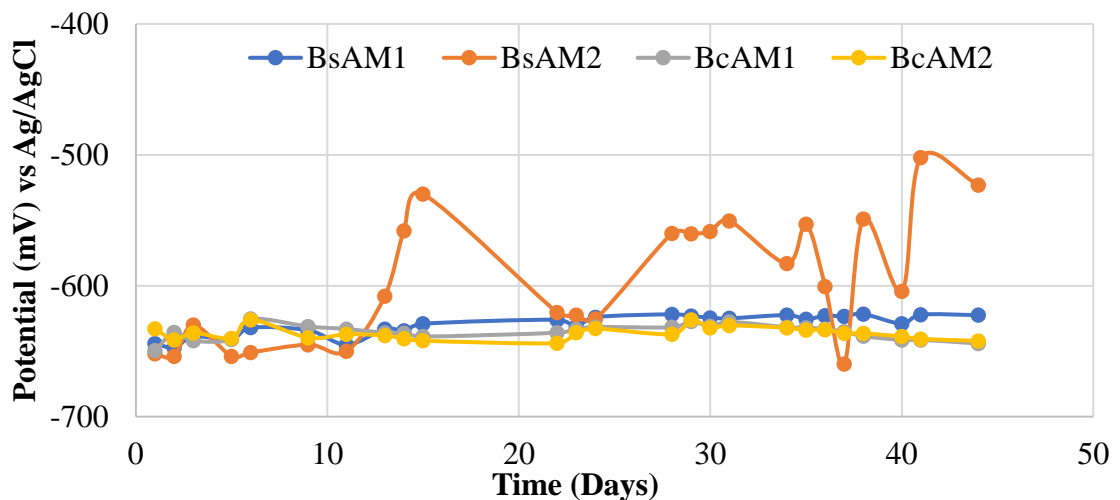
Figure 6. Corrosion potential vs time in single bevel welded joints in sea water.

Figure 6 shows the relationship between corrosion potential and time for single bevel welded joints in 3.5 wt % NaCl solution. The values fall within the high probability corrosion range according to ASTM C 876 (2015), but in accordance with Sistonen (2002), they fall within the range of severe corrosion risk. Note that the variation of the corrosion potential of sample BsAM2 was caused by experimental error, although the trend follows the other samples, where the corrosion risk is high.

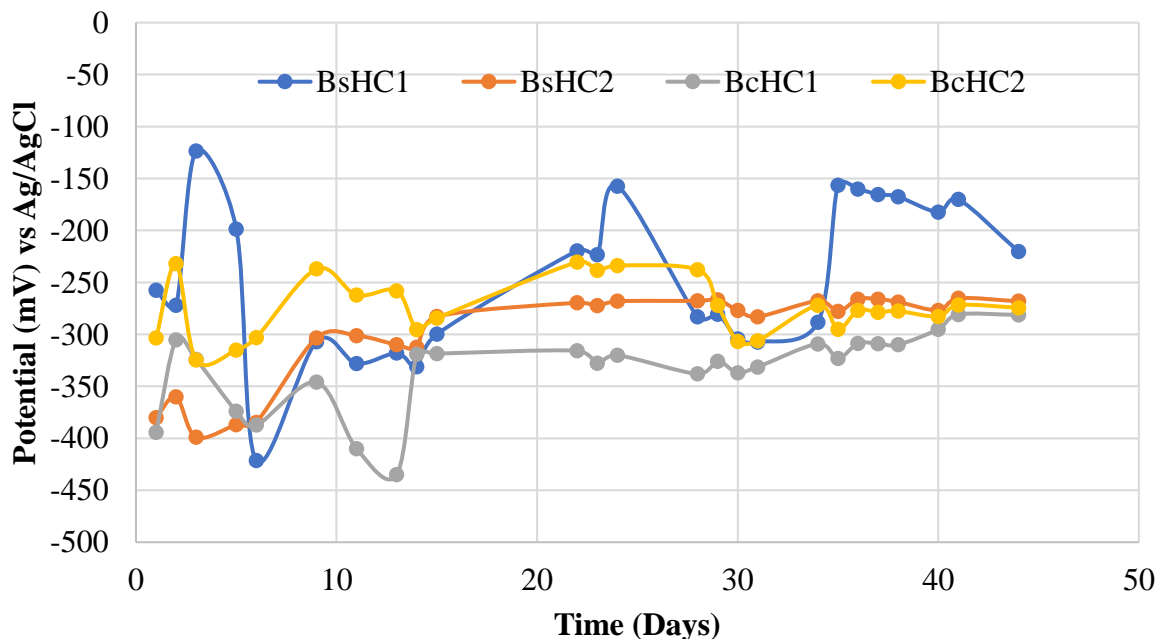
Figure 7. Potential vs time for single bevel welded joint in calcium hydroxide.

Samples with higher numbers of defects (pores, cracks, etc.) were selected for testing in calcium hydroxide to investigate if they generated a passive layer, which reduces the corrosion rate. Figure 7 shows the results, indicating that after 15 days, the values are in the probable corrosion range according to ASTM C 876 (2015) and Sistonen (2002). However, after 20 days the corrosion potentials changed to more positive values. These results indicate that the corrosion process occurred during the first 14 days, after which a compact, adherent passive layer was formed on the surface of the samples owing to the alkalinity of the environment, according to ASTM C 876 (2015) and Sistonen (2002). Thus, based on these criteria, further corrosion damage in carbon steel, stainless steel, and the welded joint should be minimal. Note that for this test, samples with a higher number of defects were selected (with and without buttering). Thus, the results suggest that alkaline conditions lead to minimal damage due to corrosion in the case of reinforcement bars for concrete.

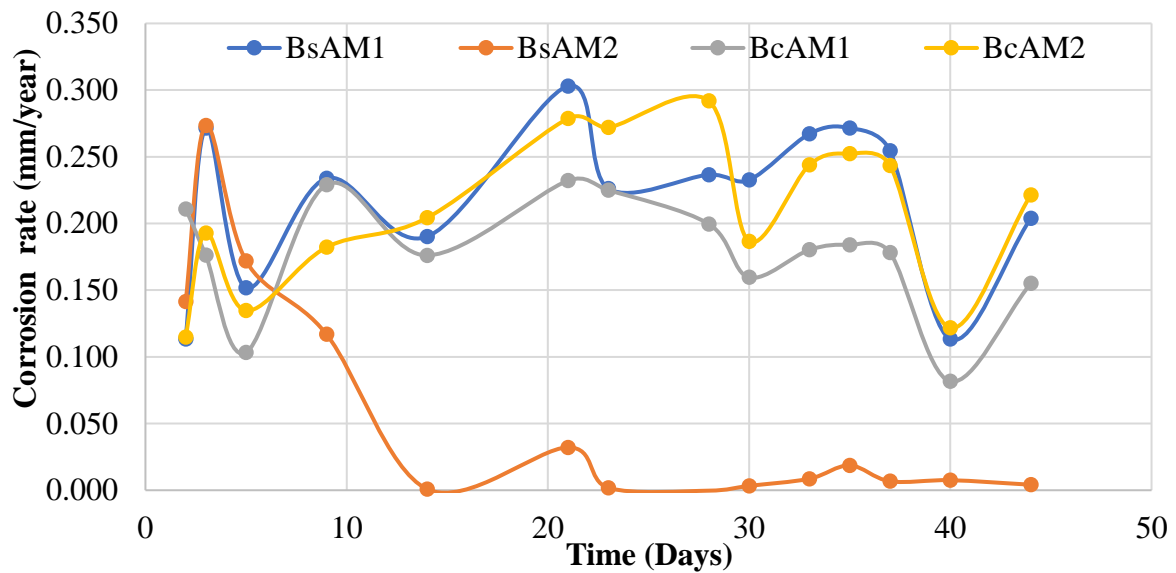
Figure 8. Corrosion rate of single bevel welded joints in sea water.

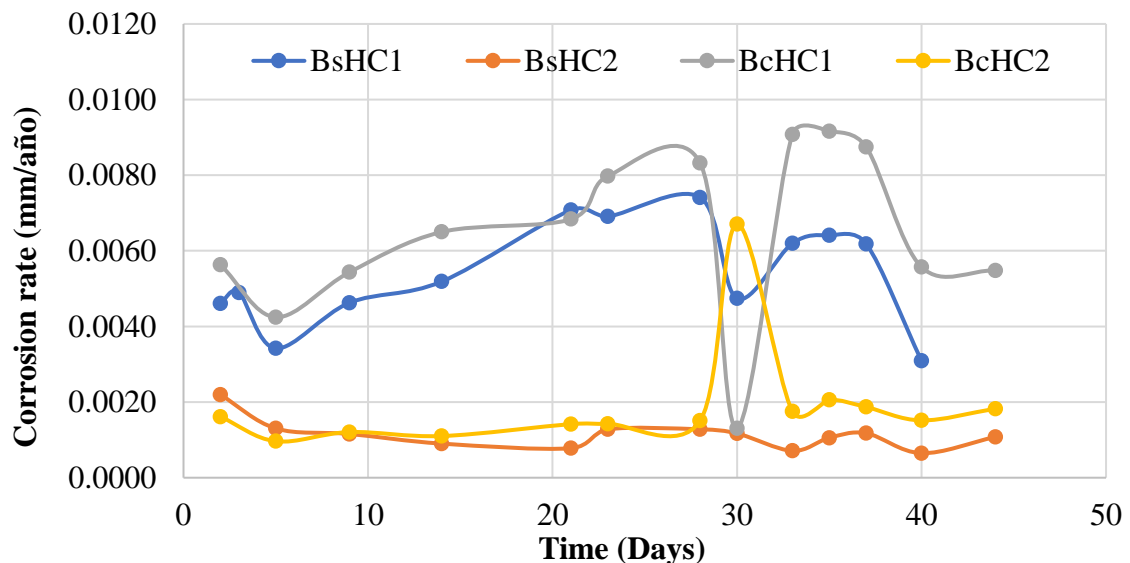
Figure 9. Corrosion rates of single bevel welded joints in calcium hydroxide.

Figure 9 displays changes in corrosion rate for calcium hydroxide, which are related to the beginning of the corrosion process and the possible passivation of the sample surfaces because of the alkaline medium in which the samples were tested.

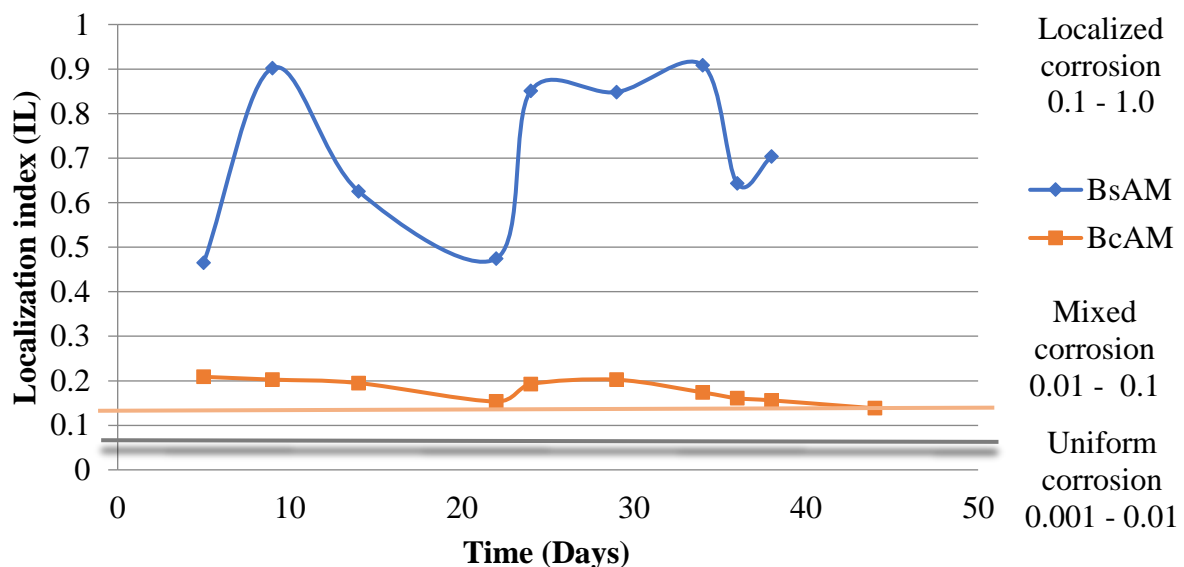
Figure 10. Results of electrochemical noise testing of BsAM and BcAM samples in seawater.

Although the values of I_L of the BcAM samples are in the localized corrosion range, the corrosion products are uniformly distributed on the sample surfaces, which agree more closely with the mixed corrosion criterion. This suggests that buttering leads to more uniform corrosion. The general scientific consensus is that uniform corrosion is less aggressive than pitting and crevice corrosion, because the latter types of corrosion cause structural damage and can lead to catastrophic failure.

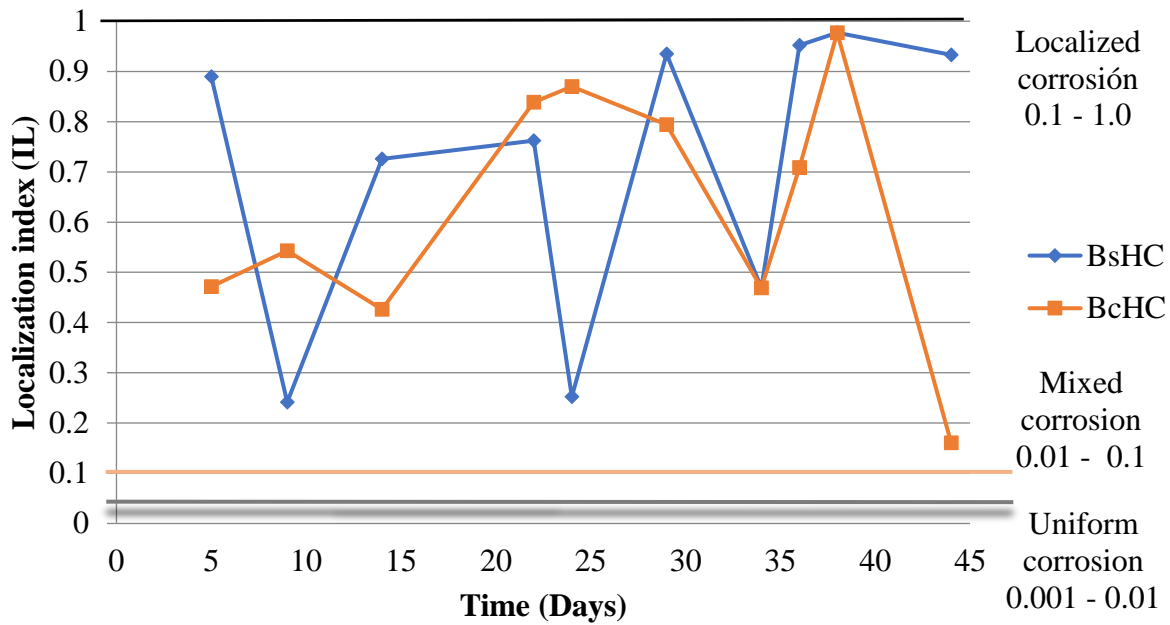
Figure 12. Graph of I_L values for samples BsHC and BcHC tested in calcium hydroxide.

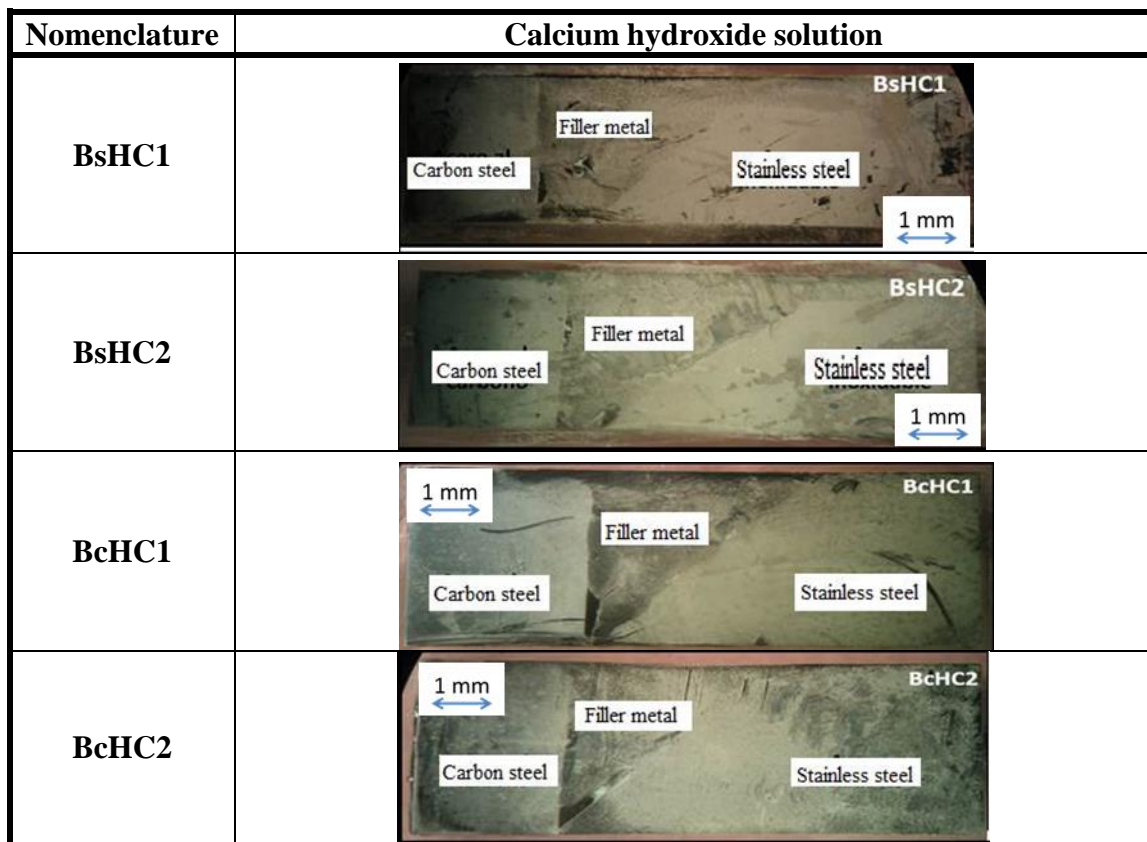
Figure 13. Surfaces of BsHC and BcHC samples after testing in calcium hydroxide. (Ramírez 2016)

Figure 13 shows stereographic images of samples tested in calcium hydroxide, which were covered with a white color layer (calcareous deposit), which forms a passive layer on the samples' surfaces.

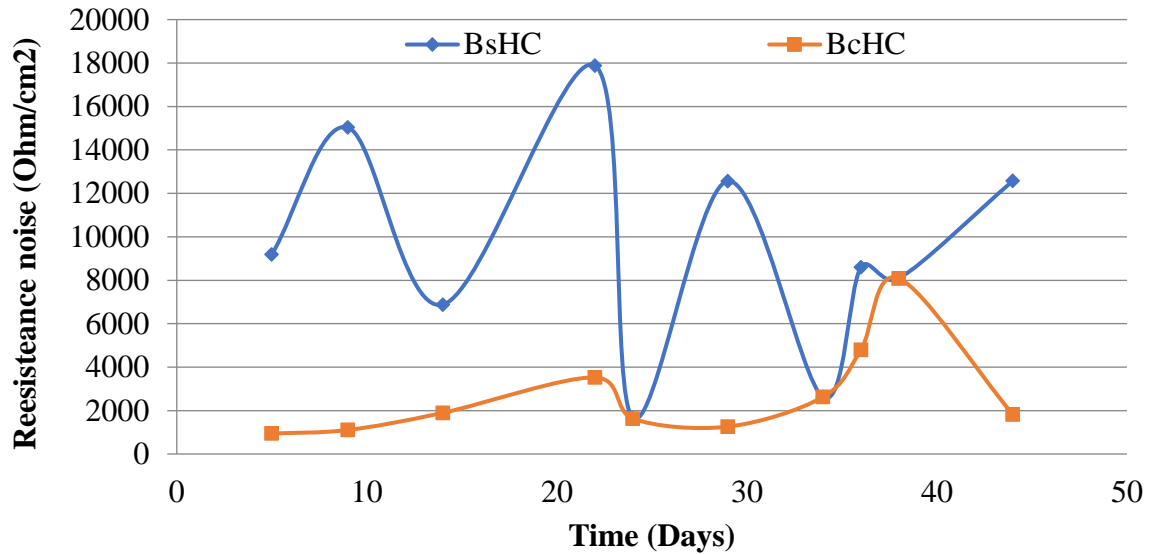
Figure 14. Resistance in noise (Rn) of the BsHC and BcHC samples tested in saline solution.

proportional. In other words, the higher the values of noise resistance, the lower the corrosion current density, indicating a lower corrosion rate. Samples in sea water (NaCl 3.5wt% solution) exhibited lower noise resistance values than the samples in the Ca(OH)₂ solution, thus had a higher corrosion current density, indicating higher corrosion rates. Figures 14 and 15 highlight these results. The results agree with the results reported by Kelly (1996) and Garcia (2014).

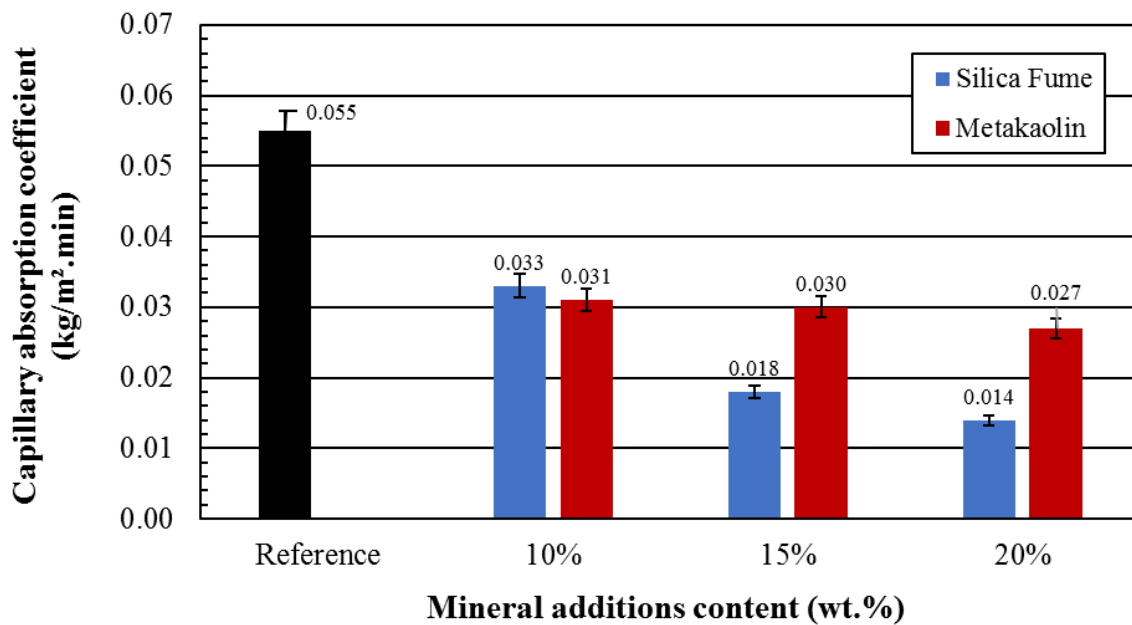
Figure 3. Capillary absorption coefficient of mortars containing silica fume and metakaolin partially replacing the Portland cement after curing for 28 days.

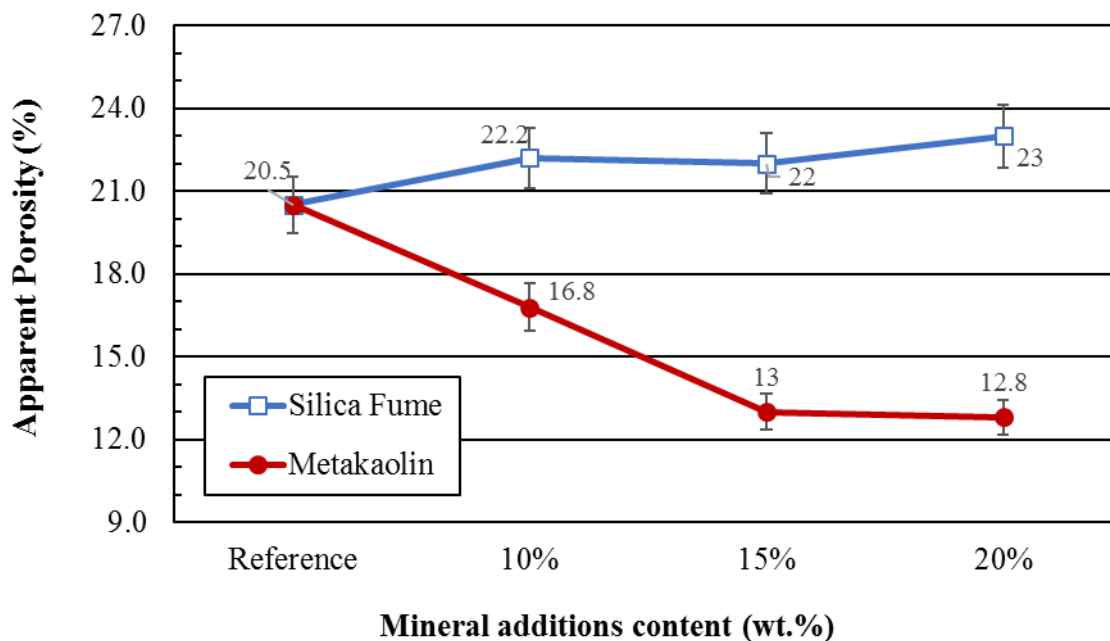
Figure 4. Apparent porosity of mortars containing silica fume and metakaolin partially replacing the Portland cement after curing for 28 days

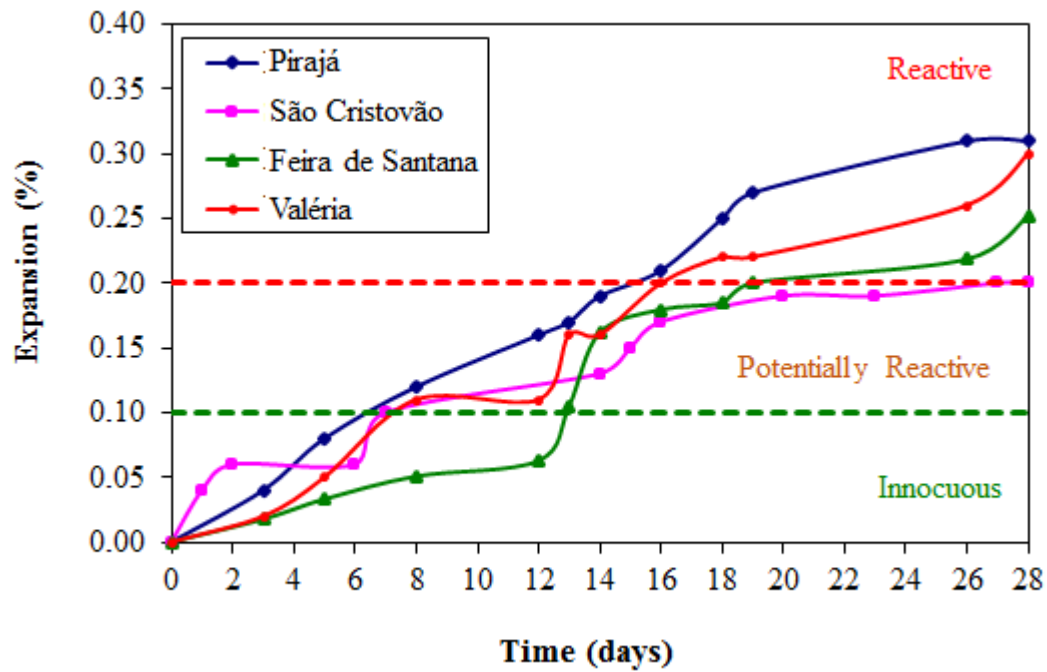
Figure 6. Expansion, due to AAR, in mortars containing gravels used in Salvador, Bahia, Brazil.
