ALCONPAT International

Revista ALCONPAT

This V9N2 issue begins with a work from **Brazil**, where Graziela Pereira da Silva and colleagues present a review about the influence of infrared thermography on masonry walls to detect pathological manifestations. A systematic review was carried out through research with automatic search and snowballing, selection and sifting of articles to restrict them to the desired theme. After that, infrared thermography in the pathological manifestations was studied along with the thermal properties and their behavior, thermal bridges, temperature difference and air infiltrations. Some care must be taken during the execution of experiments and measurements. It has also been shown that infrared thermography is a complex technique.

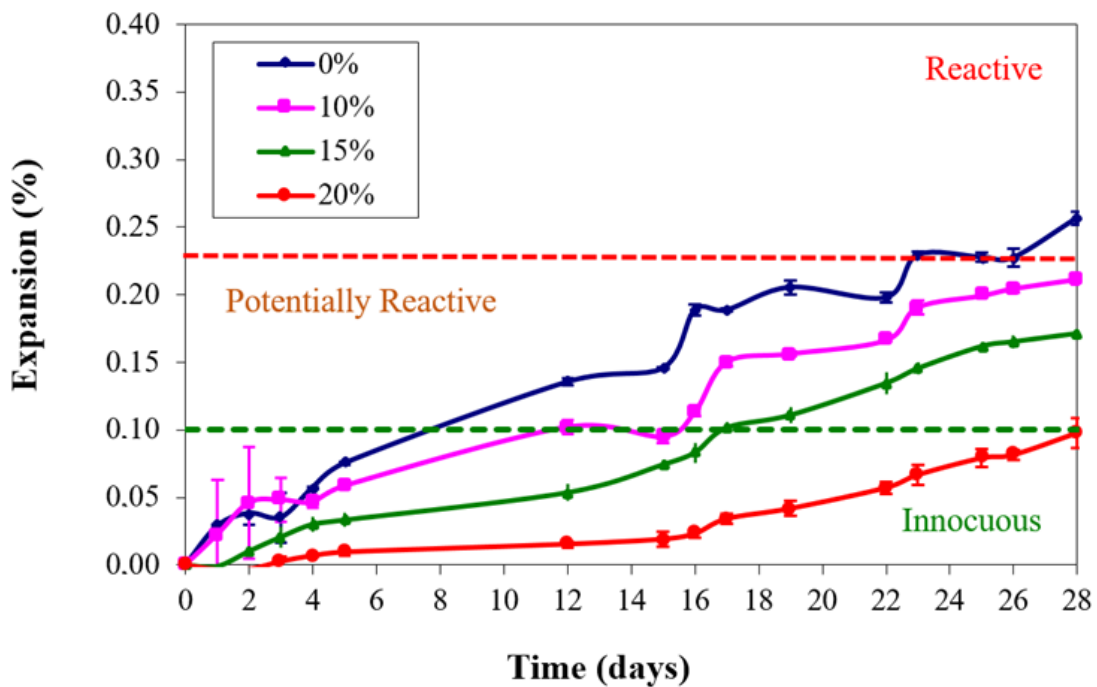
Figure 9. Expansion, due to AAR in mortars with varying metakaolin contents added.

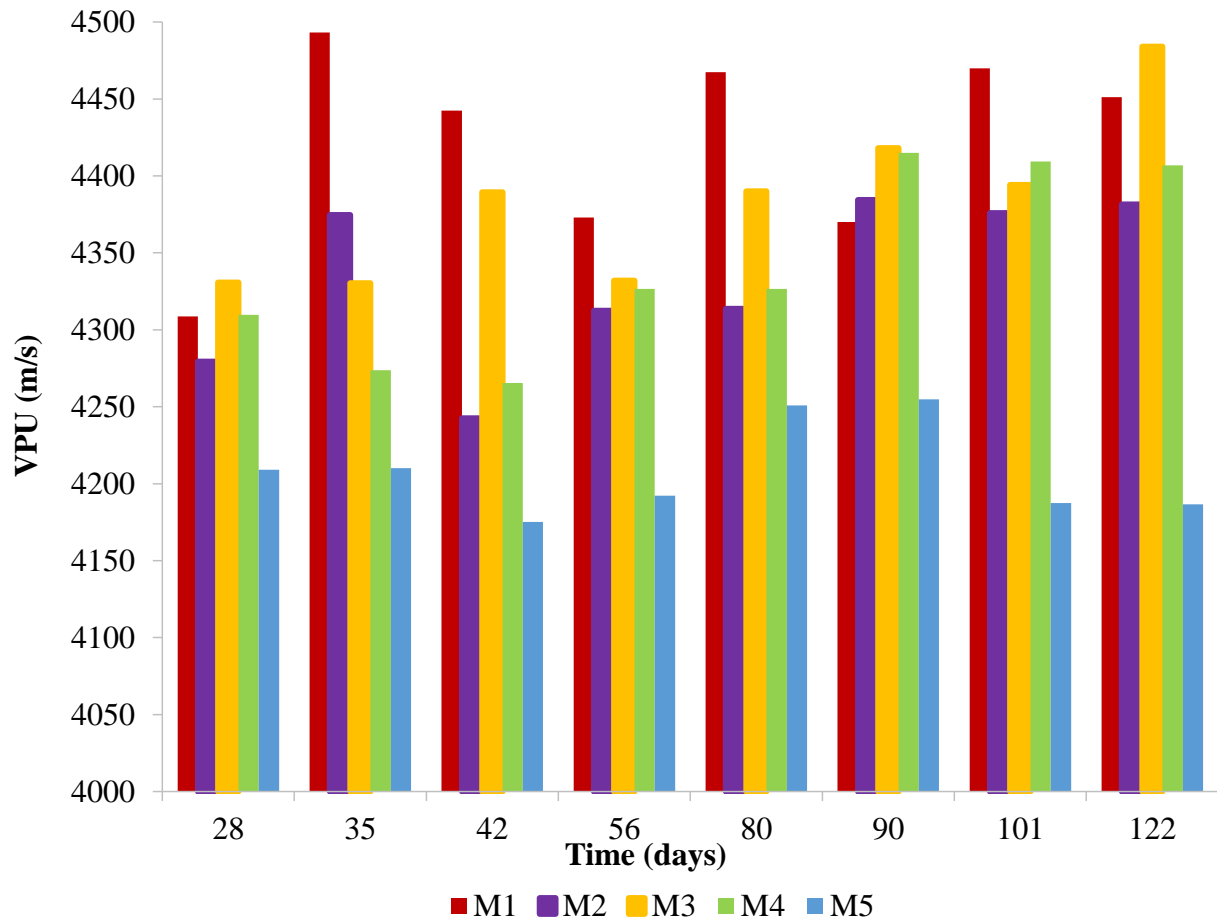
Figure 2. UPV at different ages of mixtures for M1, M2, M3, M4 and M5.

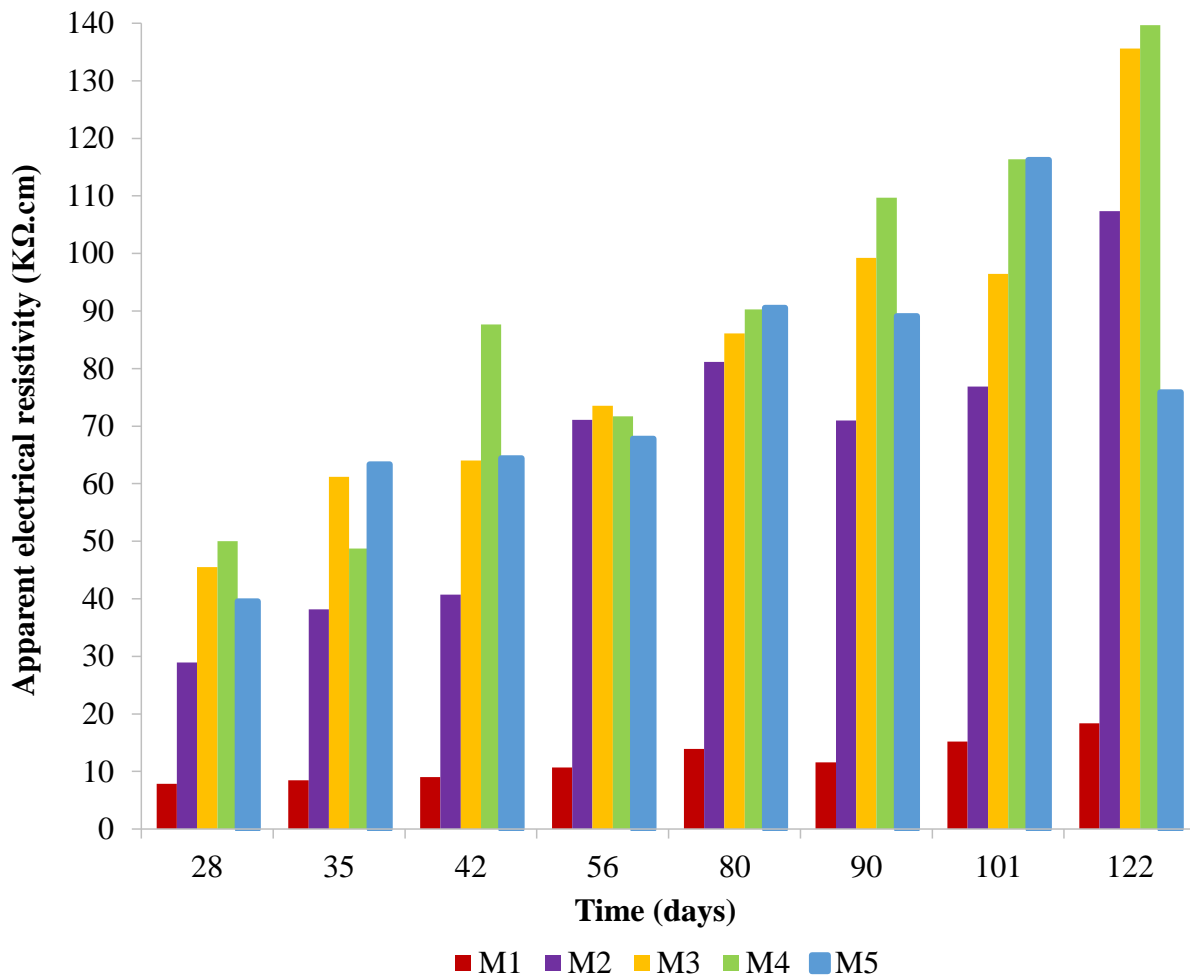
Figure 3. Apparent electrical resistivity at different ages for mixtures M1, M2, M3, M4 and M5.

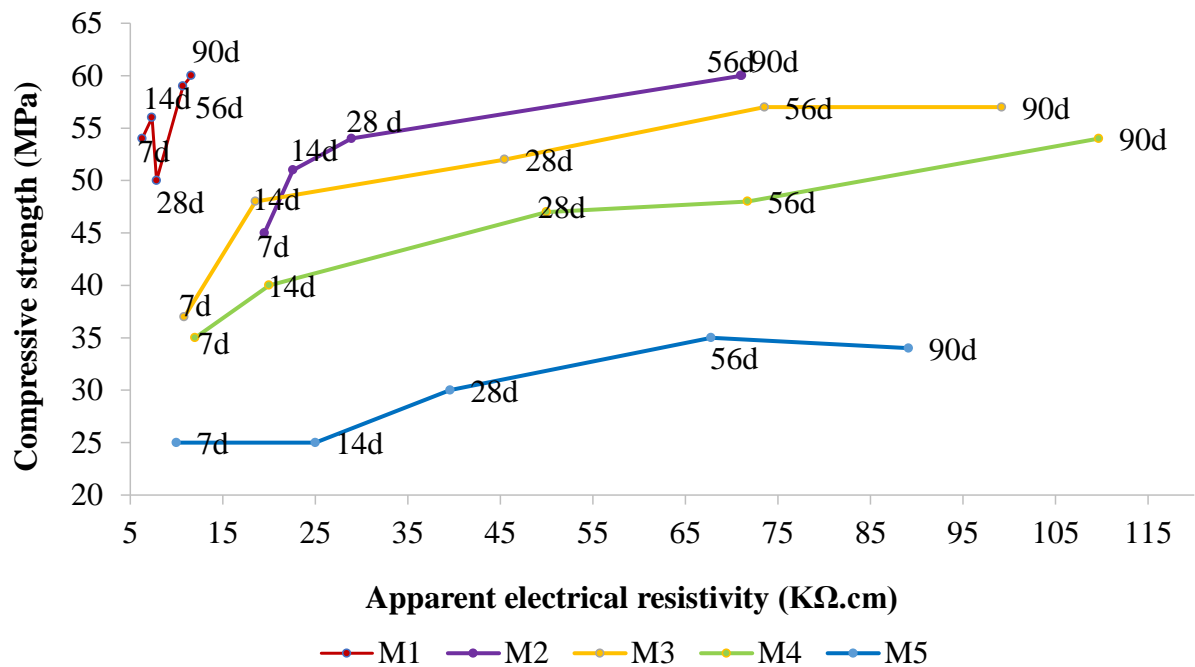
Figure 6. Apparent electrical resistivity vs. compressive strength for mixtures M1, M2, M3, M4 and M5 obtained at 7, 14, 28, 56 and 90 days.

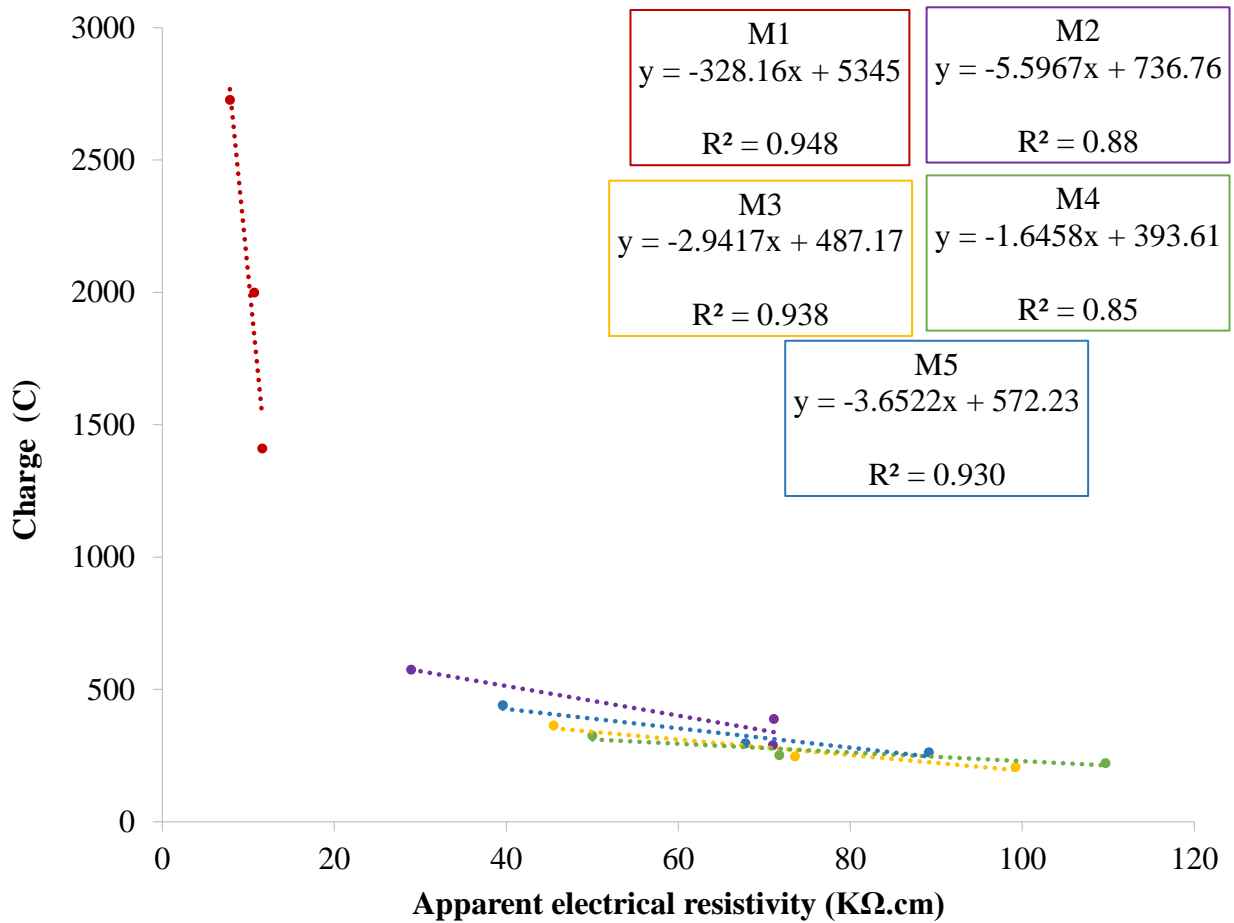
Figure 8. Apparent electrical resistivity vs. rapid chloride permeability for M1, M2, M3, M4 and M5 at 28, 56 and 90 days.

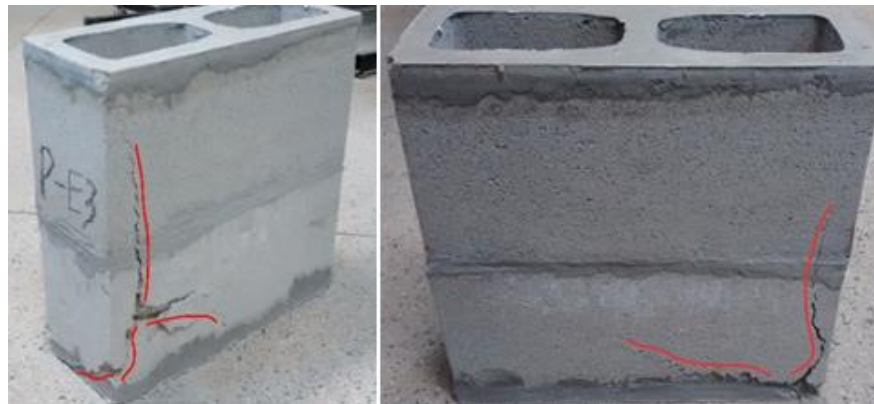
Image 3. Typical prisms rupture

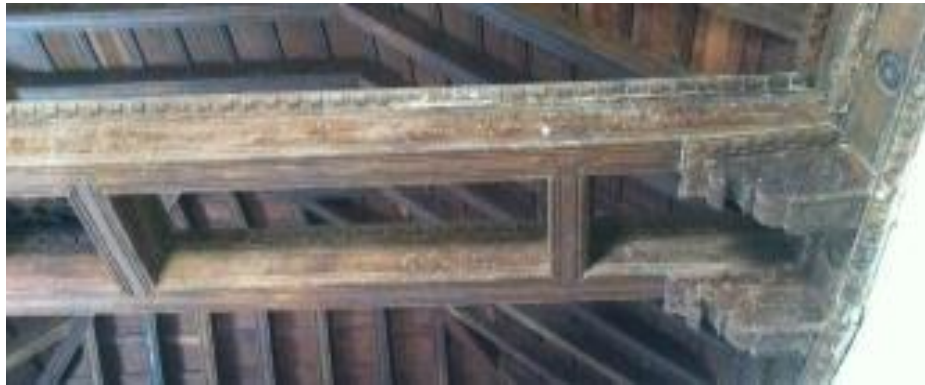
Figure 3. Tie rod beams on corbels.

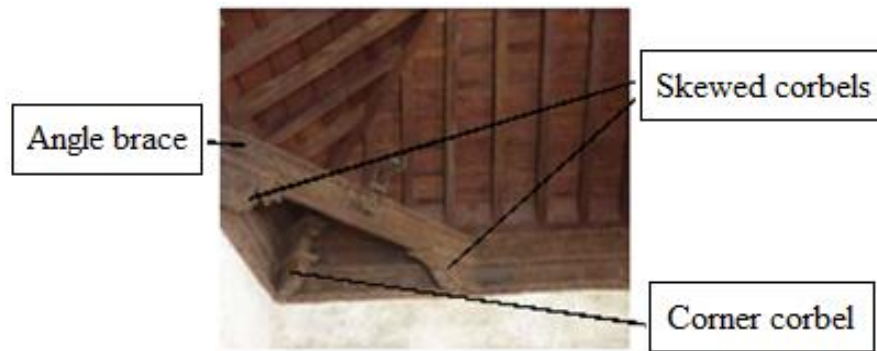
Figure 4. Angle brace, skewed corbels and corner corbel.

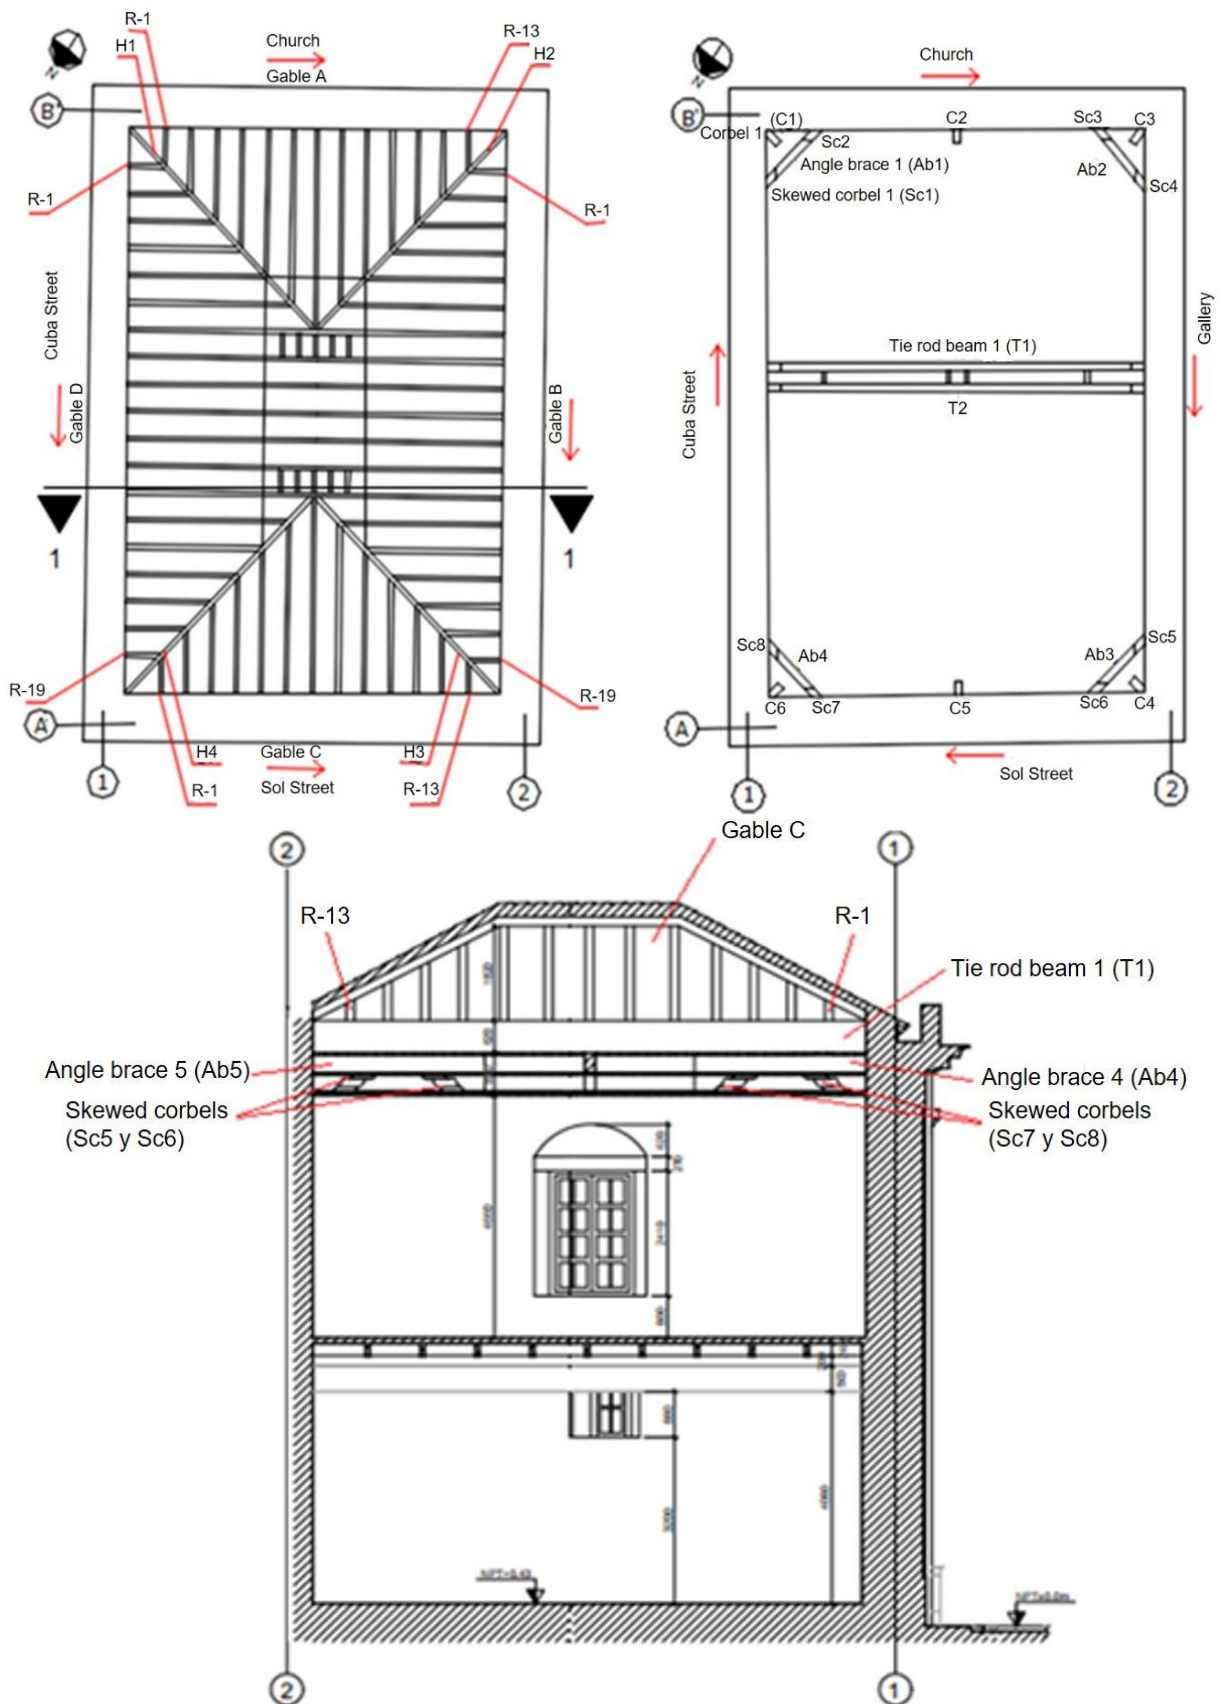
Figure 5. Nomenclature and numbering of the elements at the High Choir in an architectonic plan and in a cross section 1-1.

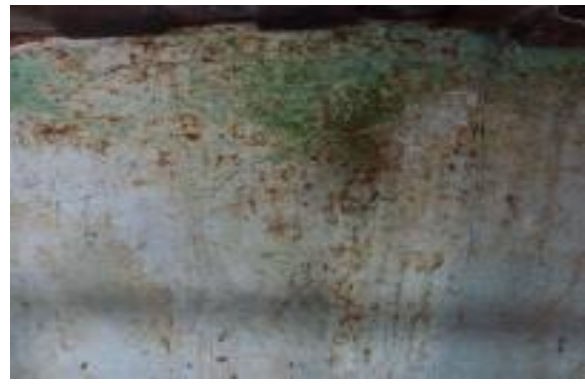
Figure 10. Top wall green patinas in axis 2.

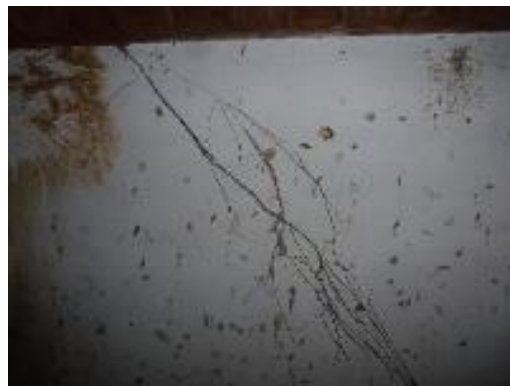
Figure 11. Roots in axis A from the feeder plants on the roof.

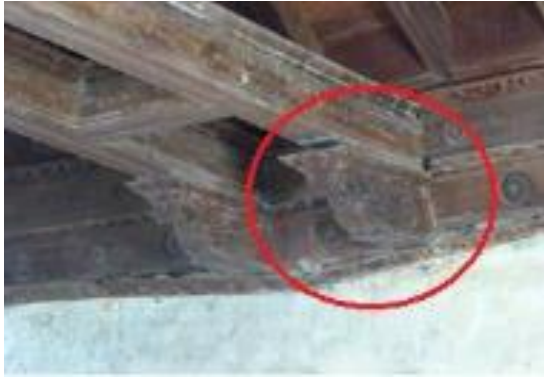
Figure 16. Dropping of corbel under tie rod beam 2 (T2), on axis 2.

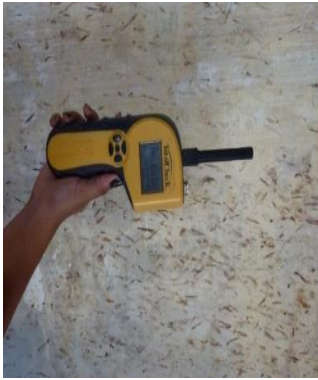
Figure 21. Thermo-hygrometer.

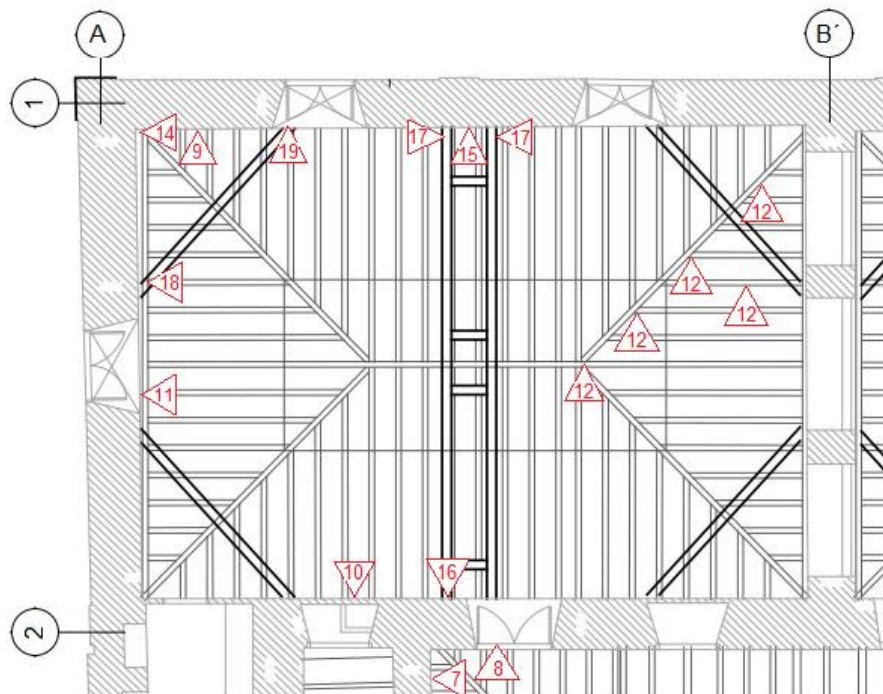
Figure 25. High Choir architectural plan showing the location and association of damages Figures 7-12 and 14-19.

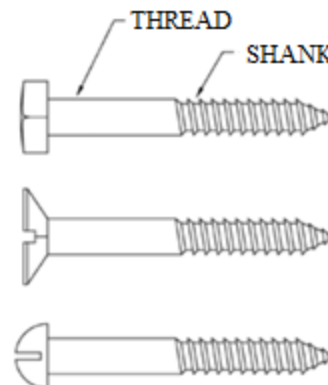
Figure 33. Coach-screws with hexagonal, countersunk, and round heads (up to down). Source: (Martitegui et al., 2009).

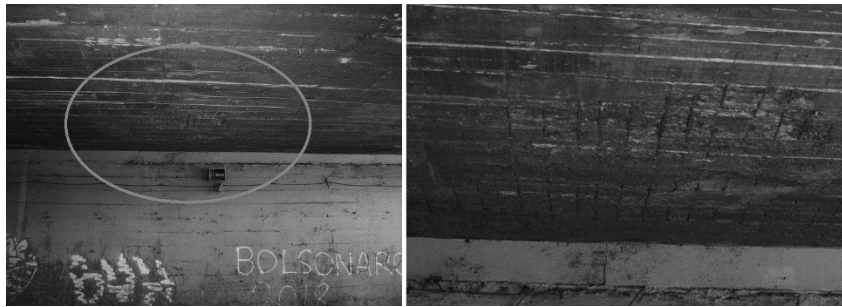
Figura 5. Cobrimento insuficiente e deterioração da Armadura

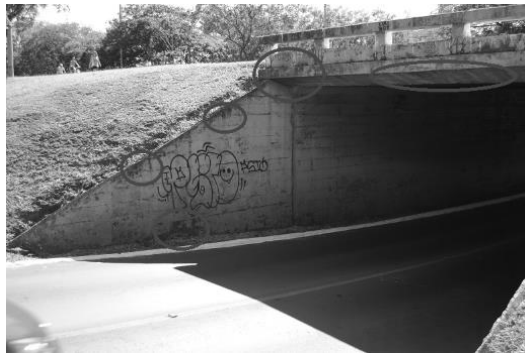
Figure 6. Stains scattered on the structure
