Revista **ALCONPAT**

Latin American Journal of Quality Control, Pathology and
Construction Recovery

Volume 10

January - April 2020

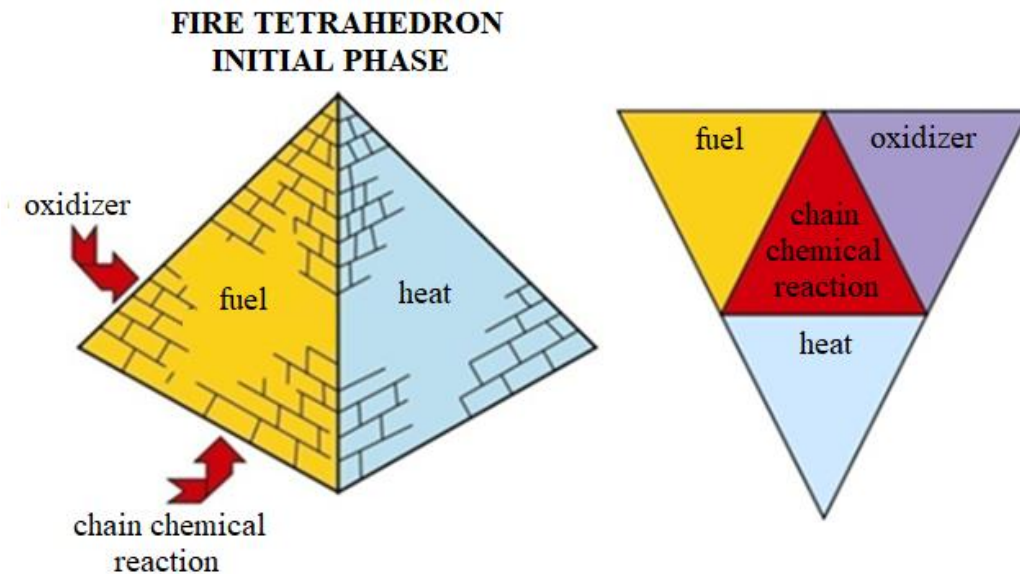
Heat is the element used to start a fire, maintain and increase its spread. Oxidizer (oxygen) is required for combustion and is present in the air surrounding us. Fuel is the propagating element of fire and can be solid, liquid or gaseous. The chain reaction makes the burning process self-sustaining. Basically, the radiated heat from the flames reaches the fuel and it is broken down into smaller particles, which combine with oxygen and burn, radiating heat back into the fuel, thus forming a constant (self-sustaining) cycle.

Figure 2. Fire tetrahedron (adapted from Seito et al., 2008).

It can be said, therefore, that concrete is not a fundamental element of Fire Tetrahedron because it is not a solid fuel. In a fire event, concrete suffers the consequences of the burning of any flammable material, whether solid, liquid or gaseous. Generally, in commercial and residential buildings, this flammable charge comes from solid cellulosic base materials such as doors, furniture, office supplies, carpeting, curtains, etc.

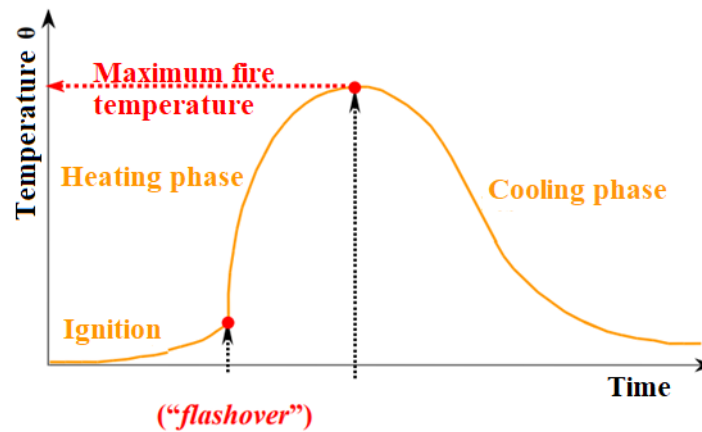
Figure 3. Main phases of a real fire (Costa & Silva, 2003).

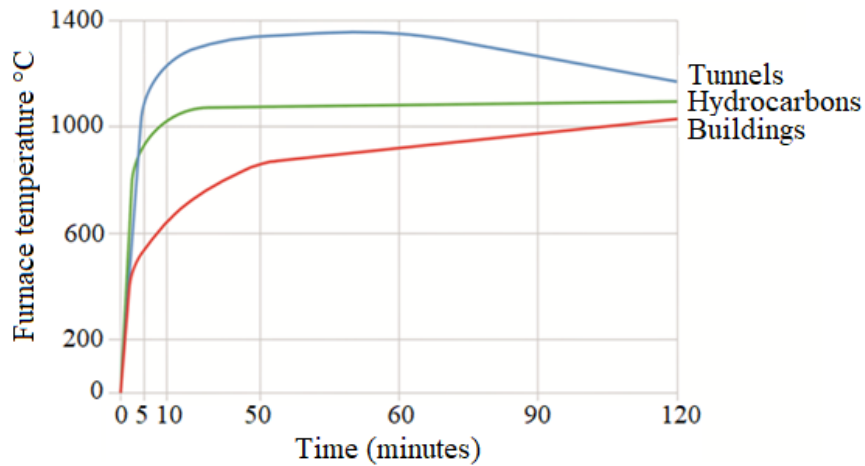
Figure 4 shows the temperature profiles that simulate three standard fire scenarios that are commonly used in experimental studies, as follows: (a) the tunnel fire scenario; (b) the one caused by hydrocarbon-based materials and (c) the one caused by buildings (by cellulosic materials).

Figure 4. “Idealized” curves for three fire simulation scenarios: tunnels, hydrocarbons and buildings - cellulosic materials - up to 120 minutes (The Concrete Center, 2004).

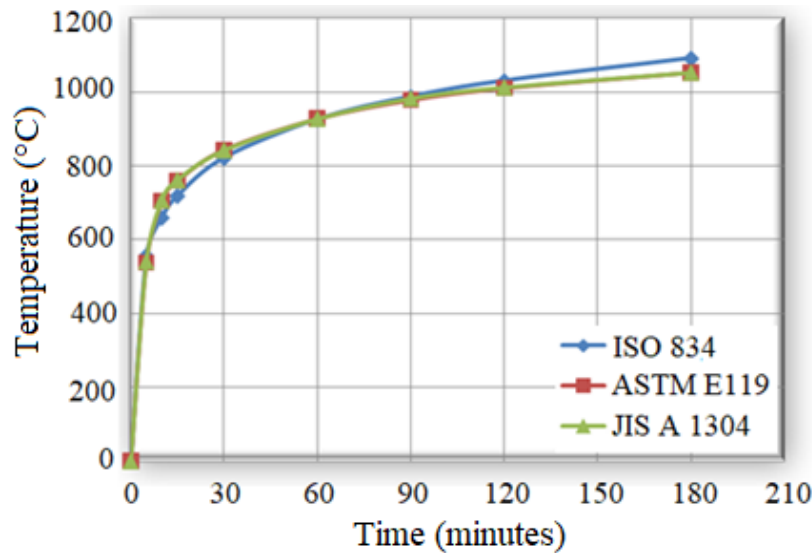
The three most widespread idealized and standardized curves in the technical field used in experimental studies involving fire scenario simulations caused by cellulosic-based materials in concrete elements are the curves: ISO 834, ASTM E119 and JIS A 1304 (Phan, 1996). These curves are very similar and can be seen, overlapping, in the Figure 5. Tunnel and hydrocarbon standard curves will not be addressed in this article and can be consulted in Leonardo Da Vinci Pilot Project: Handbook 5 (2005).

Figure 5. Standard fire curves (adapted from Phan, 1996).

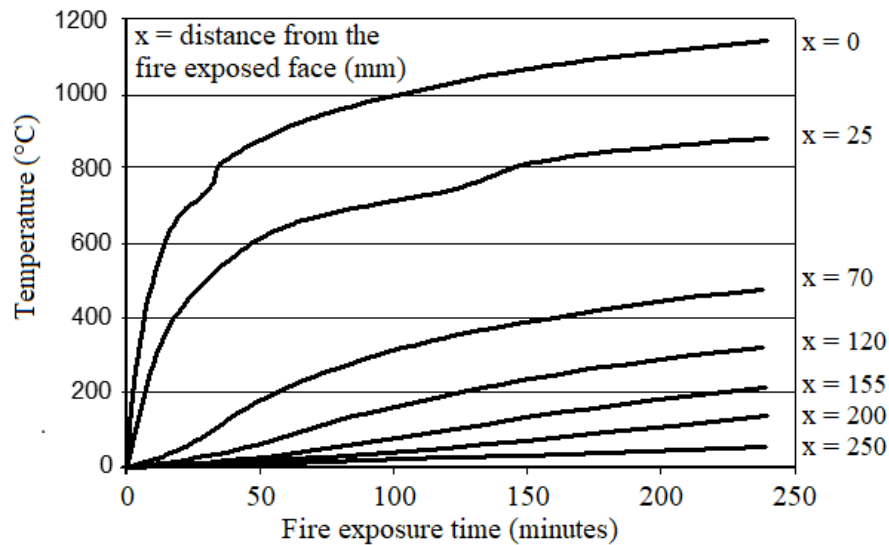
To exemplify the behavior of the temperature field evolution as a function of time in a concrete element, we present the computer simulation study by Ongah, Mendis & Sanjayan (2002) in high strength concrete walls (Figure 6) with only one side exposed to fire. The graph indicates the significant thermal gradient inside the material (concrete) according to a heat flow model that numerically simulates the fire scenario.

Figure 6. Temperature field evolution in a high strength concrete wall as a function of fire exposure time (Ongah, Mendis & Sanjayan, 2002).

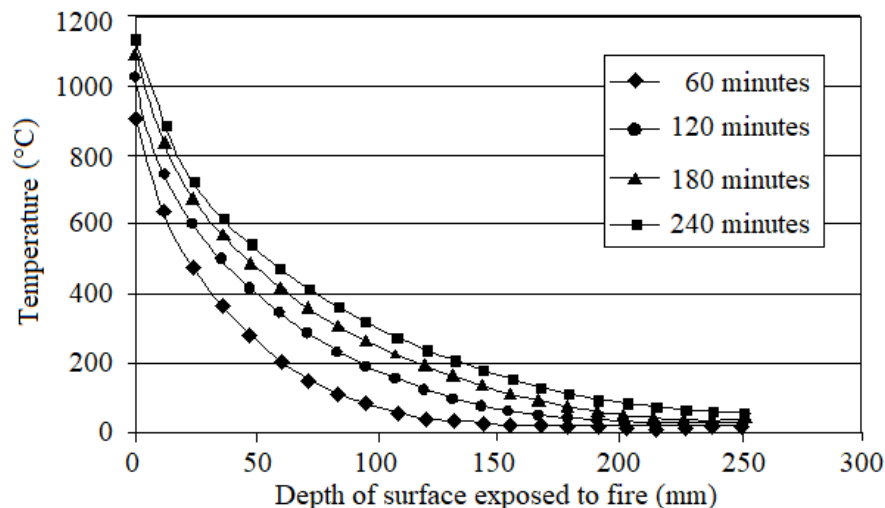
Another way to present the temperature evolution inside a concrete element, prescribed by the main international codes, can be seen in Figure 7. In this case, the instantaneous curves of standardized times as a function of the temperature and depth of the surface exposed to fire are presented, this is a very common model adopted by researchers and in the codes of various countries.

Figure 7. Calculated temperature distribution as a function of the depth of surface exposed to fire and fire exposure time, by using a numerical model (Ongah, Mendis & Sanjayan, 2002).

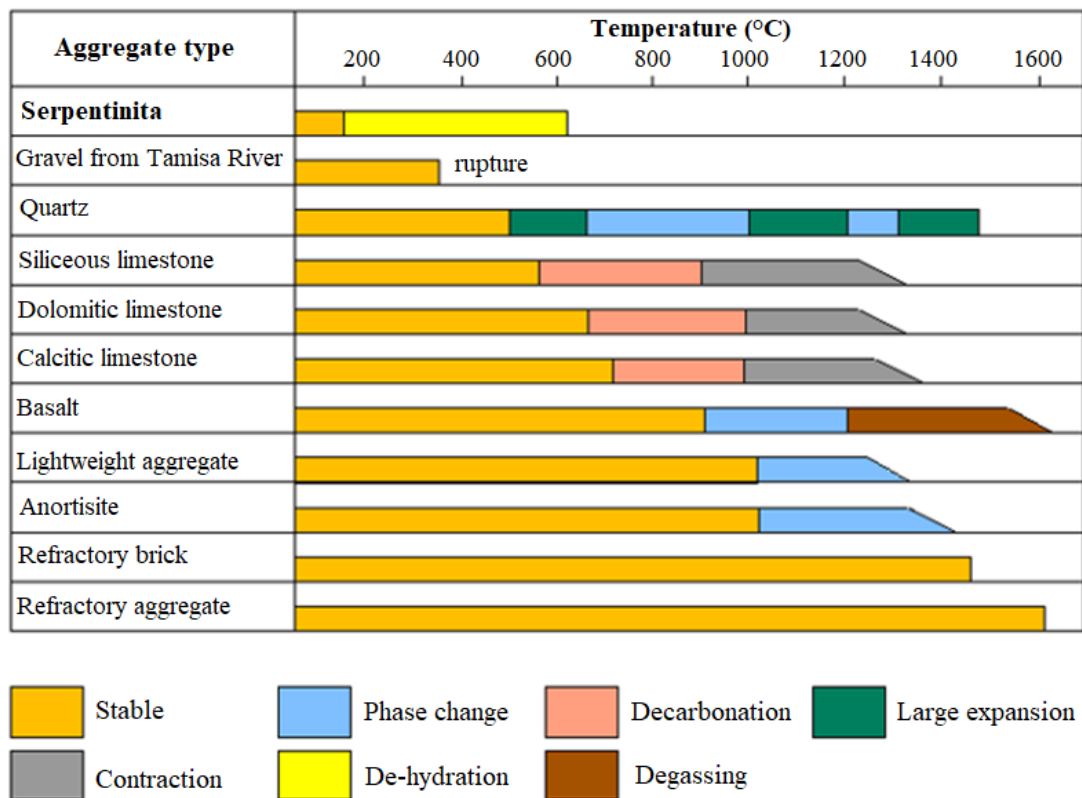
Figure 8. Behavior of various aggregates during heating (adapted from *fib*, 2007).

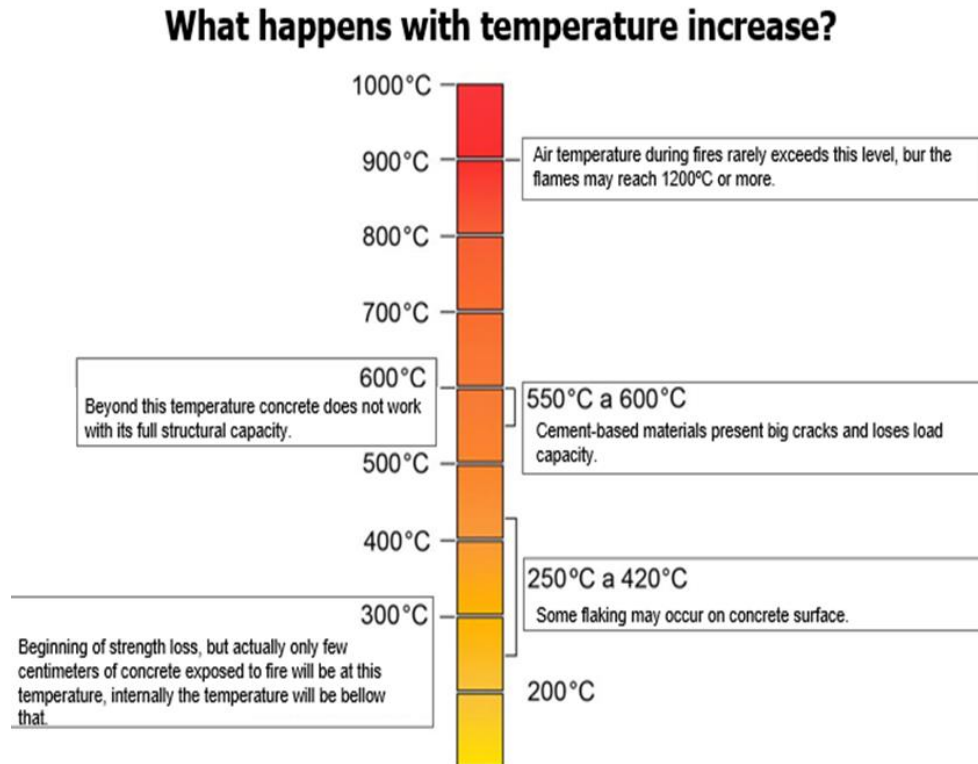
In general, the physical-chemical process of concrete, involving the interaction between aggregates and cement paste, in a fire situation, can be simplified as shown in Figure 9.

Figure 9. Physical-chemical process of concrete in fire situation (adapted from Jacobs, 2007).

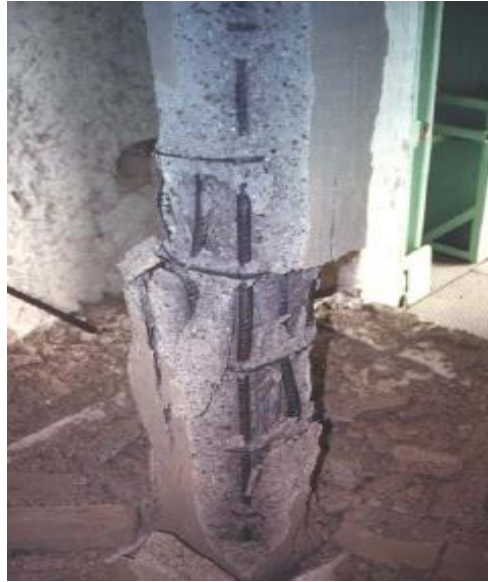
The term spalling is internationally known and standardized in leading international codes and research. The physical phenomenon known as spalling (Figure 10) can be defined as explosive, and for some even called violent/explosive, flaking of layers or concrete pieces from the surface of a structural element when exposed to high temperatures and rapid heating rates, both characterized by a fire scenario (*fib*, 2007).

Figure 10. Example of explosive spalling occurred in high strength concrete column $f_{ck} = 83$ MPa (Kodur et al., 2005).

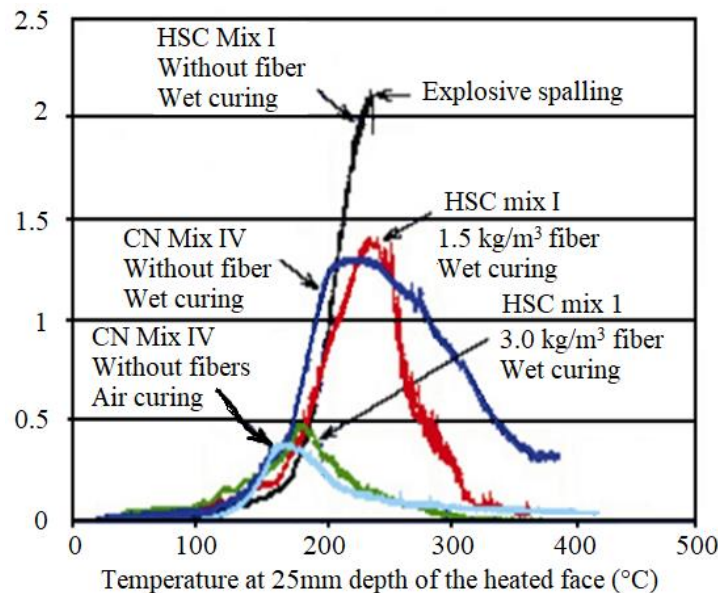
In accordance with the theory formalized by Shorter & Harmanthy (1965) apud *fib* (2007), extensive research by Phan (2002) showed that the occurrence of explosive spalling was actually related to the inability of certain high-strength concretes to leak pressure from free water and chemically combined water that are vaporized with the temperature rise inside the concrete mass. In his experiments, Phan (2002) observed that an alternative to minimize the effects of internal pressure formation on concrete can be conceived by introducing polypropylene fibers into concrete mixtures, and this fact has been proven in extensive research involving high strength concrete specimens. It was possible to characterize the behavior of the high strength concrete with respect to the internal pressure formation aspects, being considered equivalent to the normal strength concrete, when at high temperatures, simply by the introduction of polypropylene fibers. This fact was verified by studying the pore pressure exerted on these two types of concrete (normal and high strength), coming from the high temperatures that can be reached in a fire, as shown in Figure 11 (Phan, 2002).

Figure 11. Equivalent pressure of the two concrete types (CN: normal and HSC: high strength) with the introduction of polypropylene fibers into high strength concrete (at high temperatures) (Phan, 2002).

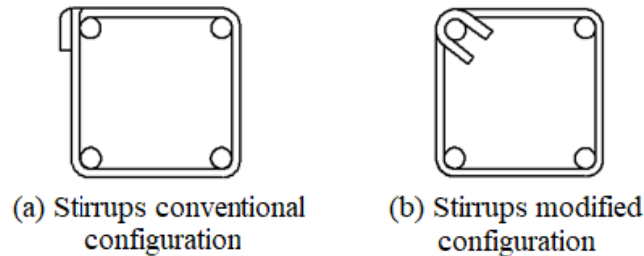
The main recommendation concerns the arrangement (configuration) of the transverse reinforcement (stirrups) with a hook-shaped locking (confinement) at 135° at the edge of the element and the corresponding reduction in stirrup spacing, which is approximately 0.75 times the usual required for normal concrete. The modifications proposed by Kodur et al. (2000) and also summarized in Kodur et al. (2005) can be seen in Figure 12.

Figure 12. High strength concrete column stirrups conventional configuration (a) and modified configuration (b) (Kodur et al., 2005).

The positive result of Kodur's et al. (2005) proposal is evident when looking at the two high-strength concrete elements of Figure 13, after the respective fire resistance verification experiments performed under the same test and material conditions. It is also important to note that in these samples there was no addition of polypropylene fibers in the concrete mix, only the modification in the arrangement (configuration) of the reinforcement (indicated in Figure 12).

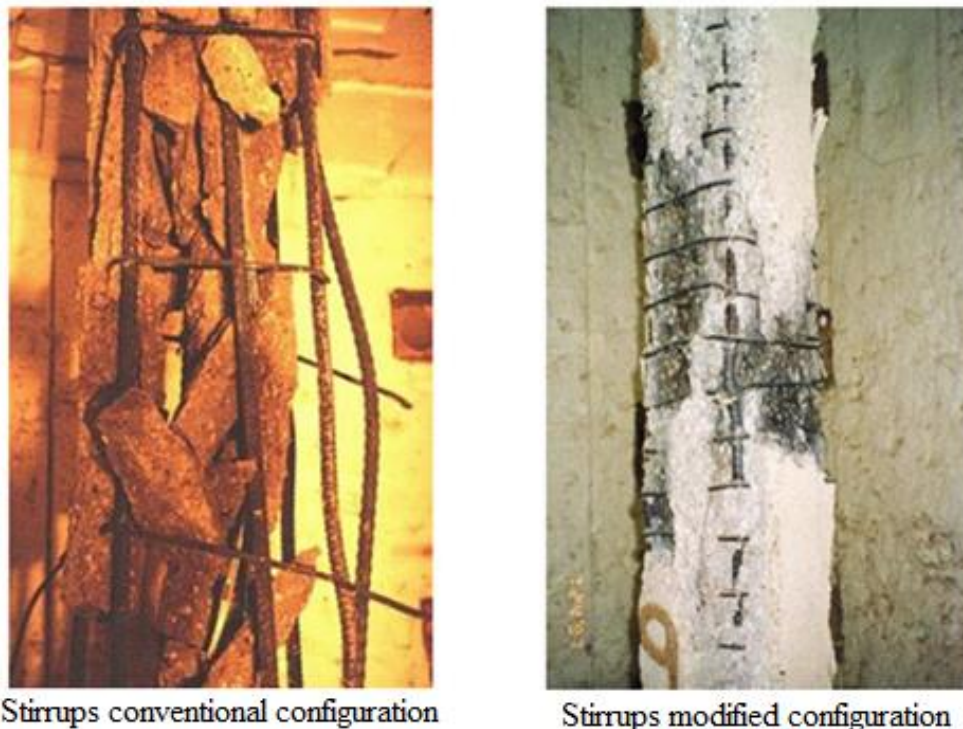
Figure 13. Results obtained after test under the high temperatures: (a) conventional configuration of the high strength column reinforcement and (b) modified configuration (Kodur et al., 2005).

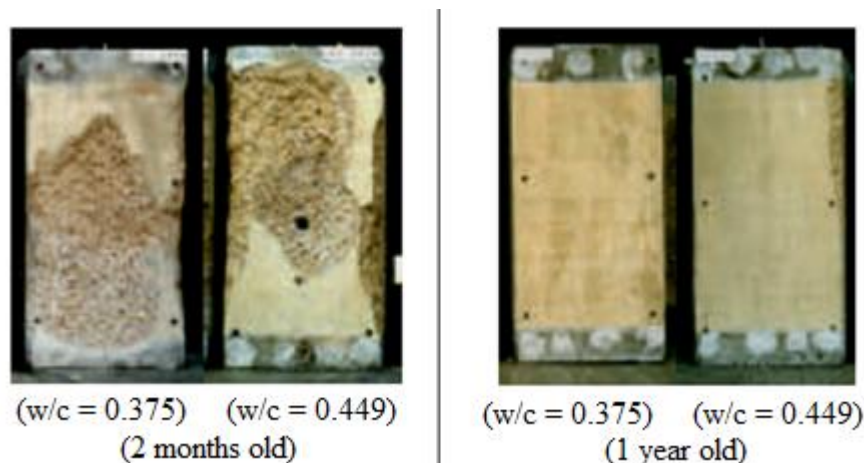
The experiment conducted by Morita et al. (2002) seems to contribute to highlight how much the conducted research may be limited to evaluate spalling severity in concrete elements at premature ages, since the occurrence of this type of phenomenon depends significantly on the time factor (sample age).

Figure 14. Reinforced concrete columns after fire simulation experiment (180min): effect of water/cement ratio and age on the occurrence of spalling phenomenon, 70cm square cross-section (Morita et al., 2002).

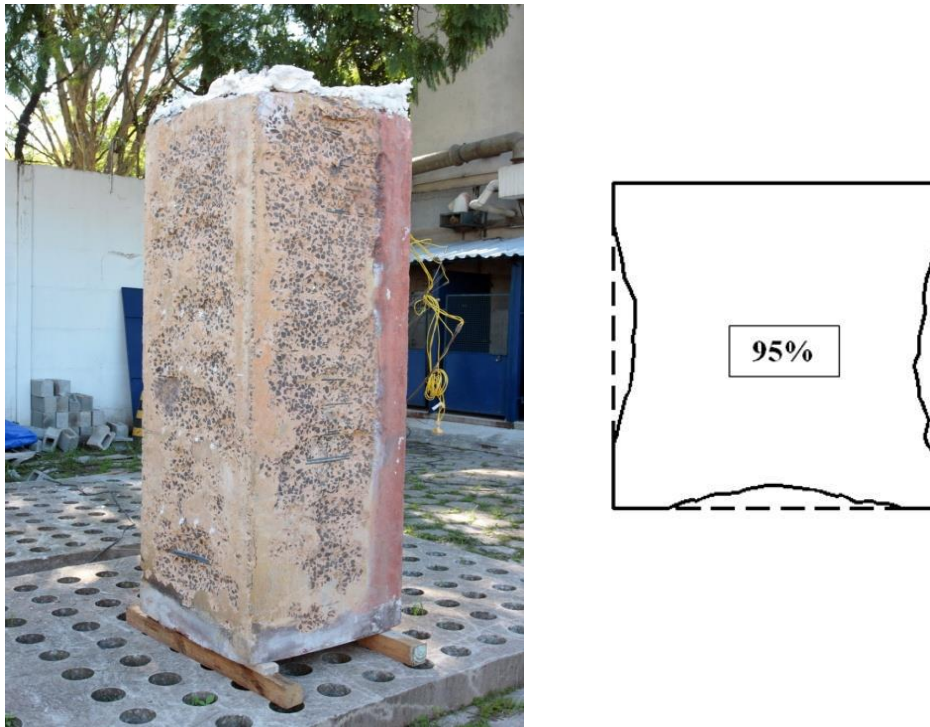
In addition to advanced age, Britetz (2011) pointed out that other factors may have contributed positively to the good performance, such as the type of coarse aggregate used in the original concrete mix (basalt), as well as the cross-sectional size and reinforcement configuration.

Figure 15. Column integrity and preserved cross-sectional detail after 180min (3h) test (showing the small cross-sectional reduction by spalling) (Britetz, 2011).

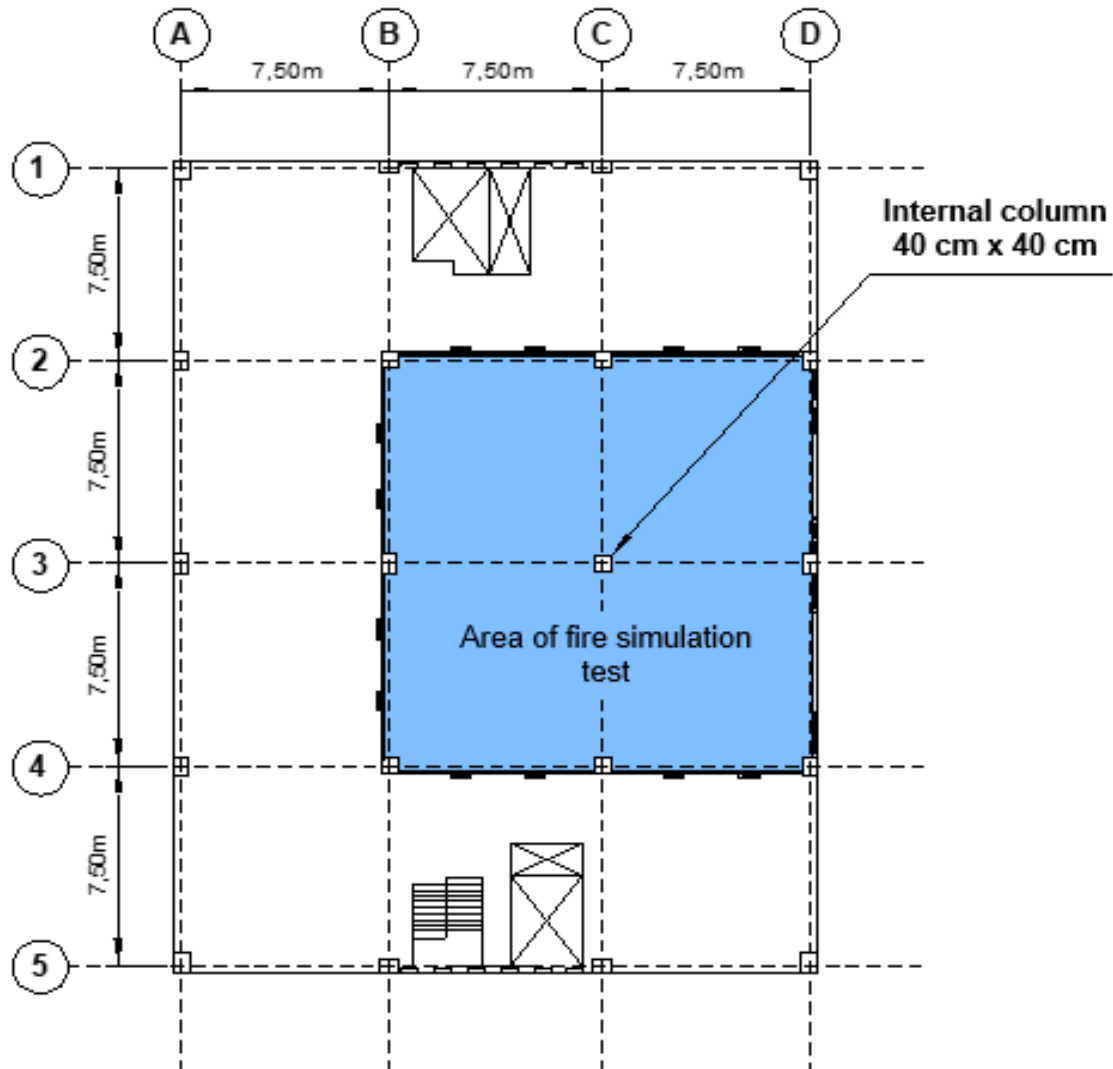
As described by Chana & Price (2003), the fire simulation took place in a region occupied by four compartments in a total area of 225m^2 with a height of 4.25m (ceiling height) on the ground floor of the building. Intentionally, an internal column was exposed on all four faces and some of its end partially, as observed in the plan of Figure 17. The experiment also involved ventilation openings projected on the outer walls of the compartments to be ignited, as well as the loading simulation. The slabs were evenly loaded with sandbags for a load of 3.25kN/m^2 (325kgf/m^2) and in the column region additional bags were positioned to simulate an axial stress of 925kN (92.5tf).

Figure 17. Plan of the prototype structure in reinforced concrete indicating the area under fire simulation (Chana & Price, 2003).

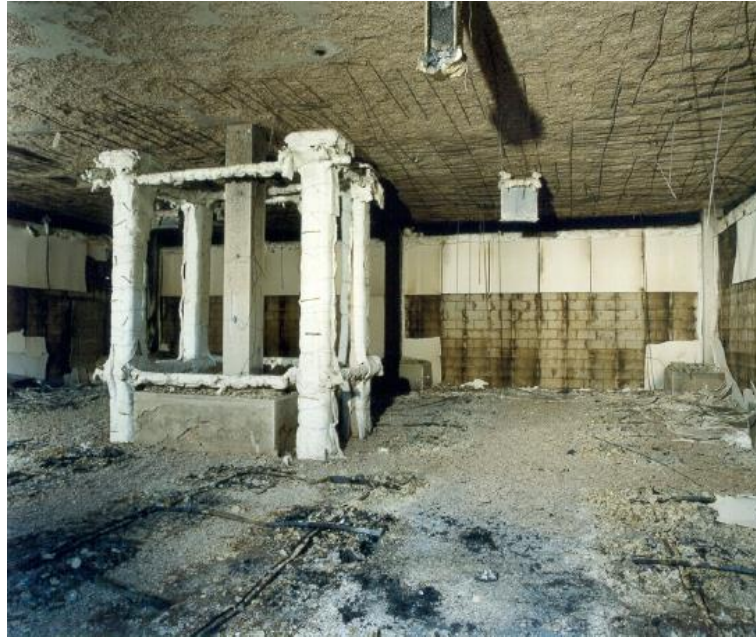
During the fire simulation, in the first 10 minutes of the experiment, there was the occurrence of low intensity, superficial spalling characterized by a discreet popping sound. However, after this period and for a further 15 minutes, the intensity was much higher, indicating a probable explosive spalling, which was later found mainly on the slab (ceiling) of the burning compartments ($f_{ck} = 74$ MPa). After 25 minutes, spalling occurrences decreased significantly. The extent and severity of the occurrence of the spalling phenomenon after the experiment can be observed in Figure 18.

Figure 18. Detail of extent and severity of slab spalling ($f_{ck} = 74$ MPa) after fire simulation. Highlighting, observe the integrity conditions of the high strength concrete column ($f_{ck} = 103$ MPa) (Chana & Price, 2003).

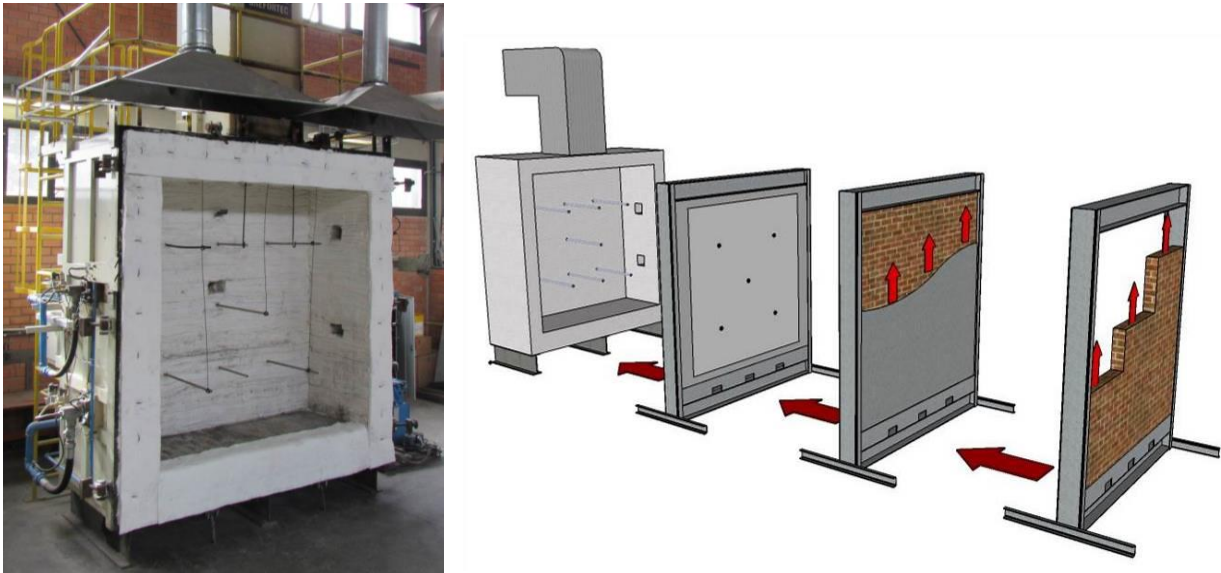
The test was performed at Unisinos' Fire Safety Laboratory. The wall was tested after 56 days of curing in a vertical furnace. The furnace has four burners arranged according to Figure 4, controlled by two thermocouples that allow the measurement of temperature evolution by ISO 834 (2014). Figure 4 also shows the wall mounting and installation sequence in the test furnace. The furnace has a chimney that regulates the flow of gases generated by the heating and the internal pressure throughout the test, as well as thermal insulation composed by ceramic fiber blanket and four gas burners, digitally controlled by a digital control center.

Figure 4. Detail of system coupling to vertical furnace.

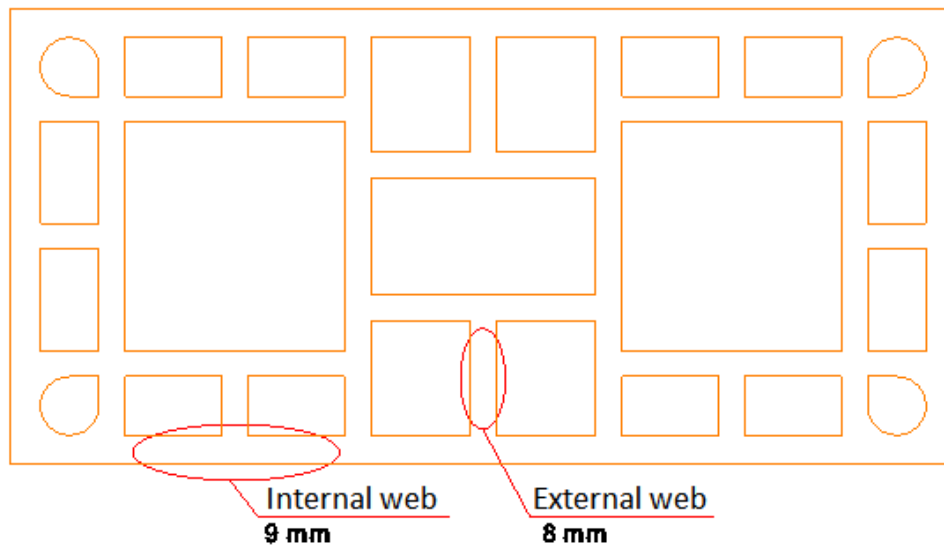
With the calibration performed according to the experimental result, the process of computational extrapolation for different block geometries began. For this, three commercial thicknesses of 11,5, 14 and 19 cm of ceramic blocks were used. For each of these thicknesses, three blocks were defined, varying the number of alveoli and, therefore, percentage of voids. Three distinct geometries were proposed, but the thickness of the internal walls of the block were constant, with 9 mm externally and 8 mm internally, as shown in Figure 8.

Figure 8. Internal and external walls of the blocks.

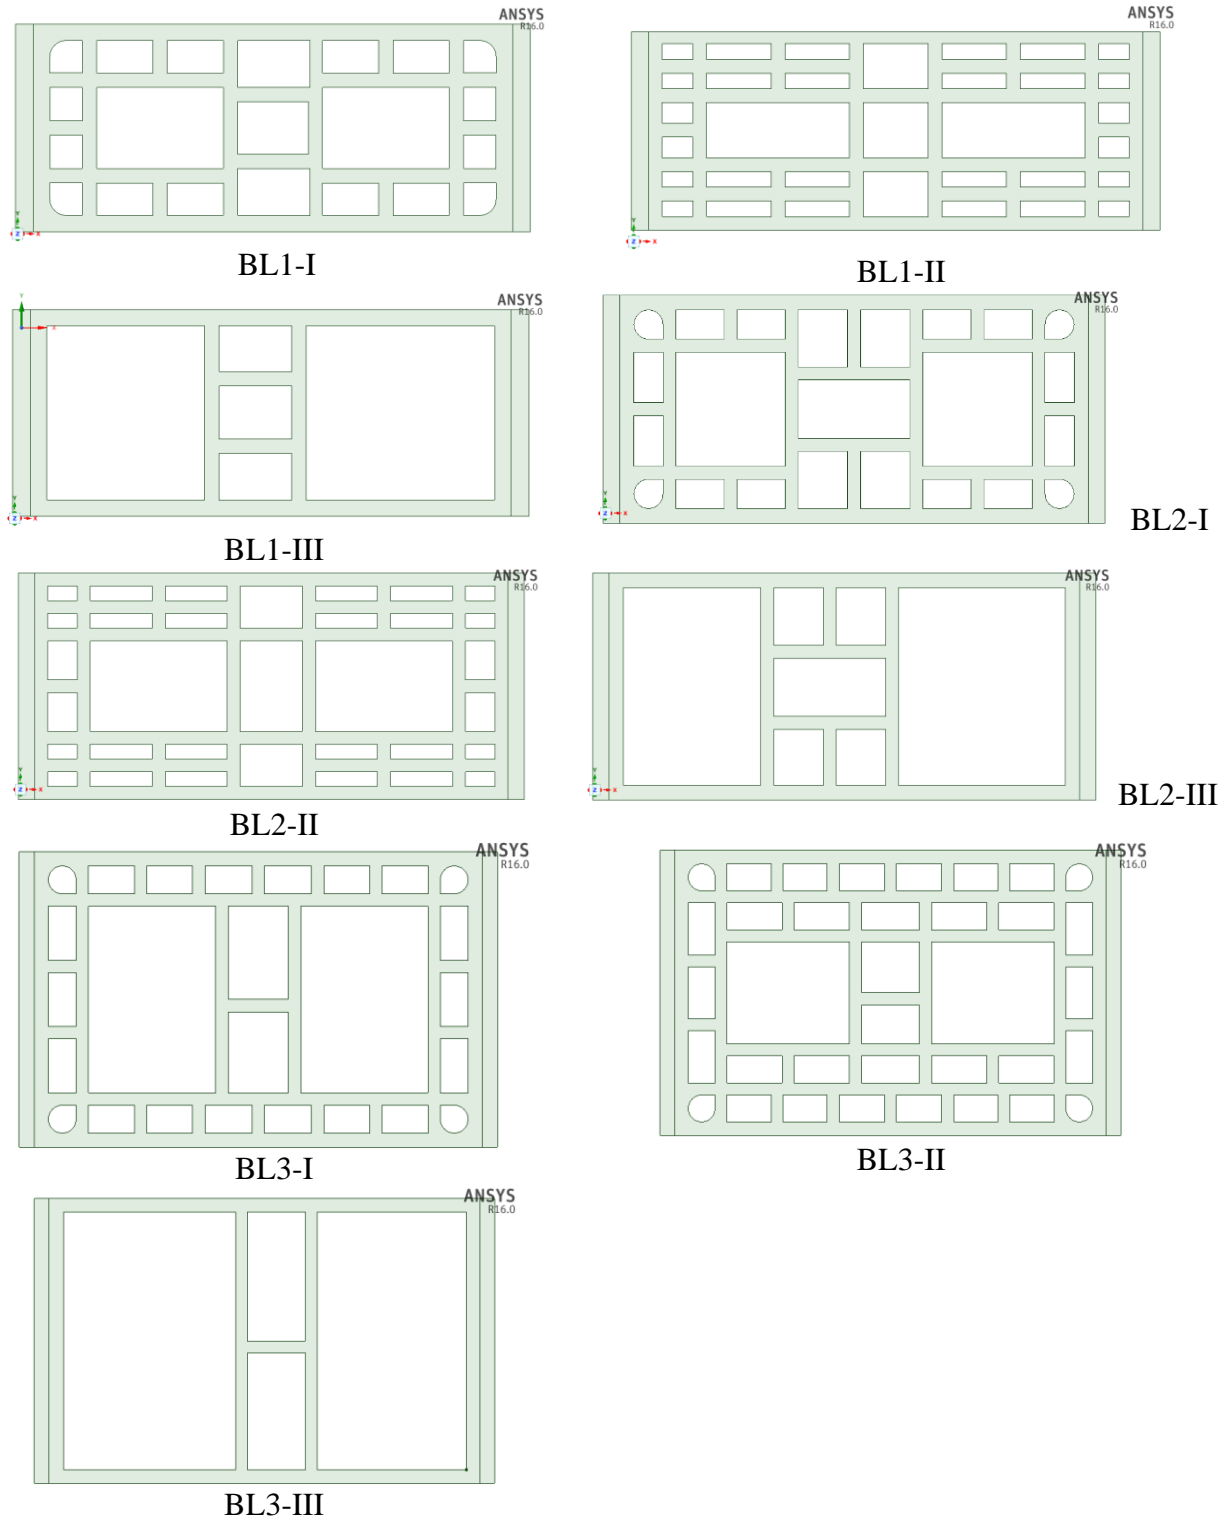
The 11,5 cm thick block family was called BL1; 14 cm thick BL2; and the 19 cm thick BL3. The percentage variations of voids within the same block family were calculated using the ratio between gross area and net area, and referred to as indexes I, II and III. Figure 9 details the blocks used in this study. The blocks were named sequentially BL1 to BL3. It is observed that the blocks with II index (BL1-II, BL2-II and BL3-II) are found in the market, the commercial ones. From there, it has been proposed blocks with smaller and slightly larger alveoli, those with I index (BL1-I, BL2-I and BL3-I), and blocks with larger alveoli and in small quantity, those with III index (BL1-III, BL2-III e BL3-III).

Figure 9. Used blocks.

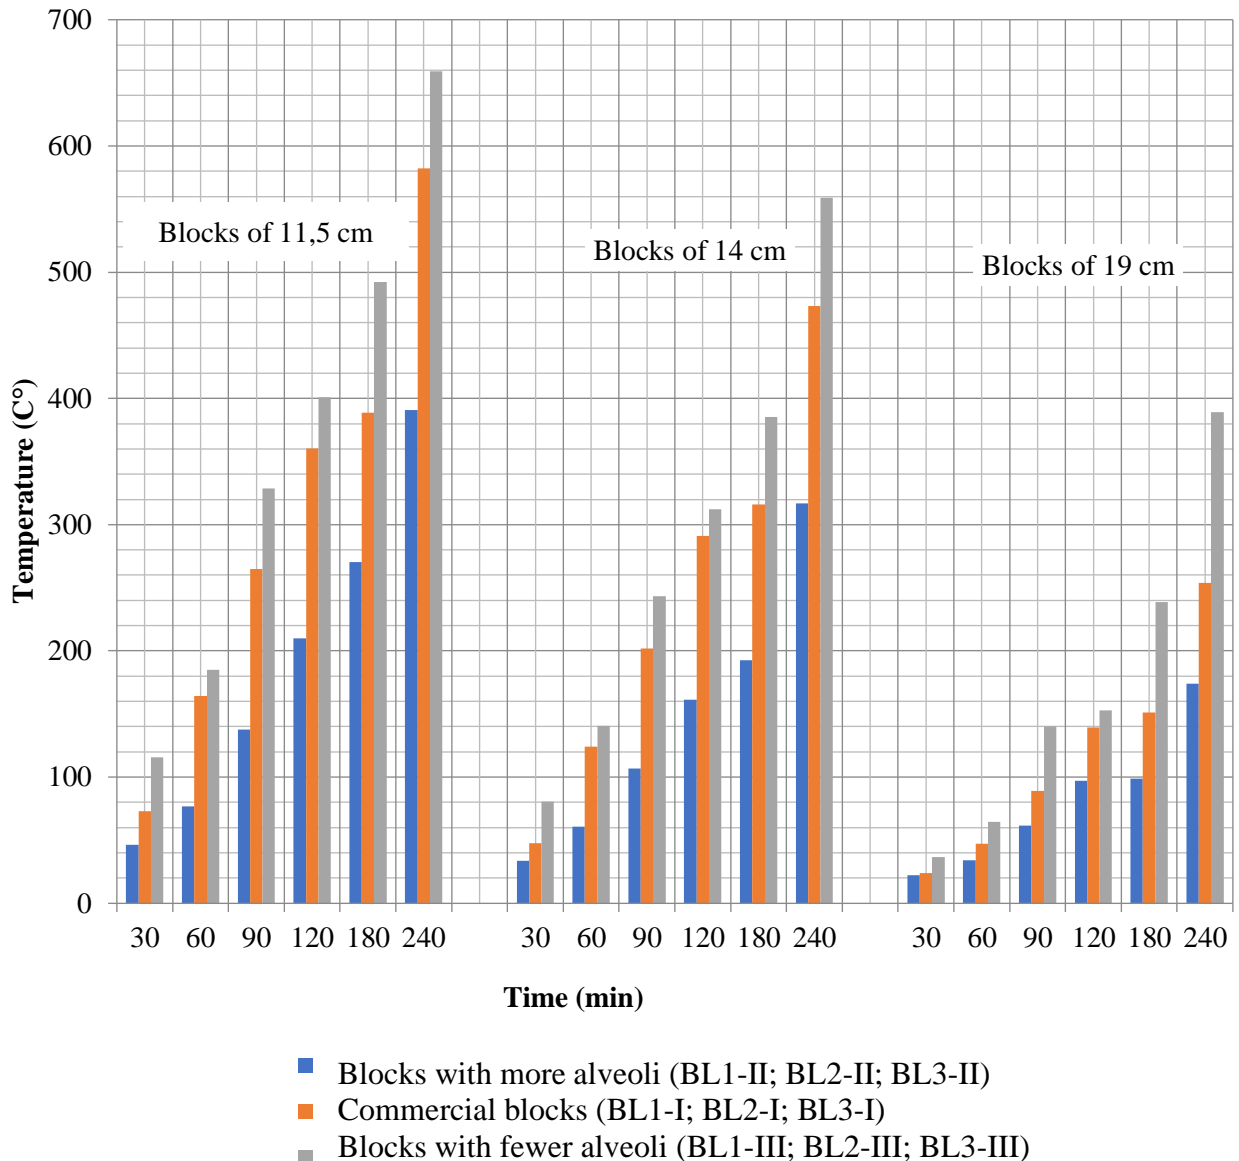
Figure 11. Comparison among the temperatures on the unexposed faces of all tested blocks.

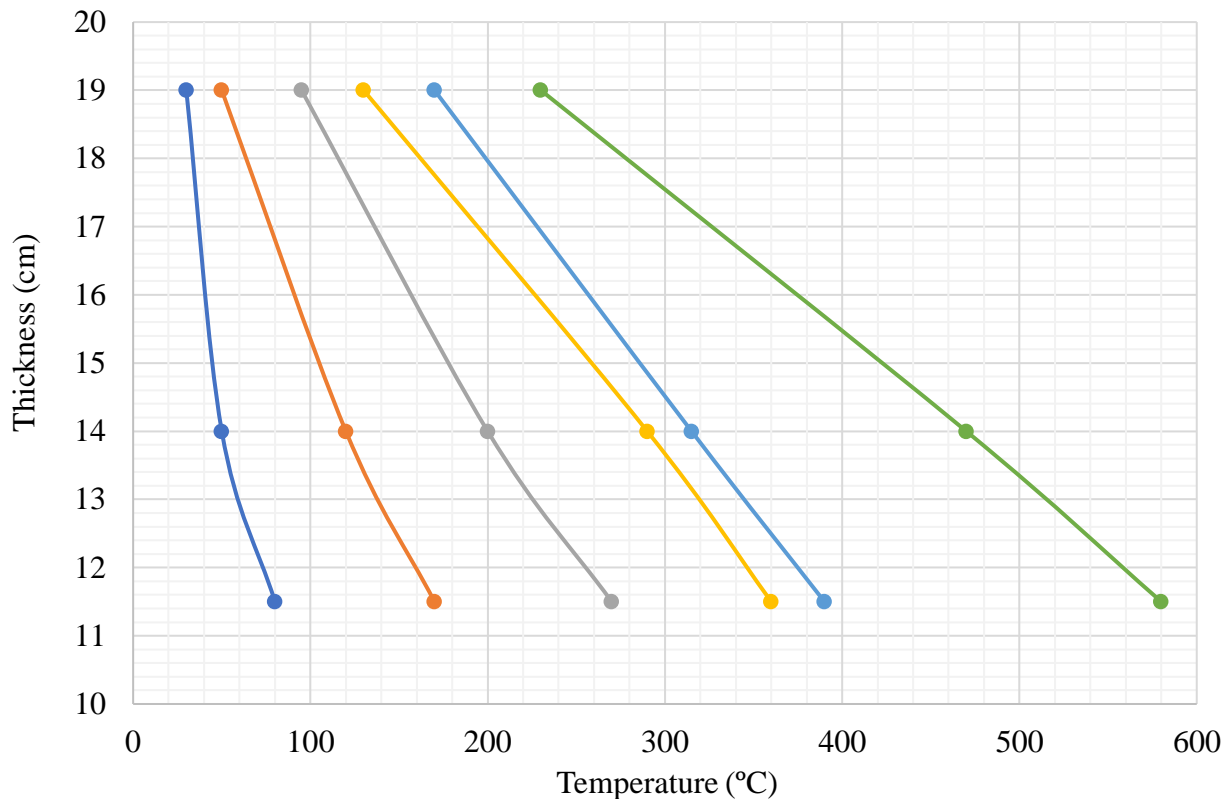
For comparison purpose, temperature evolution curves of the unexposed face of the Index II blocks were generated, in order to compare the influence of the block’s thicknesses, presented in Figure 12.

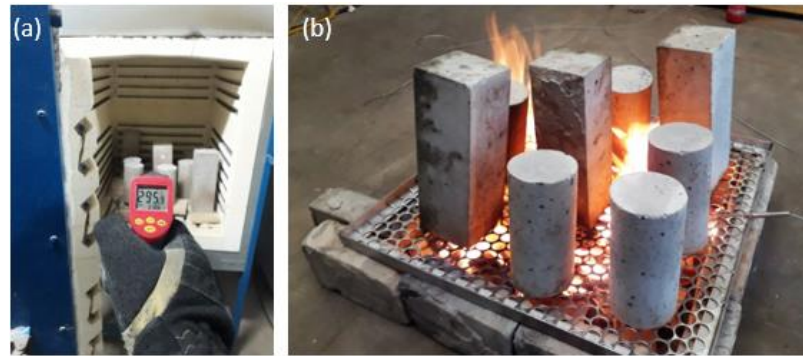
Fig. 1. Temperature rise through furnace (a) and grill fire test (b).

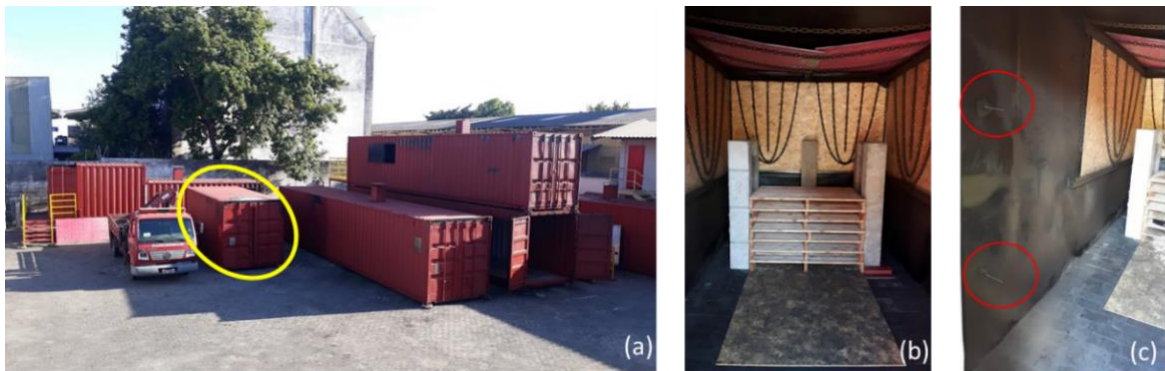
Fig. 2. Chosen simulator (a), device assembly (b) and sensor arrangement (c).

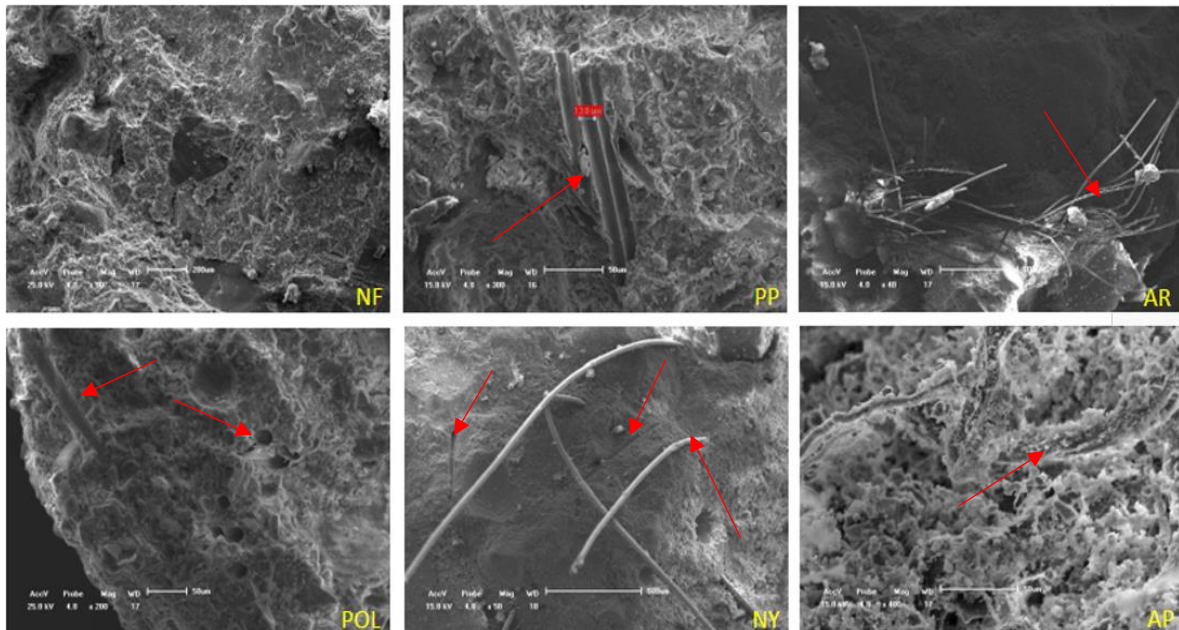
The Fig. 4 shows the concretes after being subjected to a temperature of 500°C in furnace.

Fig. 4. SEM of concretes after being subjected to a temperature of 500°C

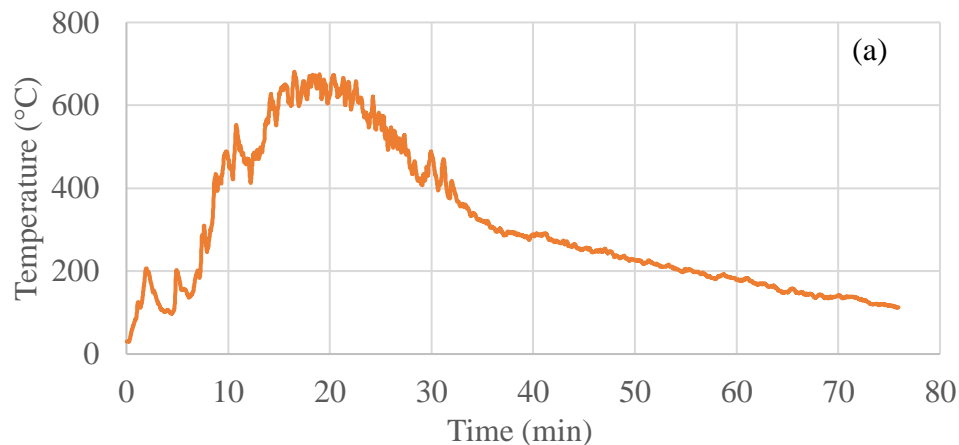
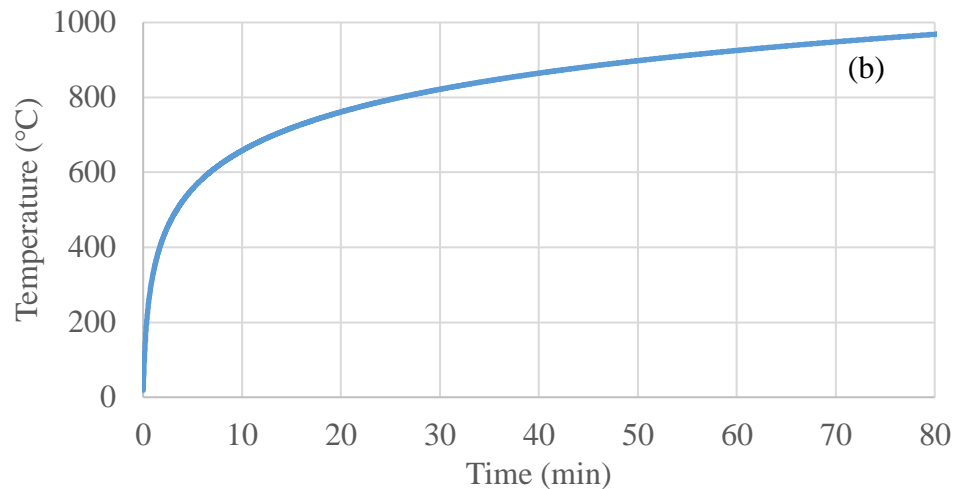
Fig. 5. Temperature x time in the grill fire test (a) and ISO 834 (b) curve

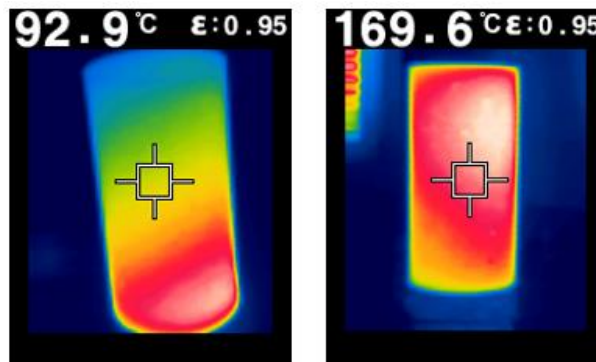
Fig. 6. Thermographic images of the specimens in cooling phase, immediately after burning on grill fire test (a) and immediately after being subjected to 500°C in furnace (b)

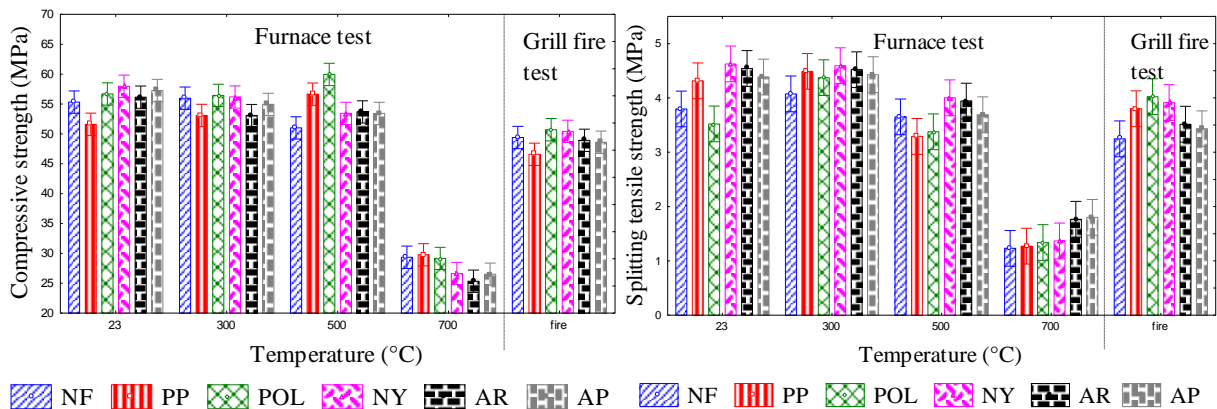
Fig. 7. Compressive strength (a) and splitting tensile strength (b) as a function of the temperature in the furnace and in the grill fire test.

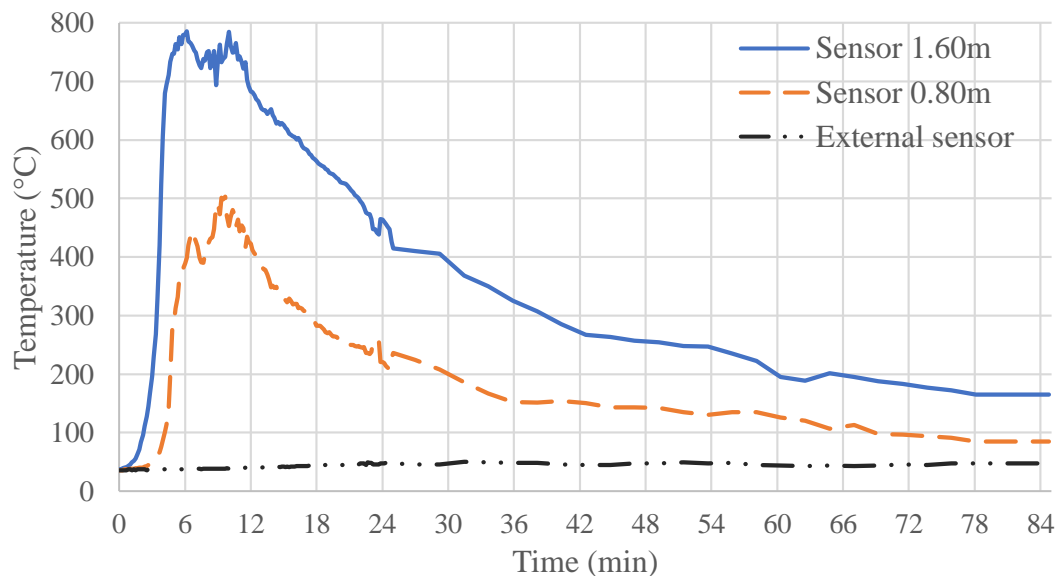
Fig. 9. Temperature vs time in the live fire simulator for the three sensors.

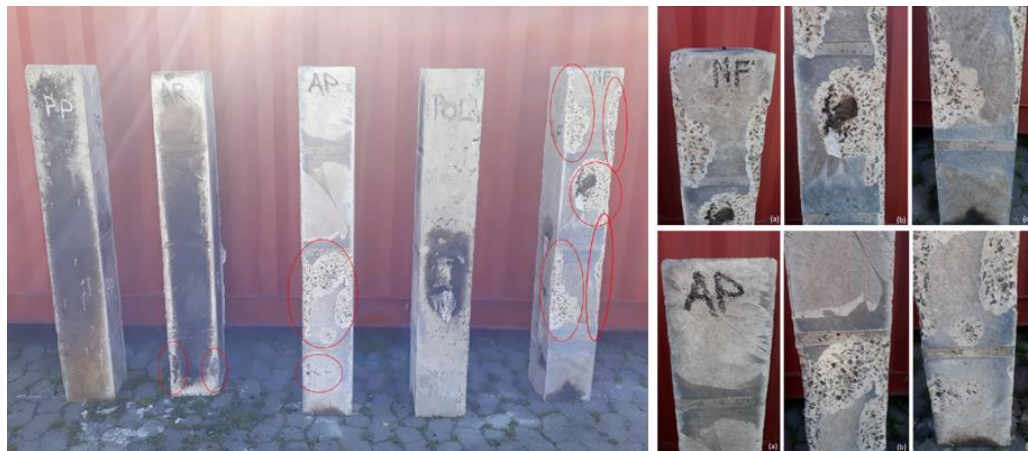
Fig. 10. Columns after being subjected to the fire and focus in NF and AP post fire, showing the top (a), center (b) and base (c).

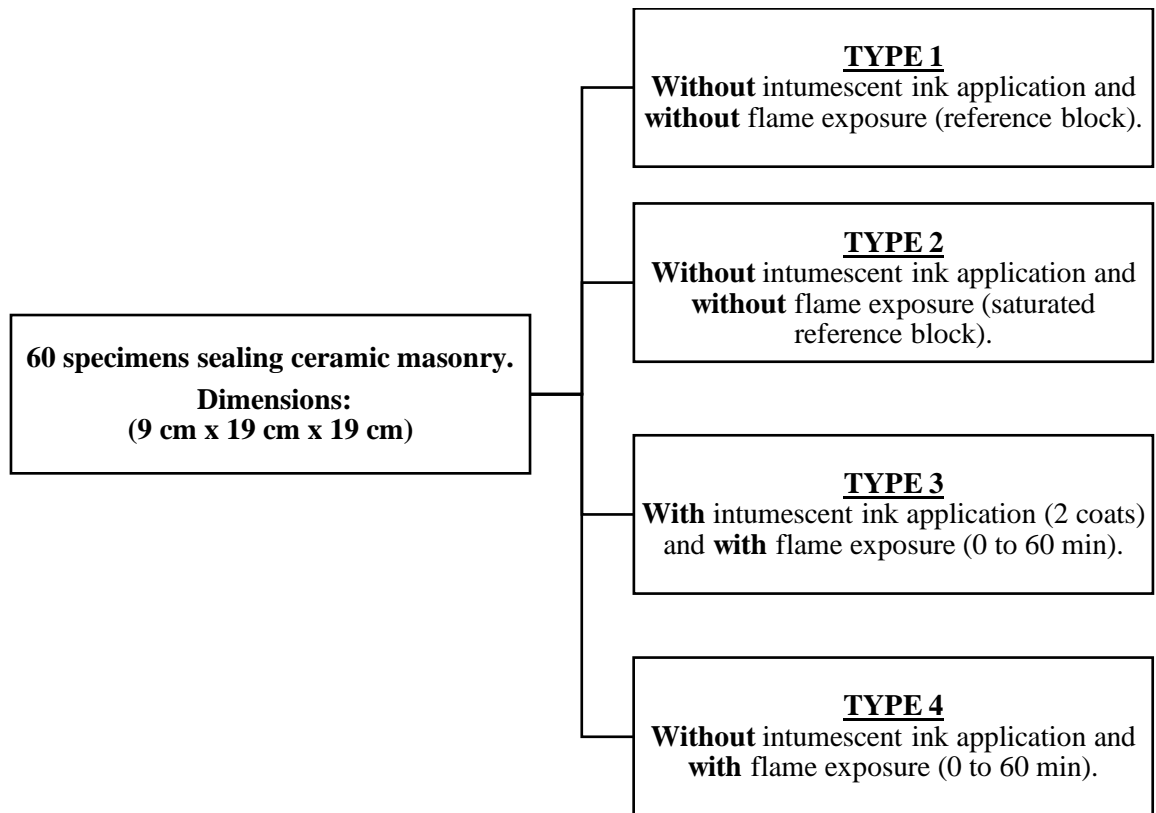
Figure 1. Experimental planning.
