Revista **ALCONPAT**

Latin American Journal of Quality Control, Pathology and
Construction Recovery

Volume 10

January - April 2020

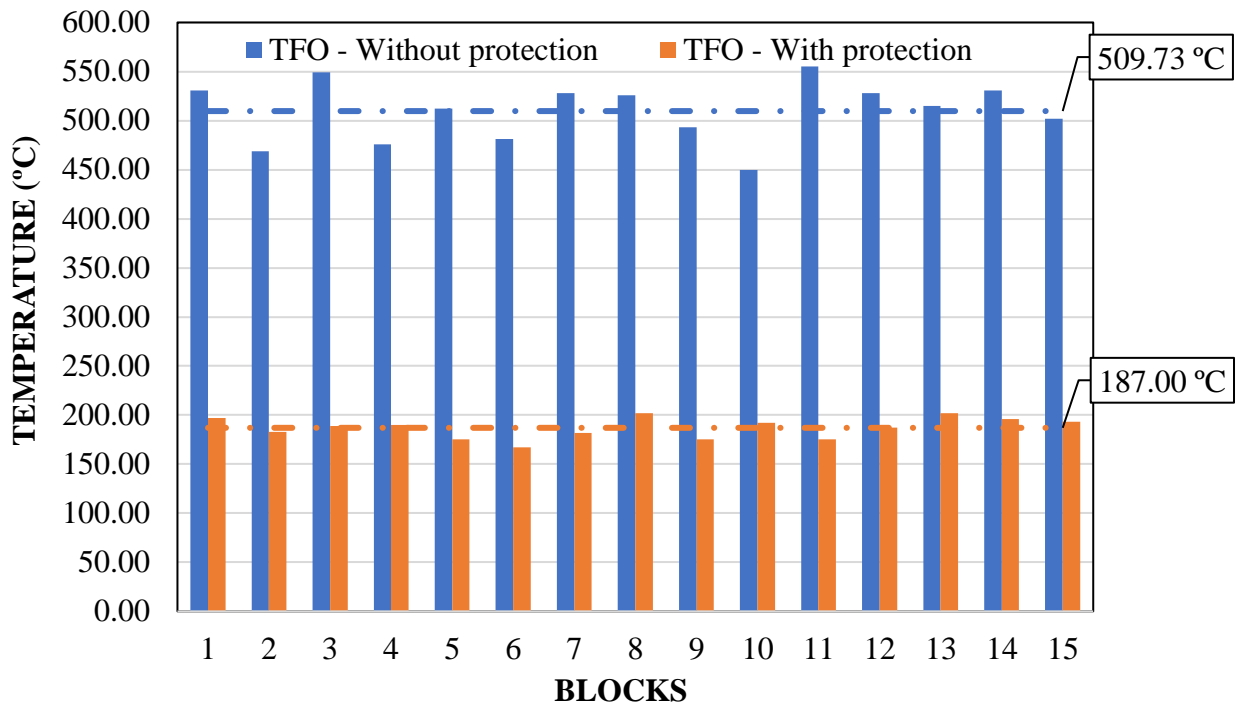
Figure 8. Comparison of the temperatures of the immediately opposing faces for the blocks with and without passive protection, types 3 and 4 respectively.

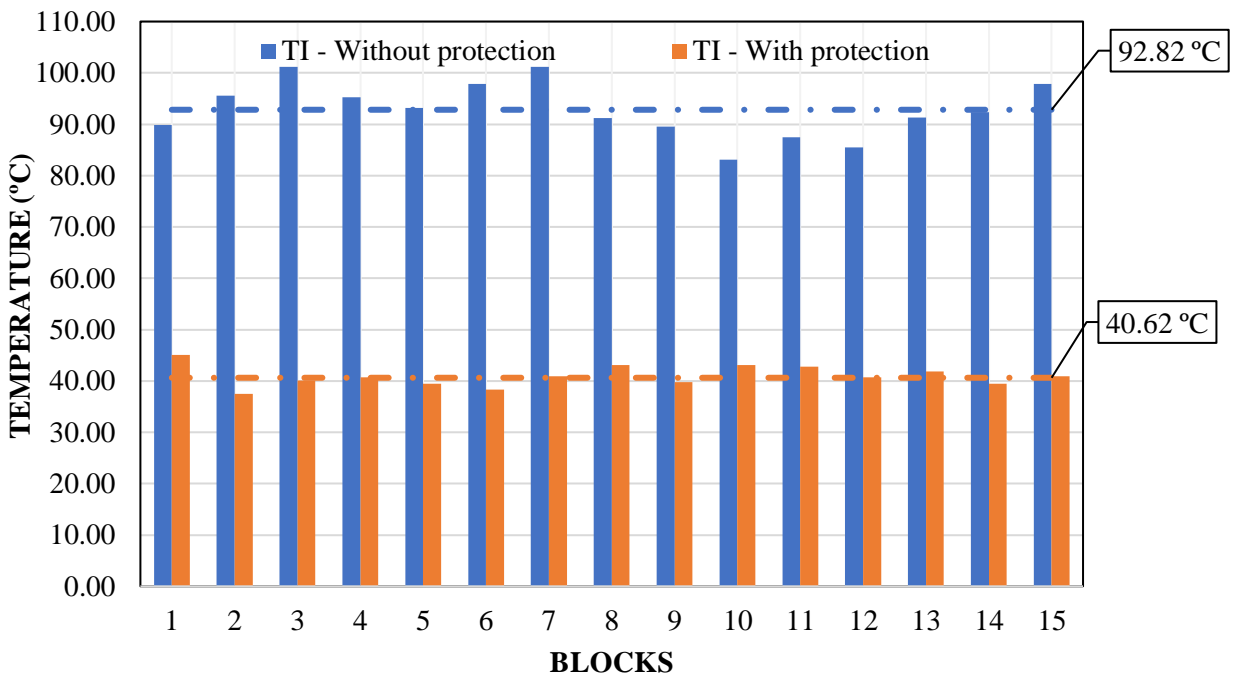
Figure 9. Comparison of the temperatures in the opposite faces for the blocks with and without passive protection, types 3 and 4 respectively.

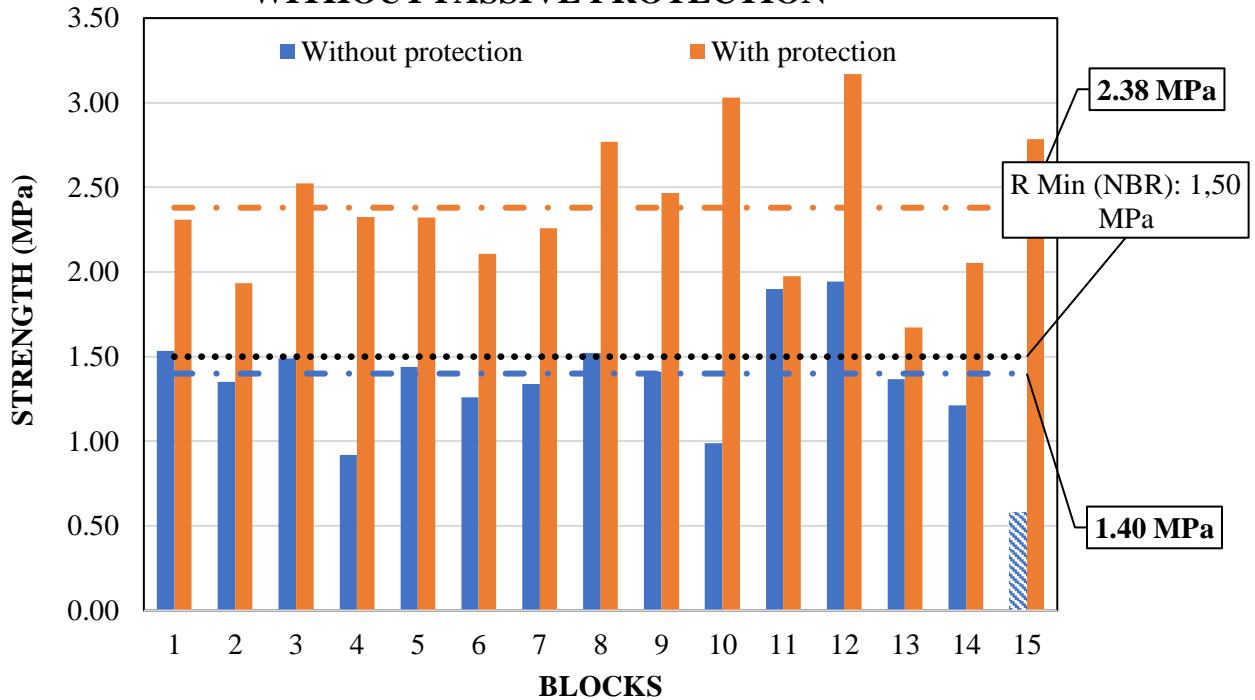
Figure 10. Compressive Strength: comparison between blocks with and without passive protection (types 3 and 4).

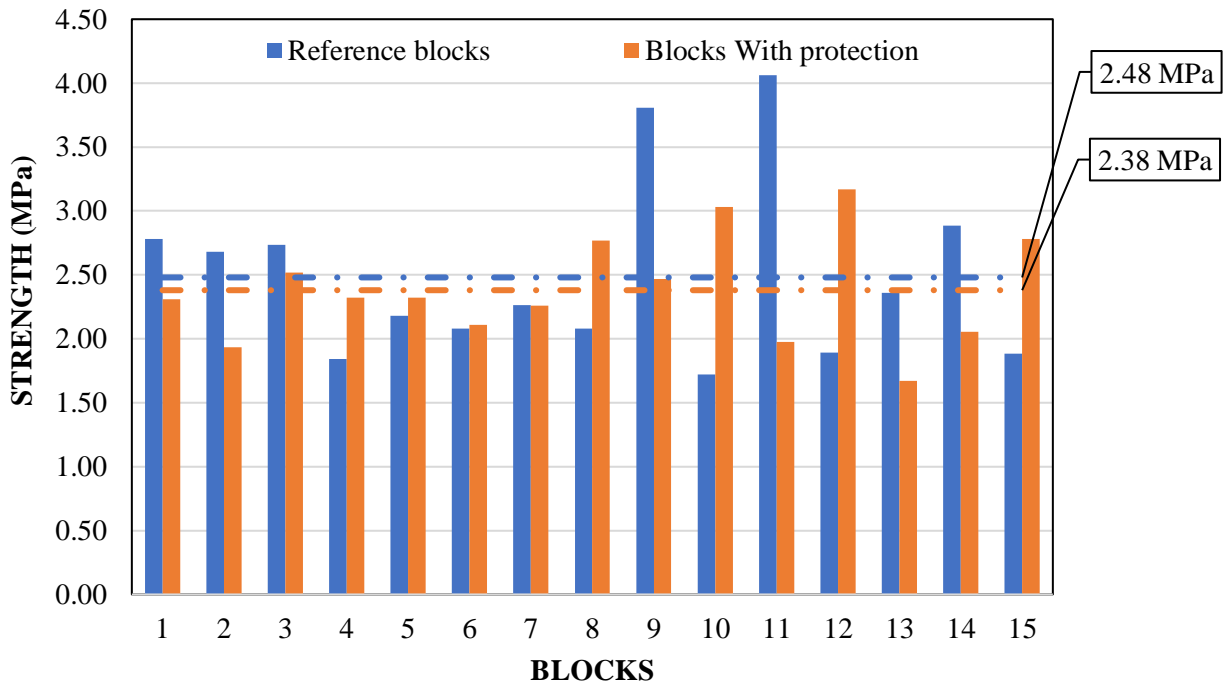
Figure 11. Compressive Strength: comparison between Reference Blocks and Blocks with Passive Protection.

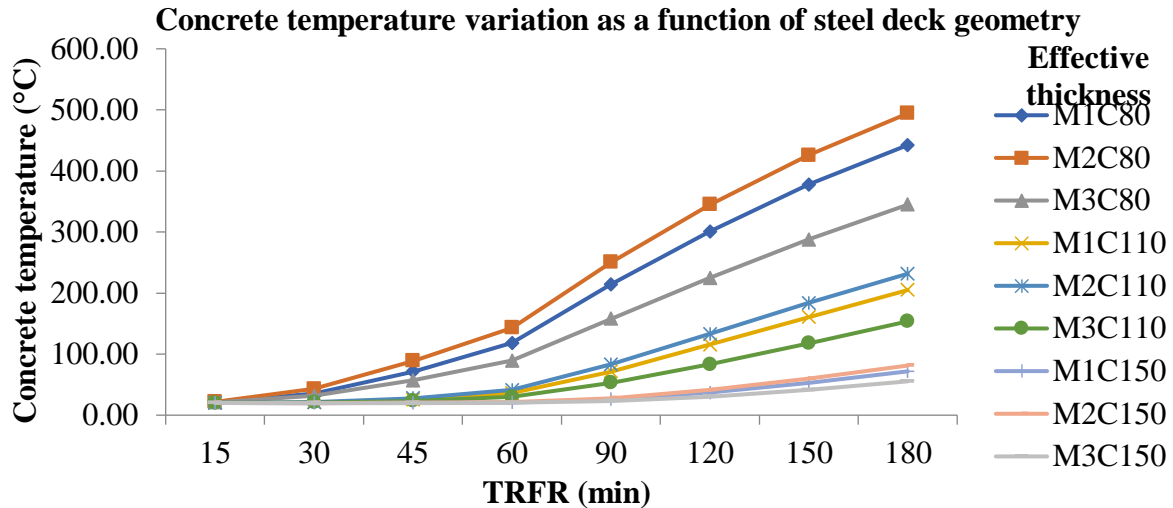
Figure 6. Concrete temperature variation as a function of steel deck geometry

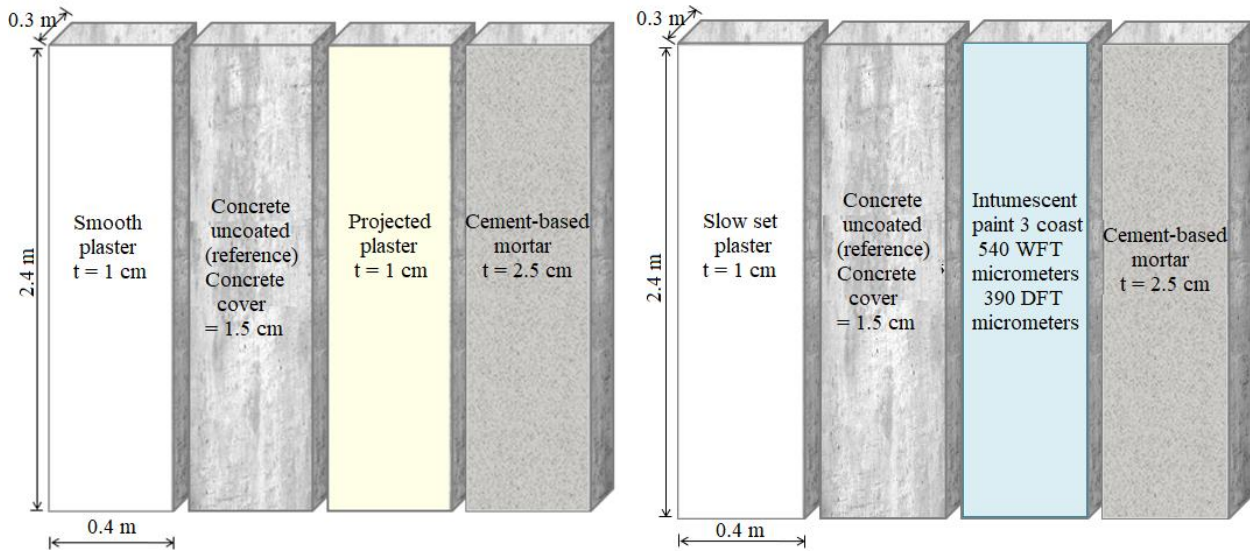
Figure 1. Concrete elements and coating systems that went through tests in both fire simulations (1st test event at left and 2nd test event at right).

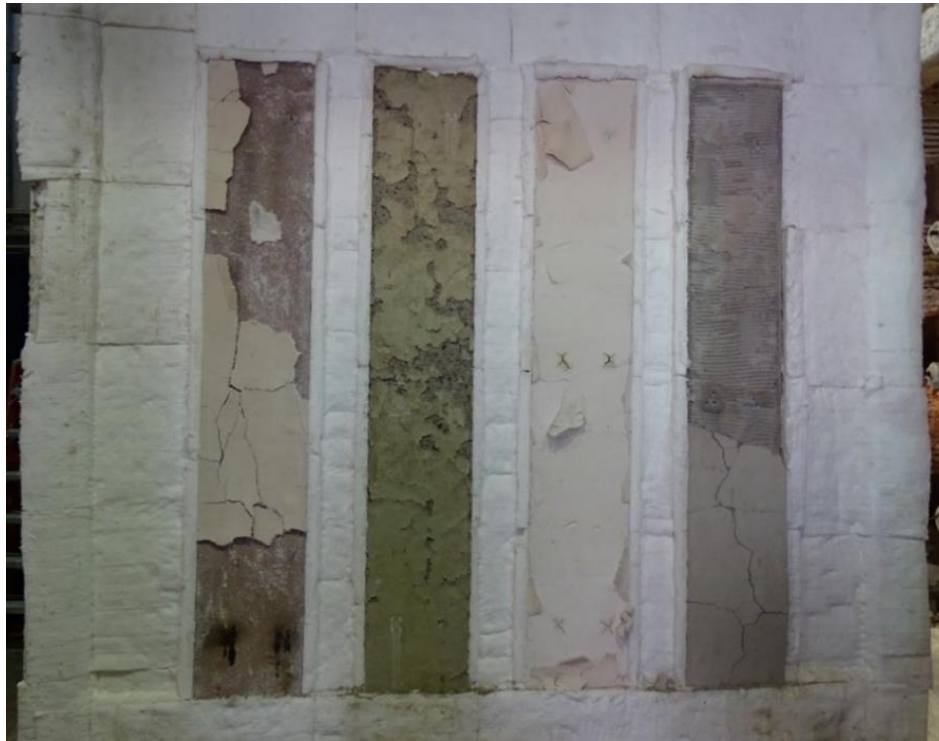
Figure 4. Detail of the elements and coatings condition after furnace opening (event 1): smooth formulated plaster coating, reference element, projected plaster coating and cement-based mortar coating.

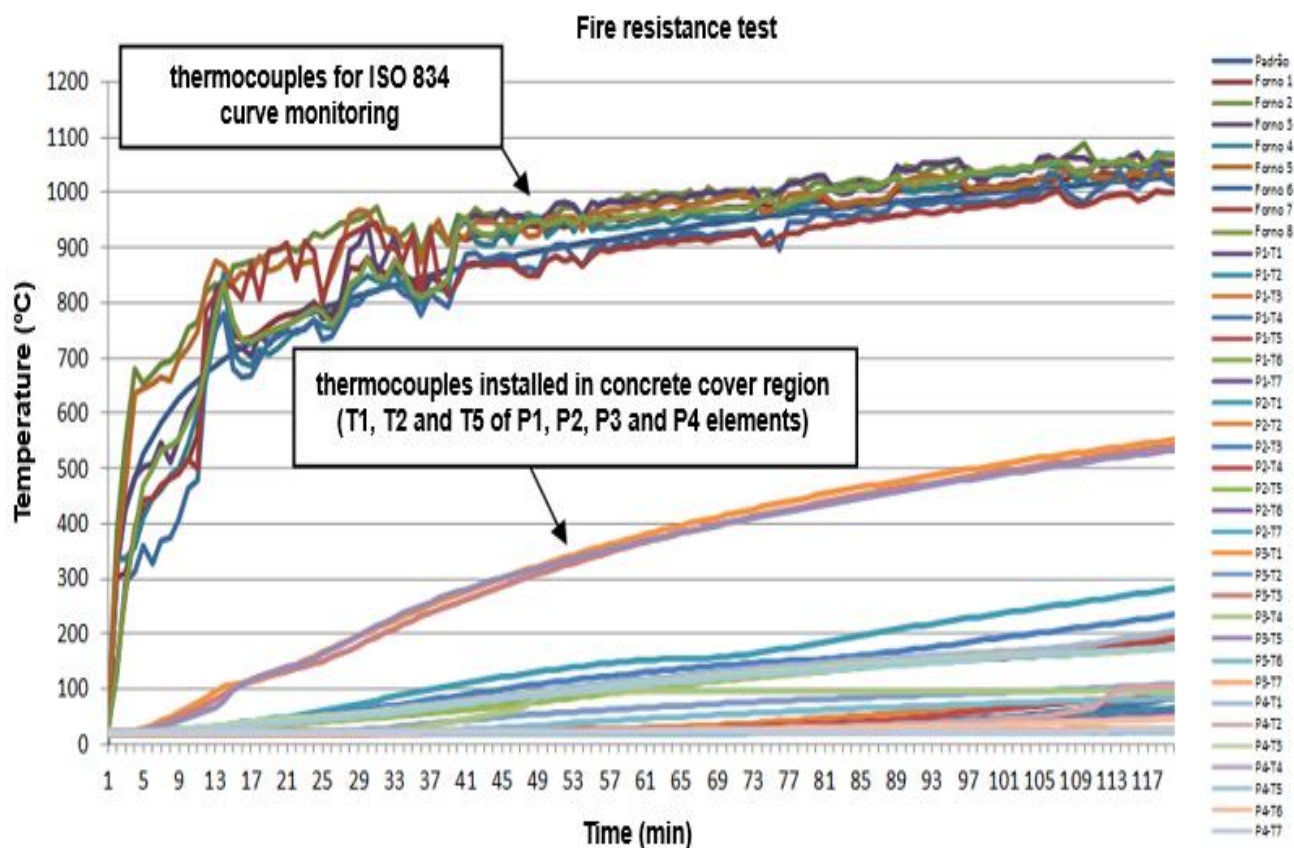
Figure 5. Temperatures obtained inside the furnace and inside the elements of 1st event.

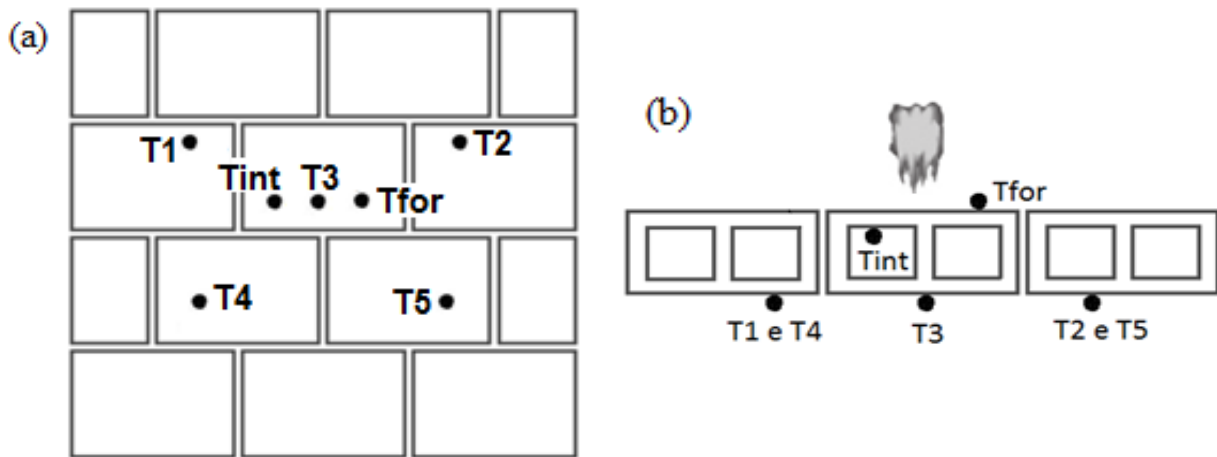
Figure 3. Thermocouple positioning in the samples. (a) Frontal view. (b) Upper View.

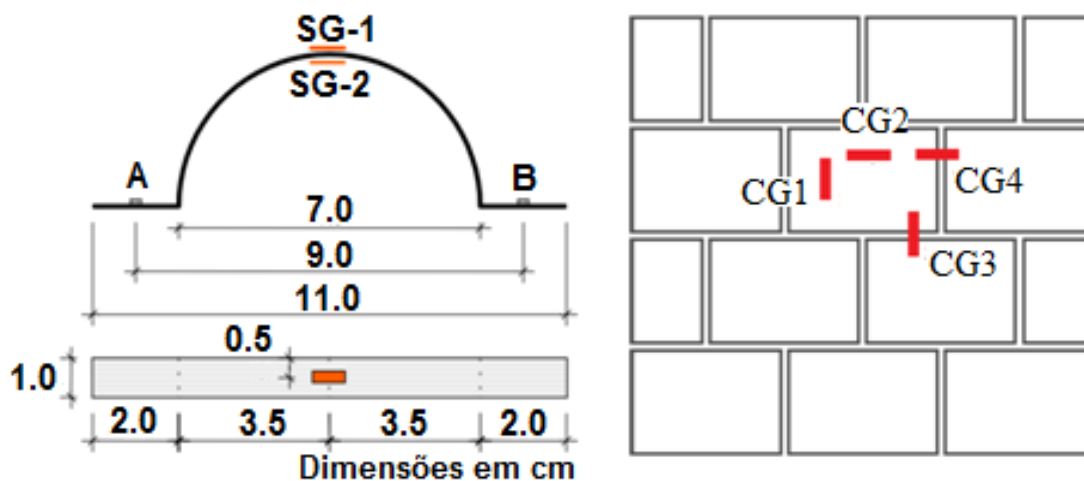
Figure 4. Clip-gages geometry (BEBER, 2003) and placement in the wall.

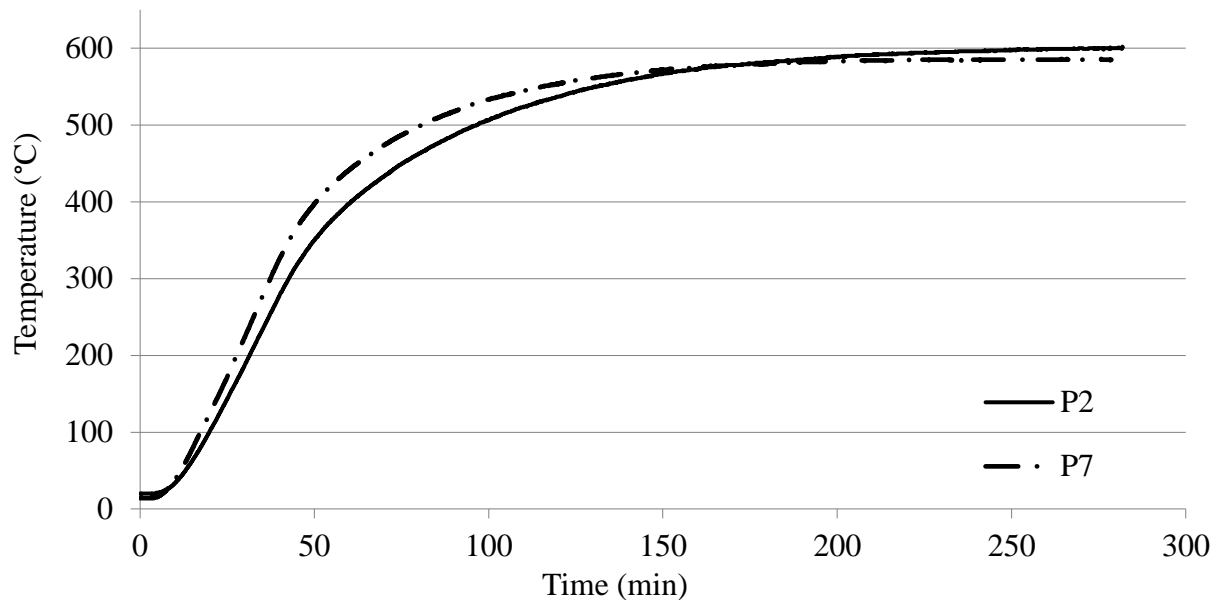
Figure 7. Temperature inside the masonry with respect to the different laying joints with traditional mortar and polymeric mortar (Group 3).

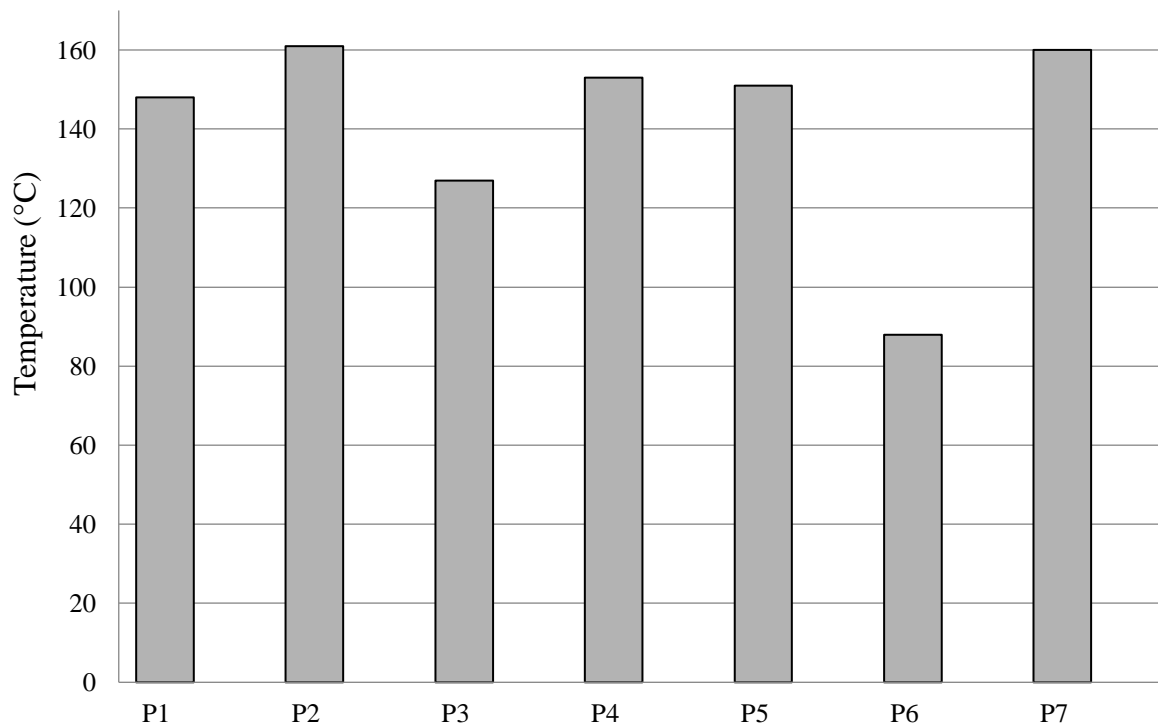
Figure 8. Maximum temperature on the unexposed face.

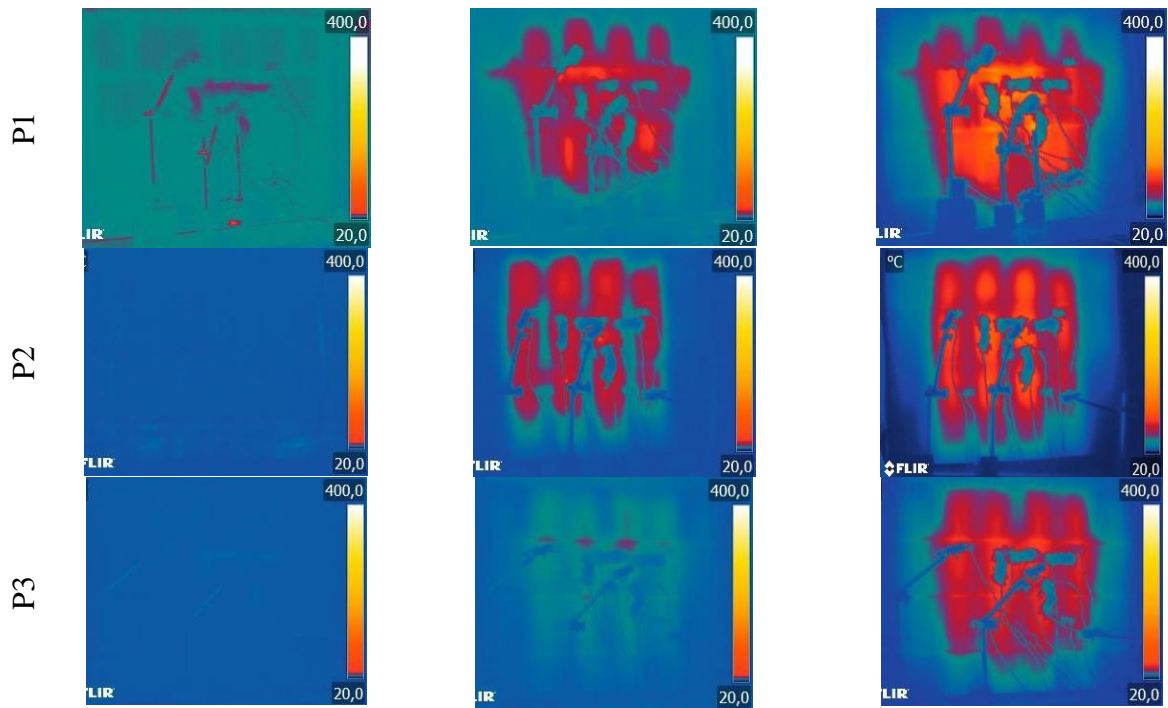
Figure 9. Thermographic Images – Group 01.

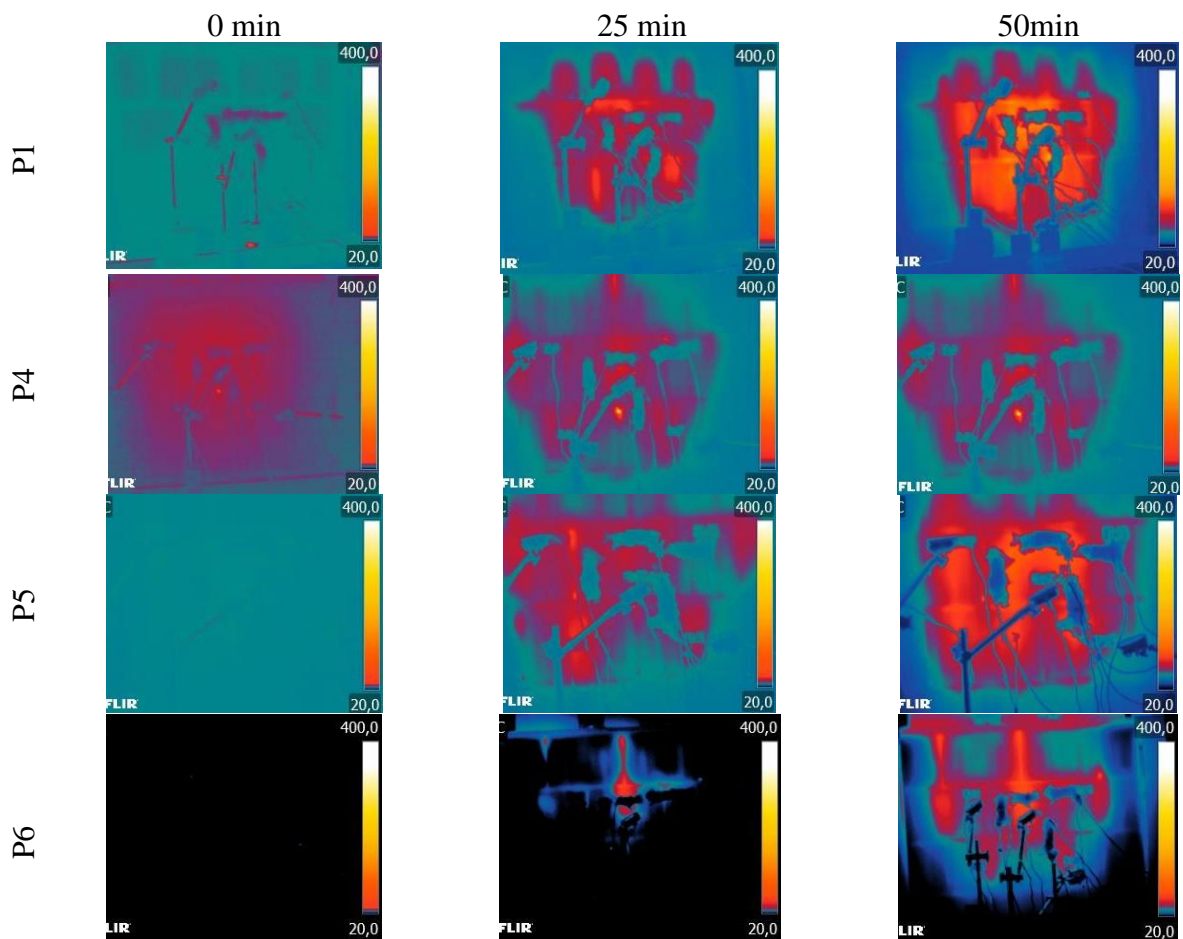
Figure 10. Thermographic Images – Group 02.

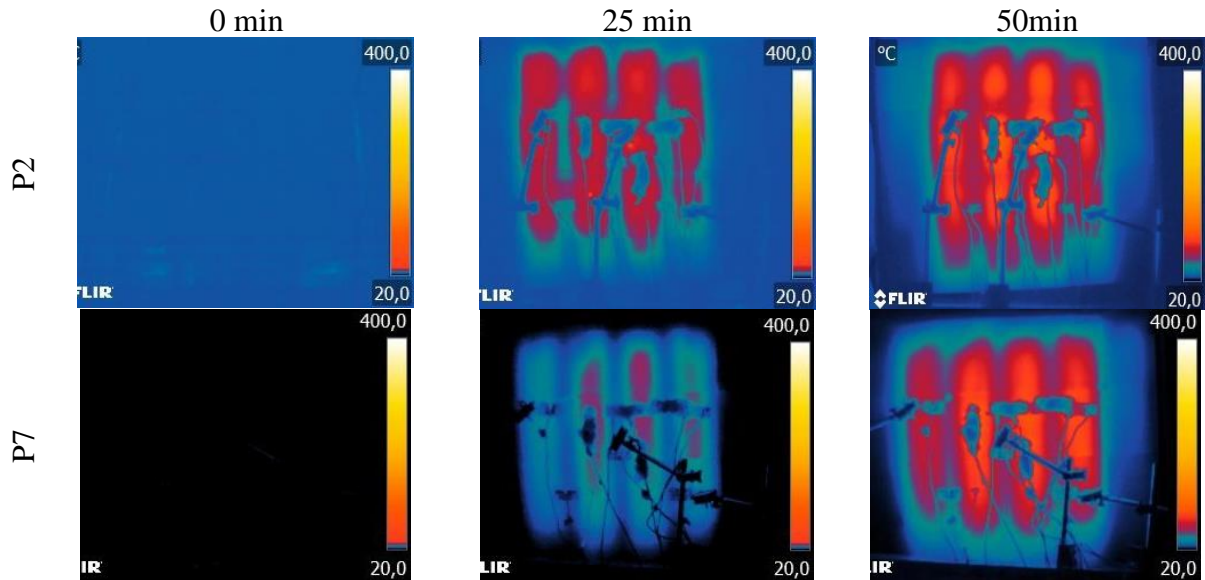
Figure 11. Thermographic Images – Group 03.

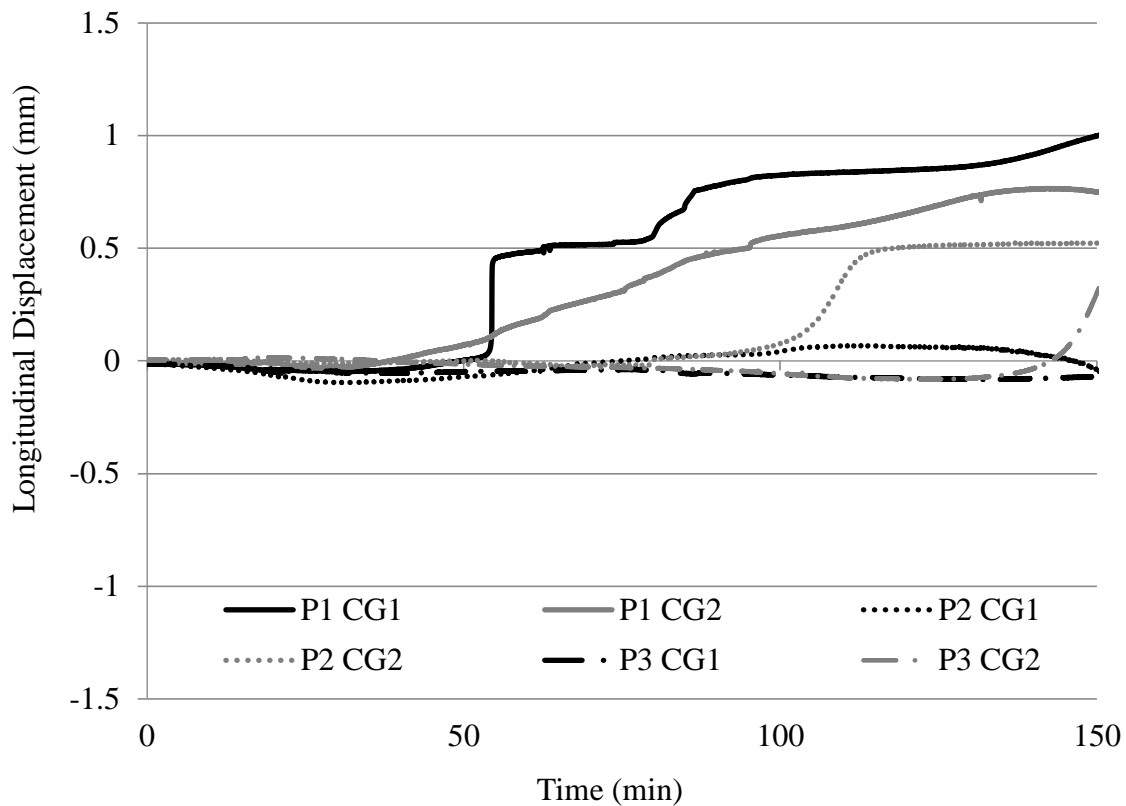
Figure 12. Longitudinal Displacement of the bricks – Group 01.

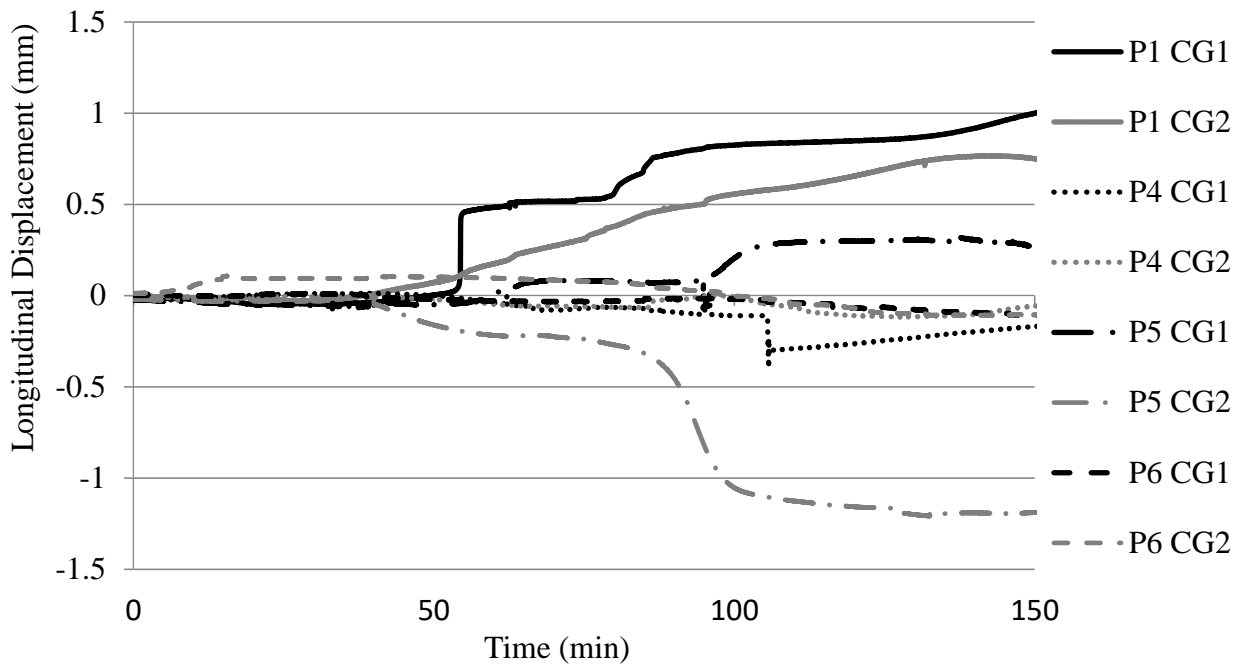
Figure 13. Longitudinal Displacement of the bricks – Group 02.

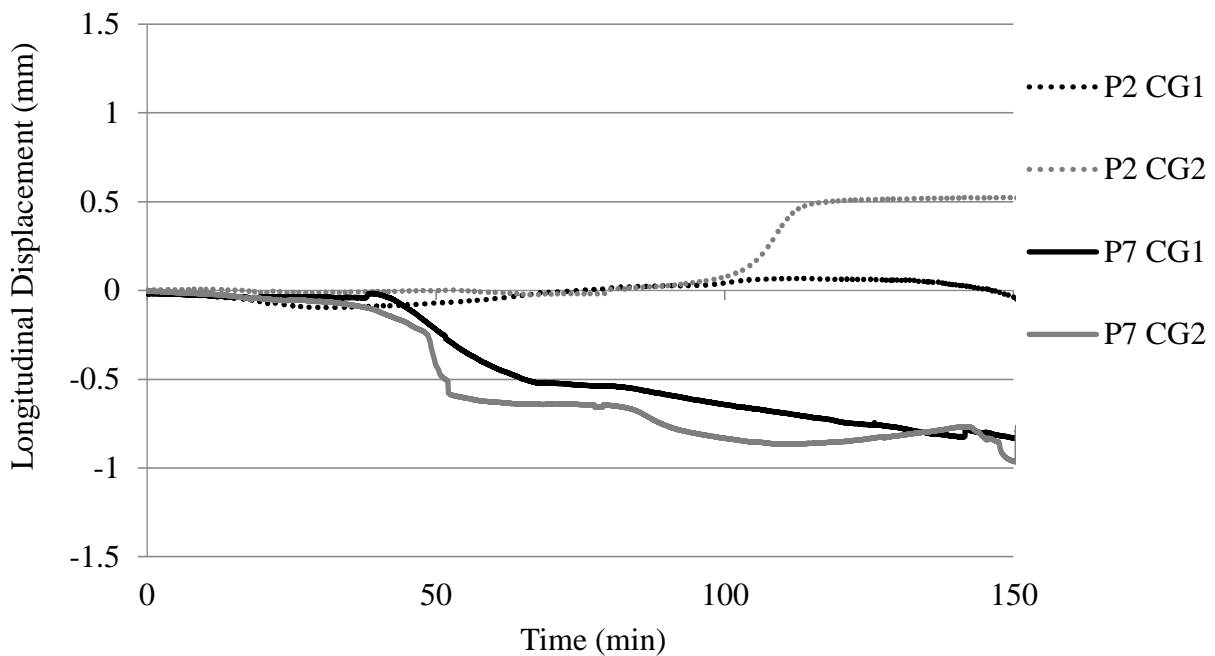
Figure 14. Longitudinal Displacement of the bricks – Group 03.

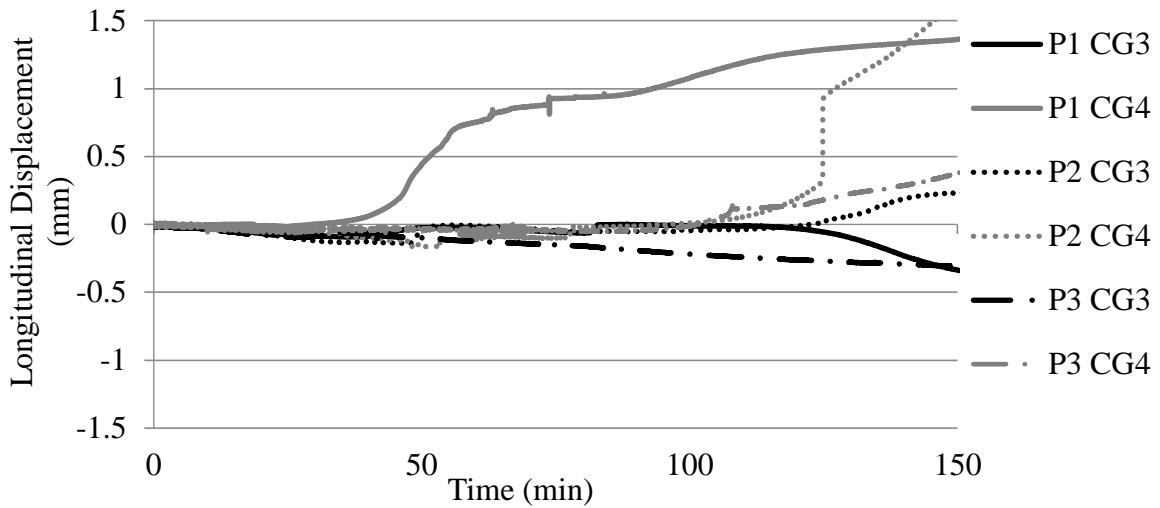
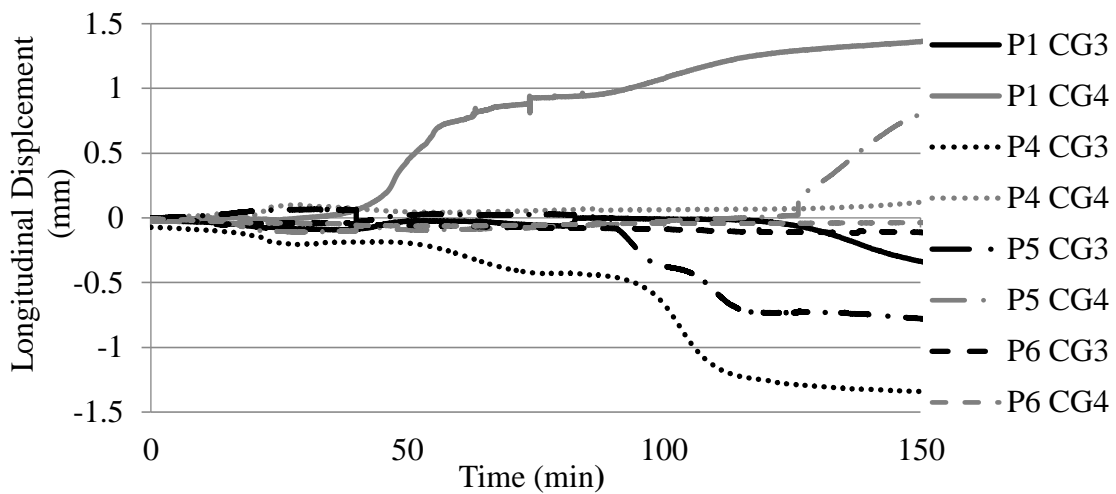
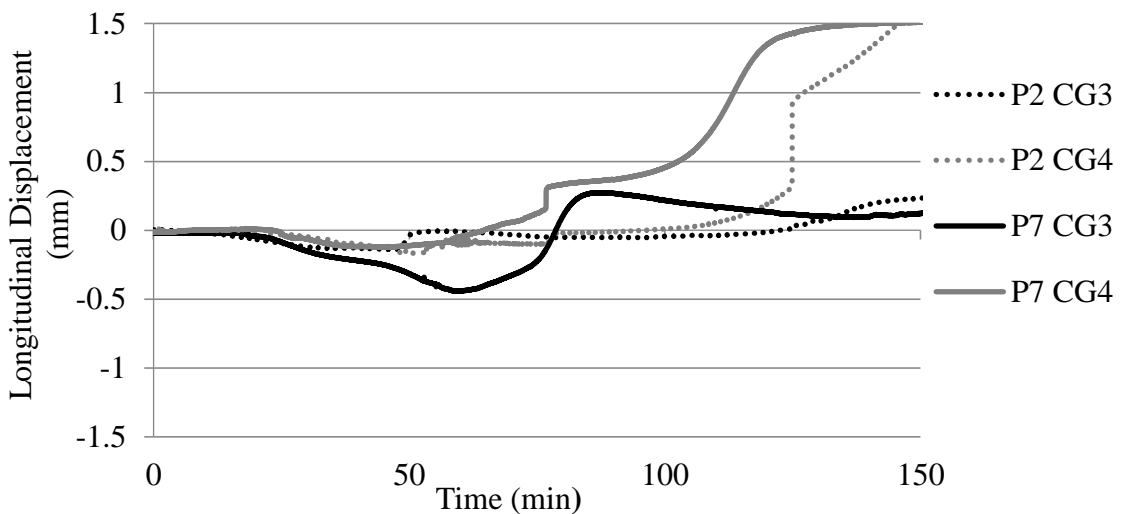
The opening movement noted on CG 4, which was manifested for most results, may have been the result of a movement of the wall as a whole, which could be expanding laterally due to an inefficient restriction in that direction. It is possible that the mortar used for capping the samples did not offer sufficient strength to prevent deformation. Thus, the crushing effect of the joint between the blocks is best visualized in the vertical direction by clip-gage 3, since in this direction the load application makes the restriction more effective.

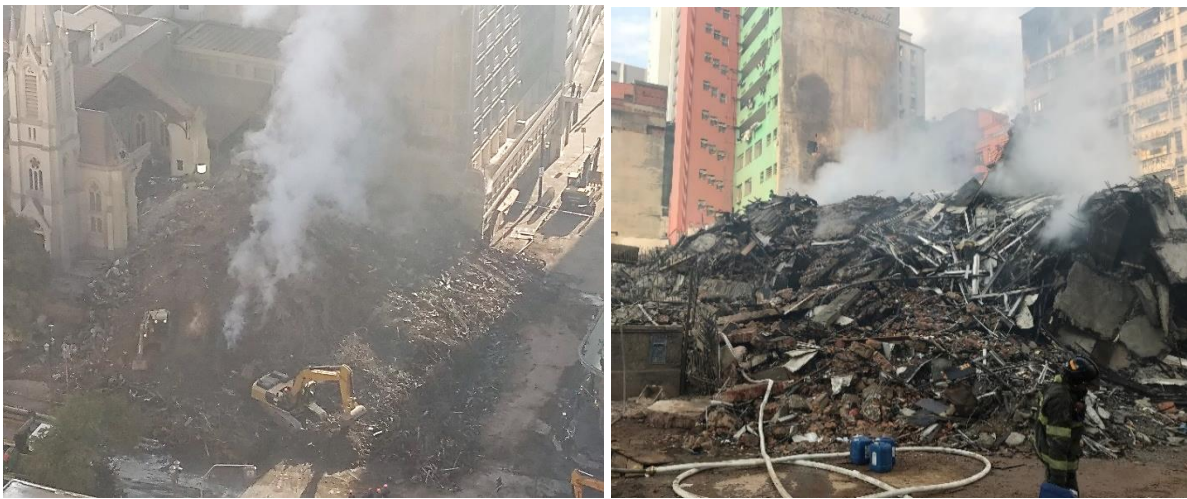
Figure 2. Wilton Paes de Almeida after its collapse (source: Paulo Helene's personal collection).

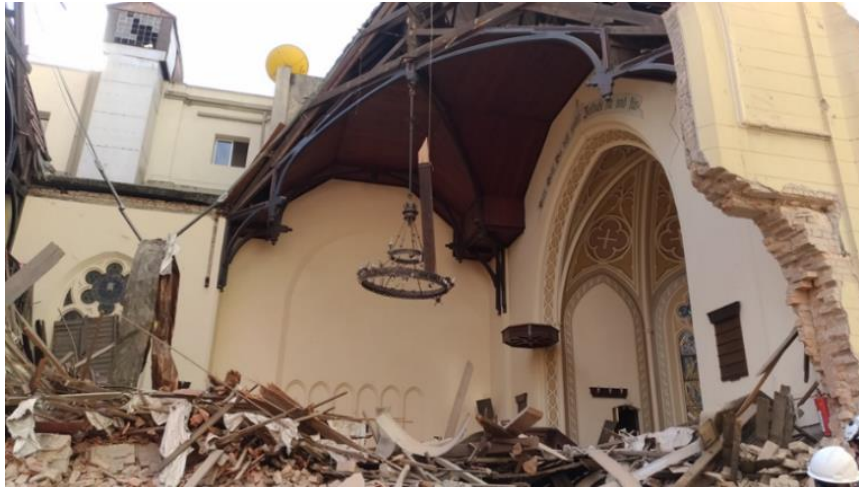
Figure 3. Damage to the Lutheran Church, next to Ed. Wilton Paes de Almeida (source: Paulo Helene's personal collection)

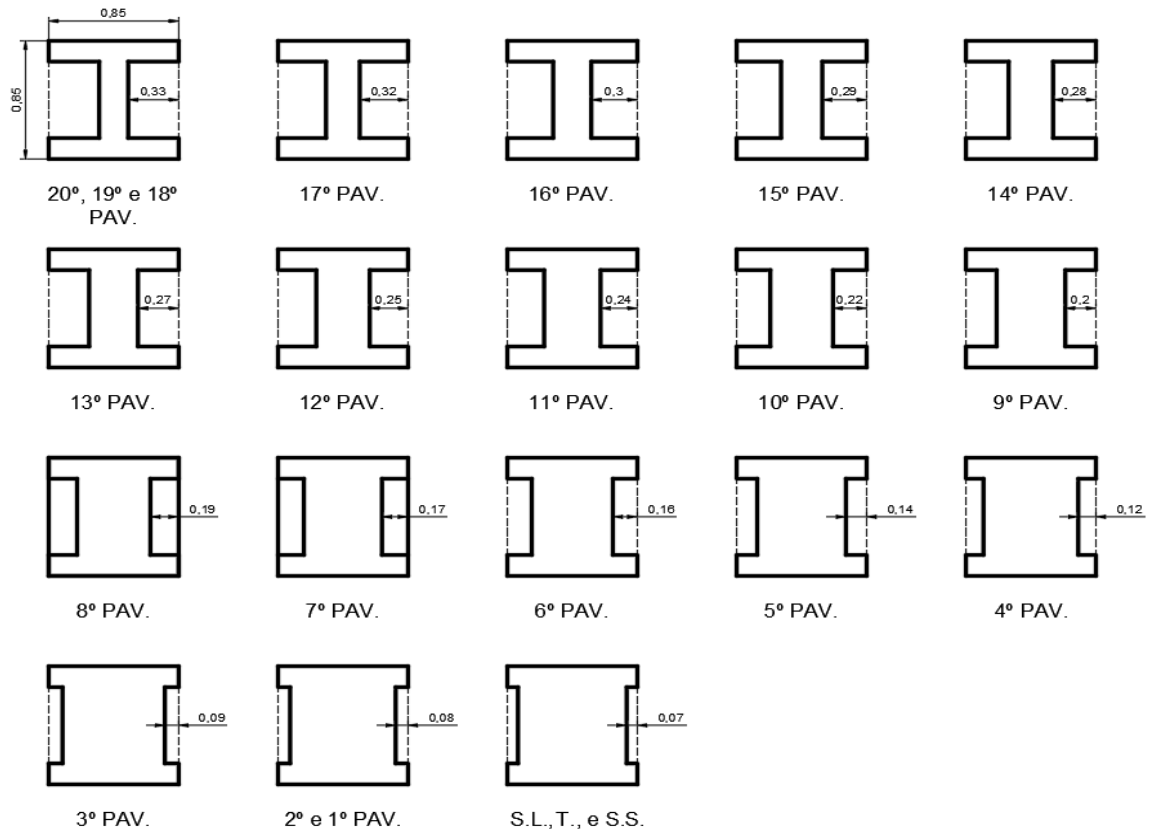
Figure 5. Scheduling of the columns (Source: executive architectural design found in the library of FAU. USP)

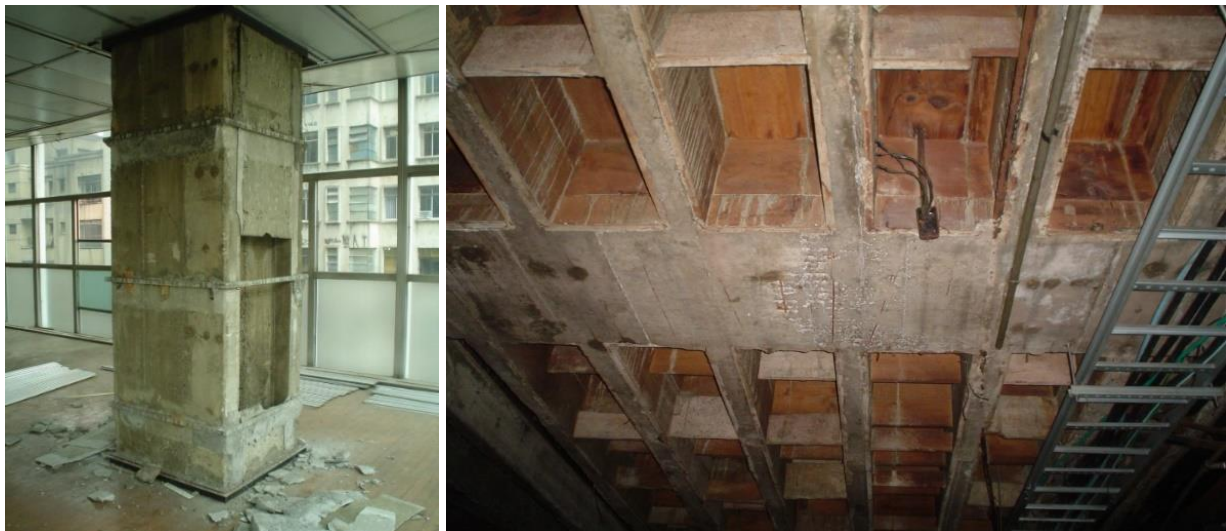
Figure 6. Columns without metal coating, where it is observed the "H" which is actually a shaft of the air conditioner and I grate beam track with AJE still forms wood.
(source: personal collection of Leandro Coelho)

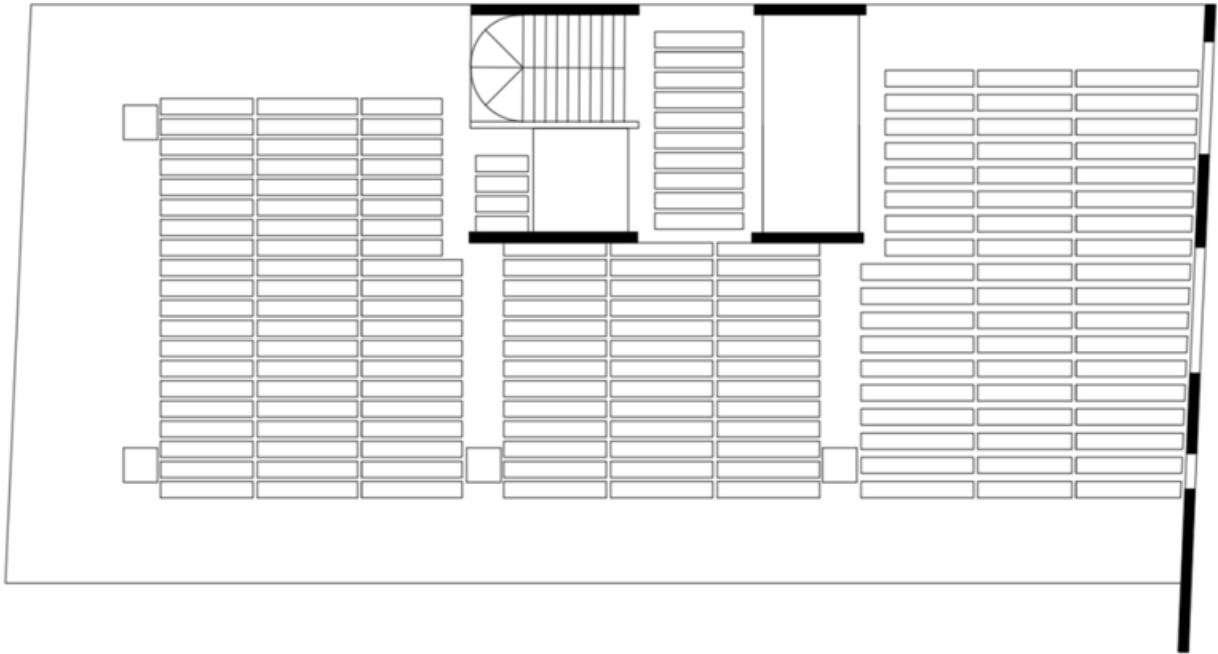
Figure 7. Grid Slab Scheme (Source: FAU-USP)

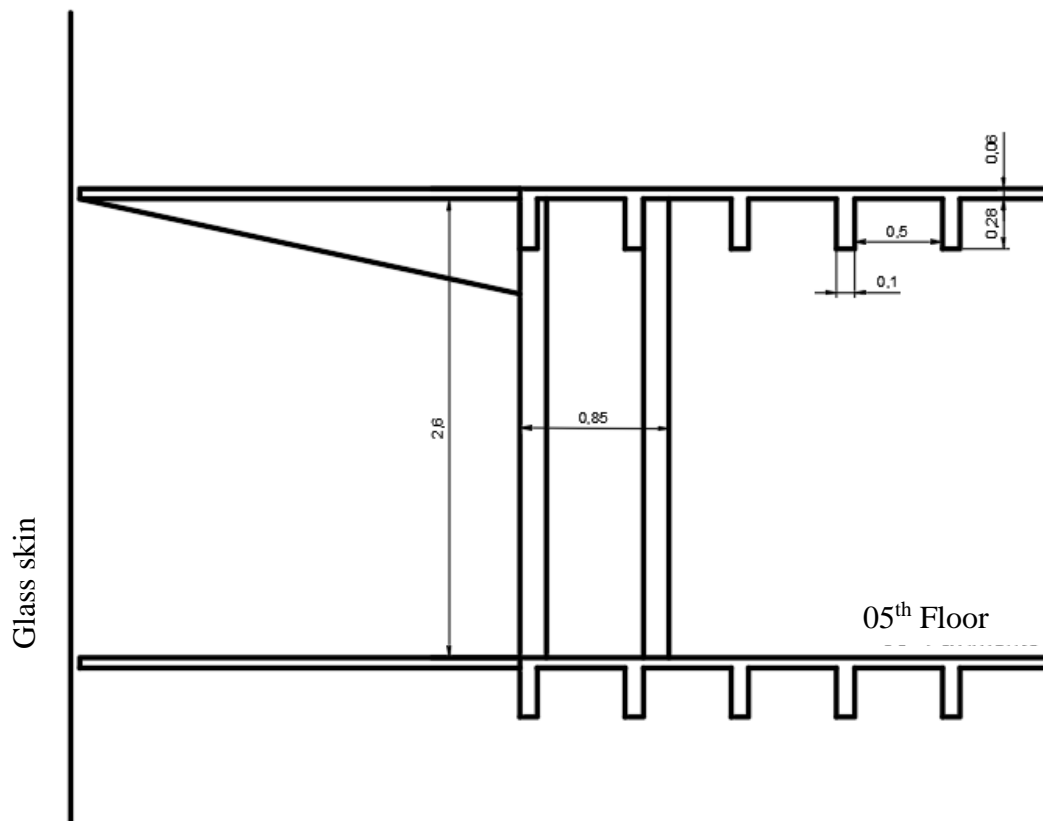
Figure 8. Grate slab cutting (Source: FAU-USP)

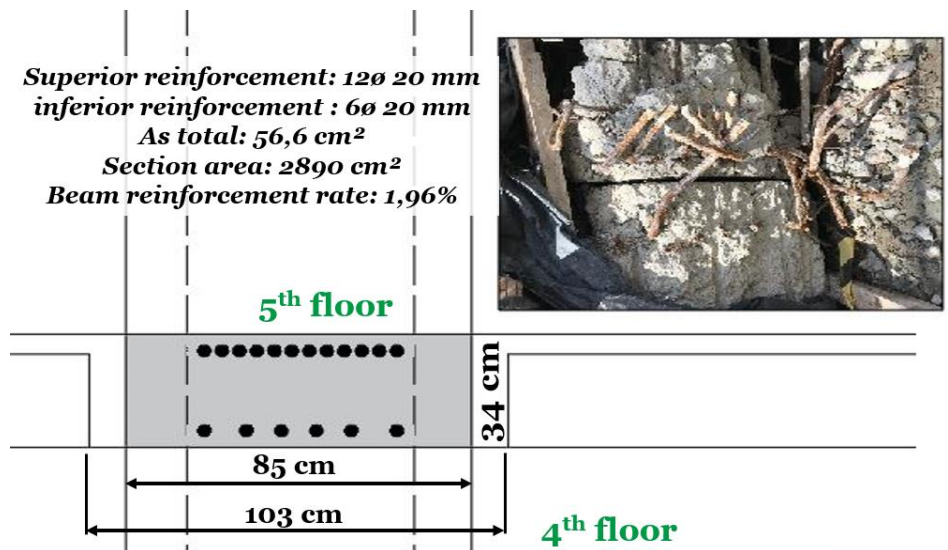
Figure 12. Configuration of the strip-beam reinforcement.

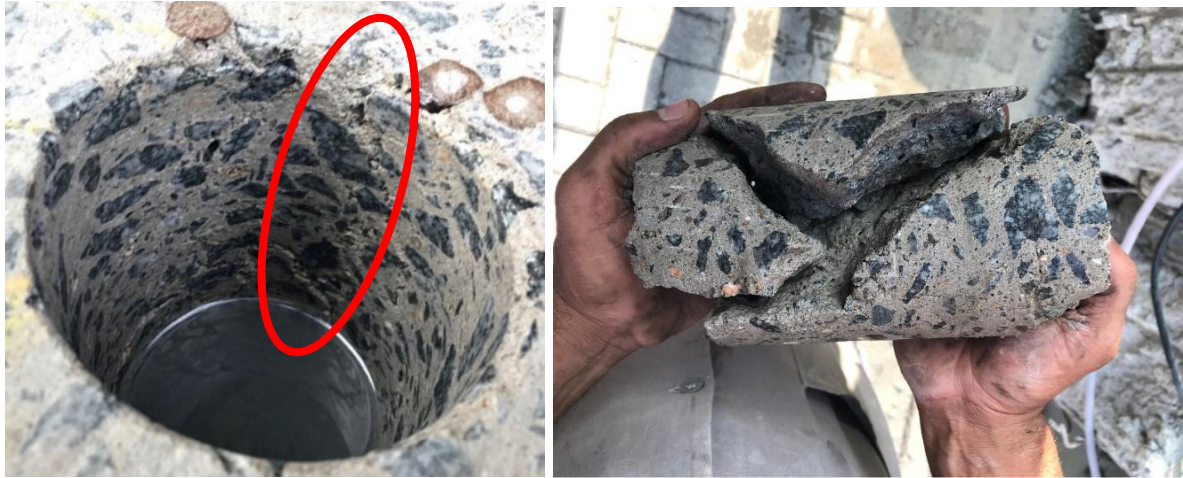
Figure 13. Visible cracks during extraction and decomposed core.
(Source: Paulo Helene's personal collection)

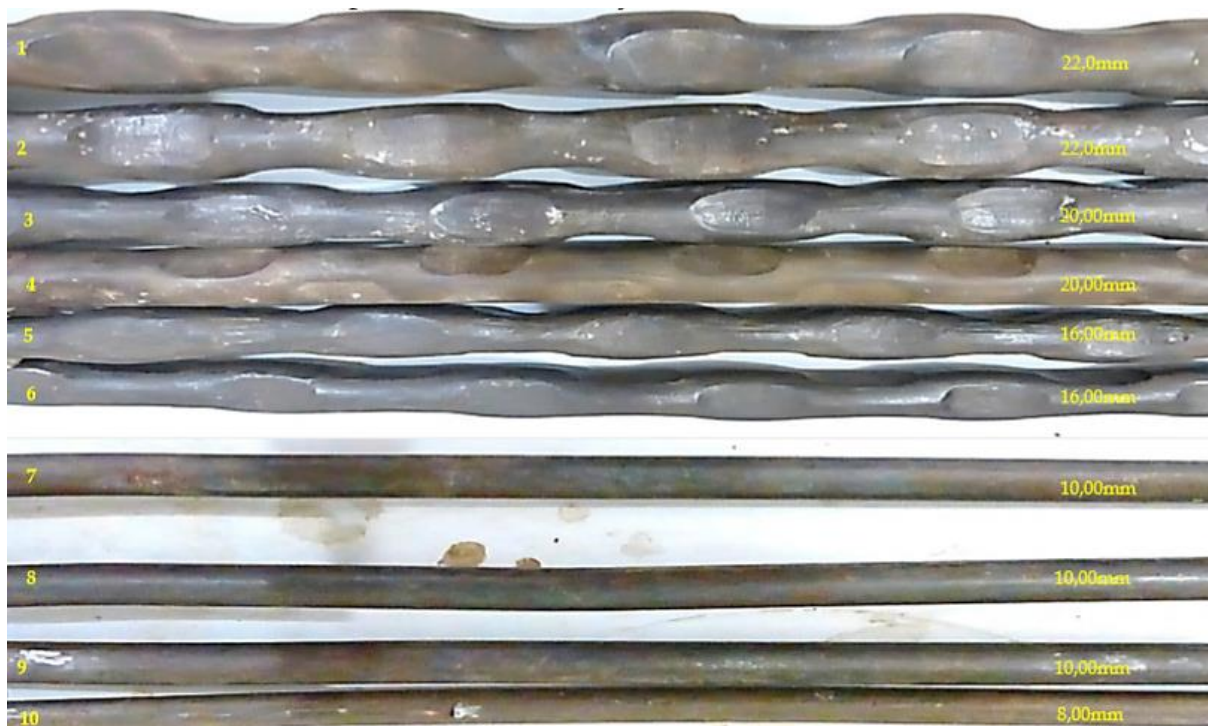
Figure 14. Classification of steel samples according to his gauge (Source: Arcelor Mittal)
