Revista **ALCONPAT**

Latin American Journal of Quality Control, Pathology and
Construction Recovery

Volume 10

January - April 2020

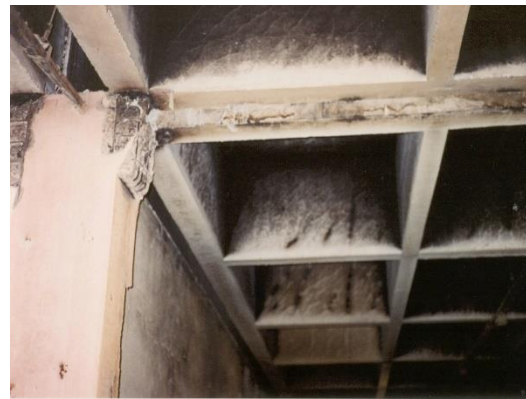
Figure 12. Support displacement of pre-molded fire structure

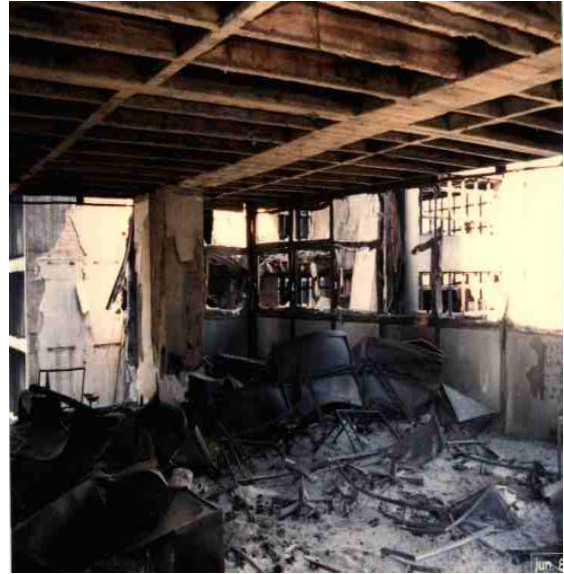
Figura 17. Fire damaged Sede I building structure
