## Durability analysis of reinforced concrete with loading induced cracks

The objective of this study is to verify the relationship between the action of loads inducing cracks and the durability of reinforced concrete. Prismatic specimens were produced and for two years these samples were subjected to artificial salt spray, under the action of different types of loading and unloaded (reference), with moist curing for 7 days. Chloride penetration tests and microstructural analysis were carried out. It was observed that loading did not influence the results of chloride penetration. However, it was observed that in the micrographs and microanalysis of the cracked samples the clearer formation of deterioration products and possible microorganisms, compared to the samples that did not suffer loading.

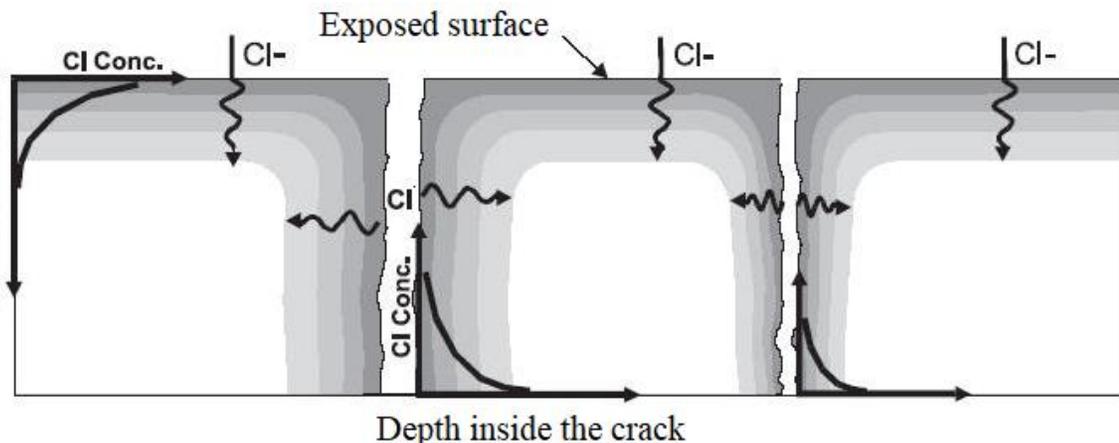
Figure 1. Penetration of chlorides on the surface and between cracks (Ismail et al., 2006).

The penetration and diffusion of chloride ions can occur through the crack as shown in Figure 1.

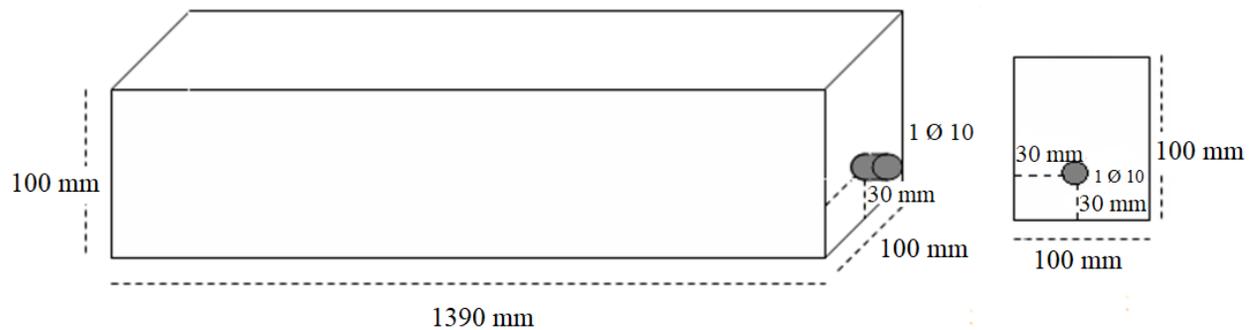
Figure 2. Scheme of dimensions of the prismatic specimens.

The prismatic specimens were molded two by two. To maintain coverage, 3 spacers of 30 mm were placed along the steel bar. Figure 2 shows the dimensions of the prismatic specimen and the position of the steel bar.

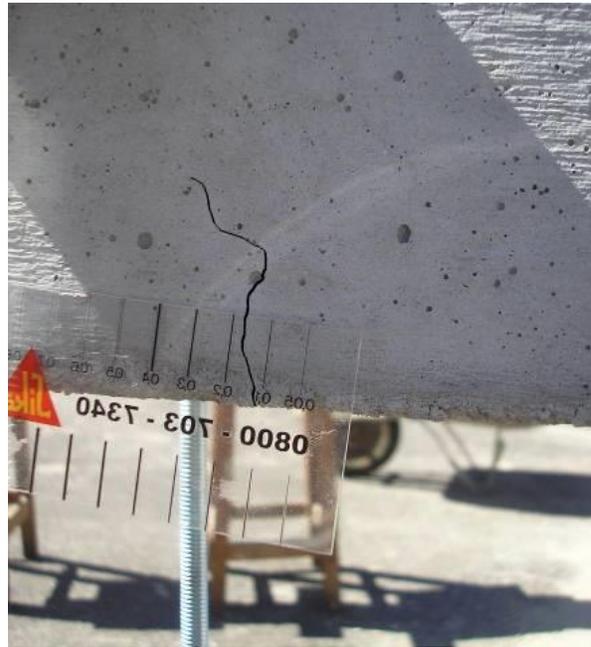
Figure 3. Measurement of the crack opening in the center of the prismatic specimen with a crack meter.

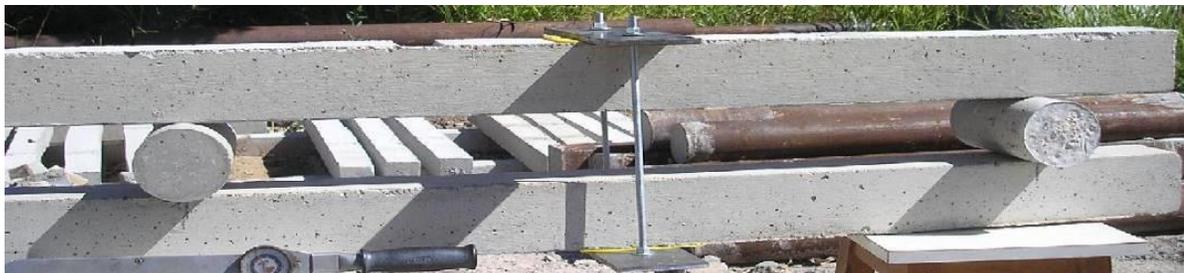
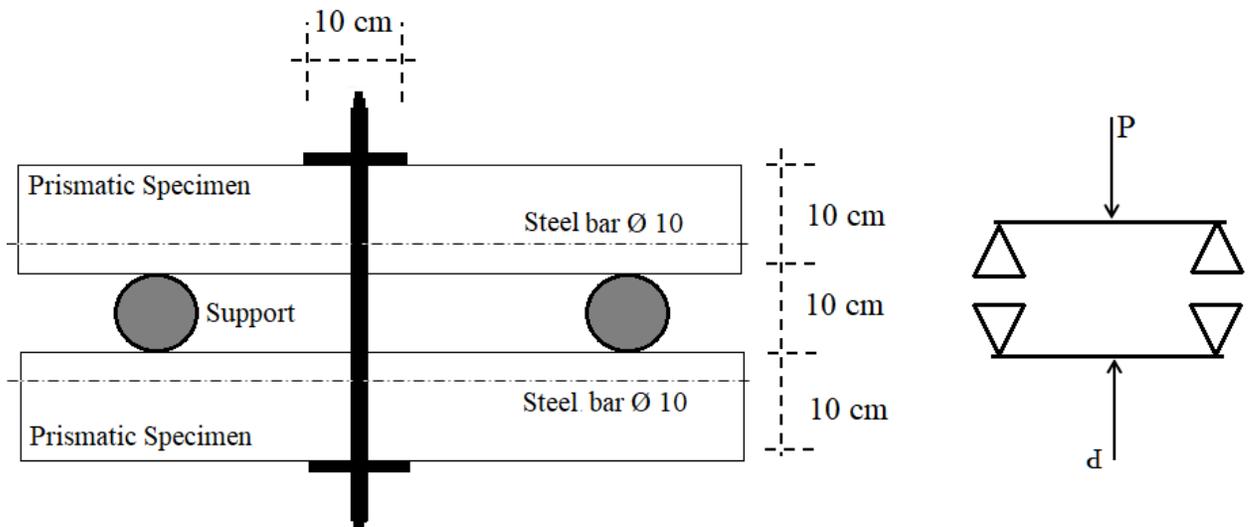
Figure 4. Permanent central loading (CCP) in the prisms.

The prismatic specimens were under constant loading until the test dates. The diagram shown in Figure 4 shows the prismatic specimens supported by cylindrical concrete specimens (10 x 20 cm) with a central porch composed of two steel plates and two threaded bars (9.5 mm, 3 nuts, 3 washers and two steel plates of 8 x 300 x 100 mm) applying the load of 250 kgf, causing holes in the center of the beams, with openings of up to 0.3 mm (within the limits of the NBR 6118 standard). The loading was carried out by applying a torque of 0.5 Kgf·m, with a torque wrench, to the threaded bars and, consequently, the concentrated force was applied to the prismatic specimen causing the crack.

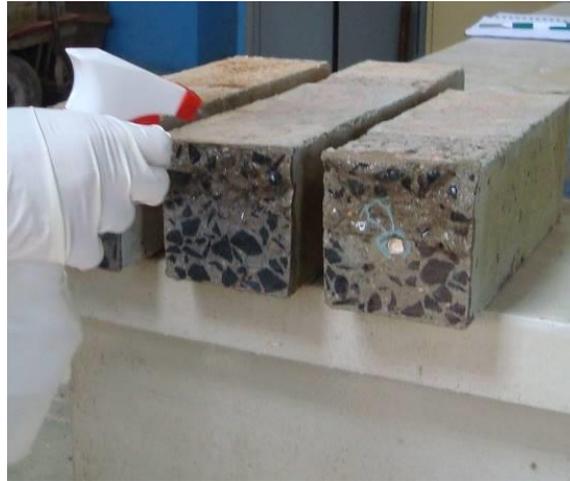
Figure 5. Chloride penetration tests with silver nitrate spray.

To determine the depth of penetration of chlorides, the cross section of the samples was broken, whose evaluation is carried out by spraying silver nitrate (0.1N solution) on the concrete surface, causing a photochemical reaction, where the free chlorides present in the concrete react with the silver ions of the silver nitrate solution to form a white precipitate. In areas where there are no combined chloride or chloride ions, there is the appearance of a brown color, the silver oxide, due to the reaction between the silver ions and the hydroxyls present in the pores of the cementitious material (Jucá et al., 2002; Real et al., 2015). Through this method, the objective is to evaluate whether the chloride front has reached the reinforcement. The steps of the test can be seen in Figure 5.

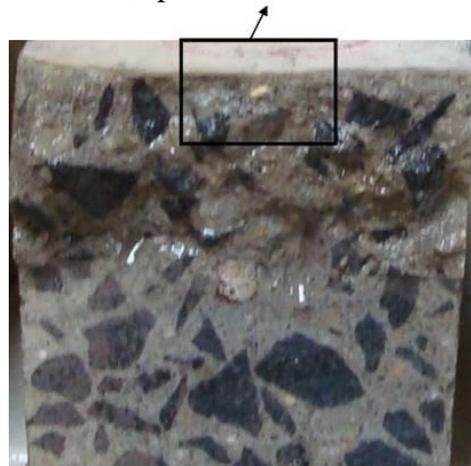
Area where the sample was removed for microstructure tests.

Figure 6. Place where the sample was taken for microstructure tests.

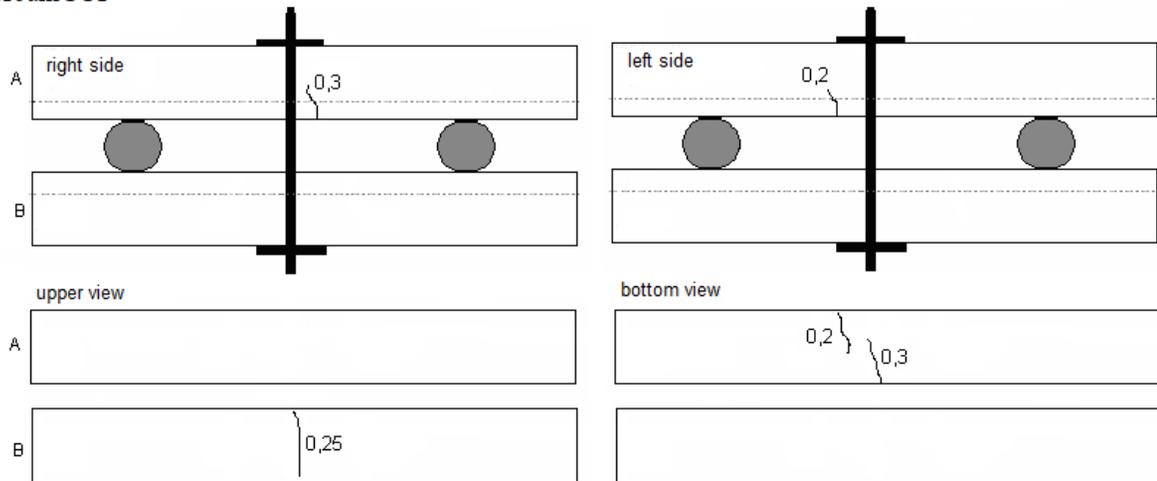
Figure 7. Mapping of cracks in concretes that have been under permanent central loading for 6 months (M6umCCP).

The M6umCCP concretes in Figure 7 had crack openings of 0.2 mm and 0.3 mm. Over the exposure period there was an increase of 0.3 mm to 0.4 mm and 0.25 mm to 0.35 mm.

Throughout the period that the prismatic specimens submitted to permanent central loading were exposed in the environment, mapping of the cracks was performed, as shown in Figure 7 (6 months old) and Figure 8 (24 months old).

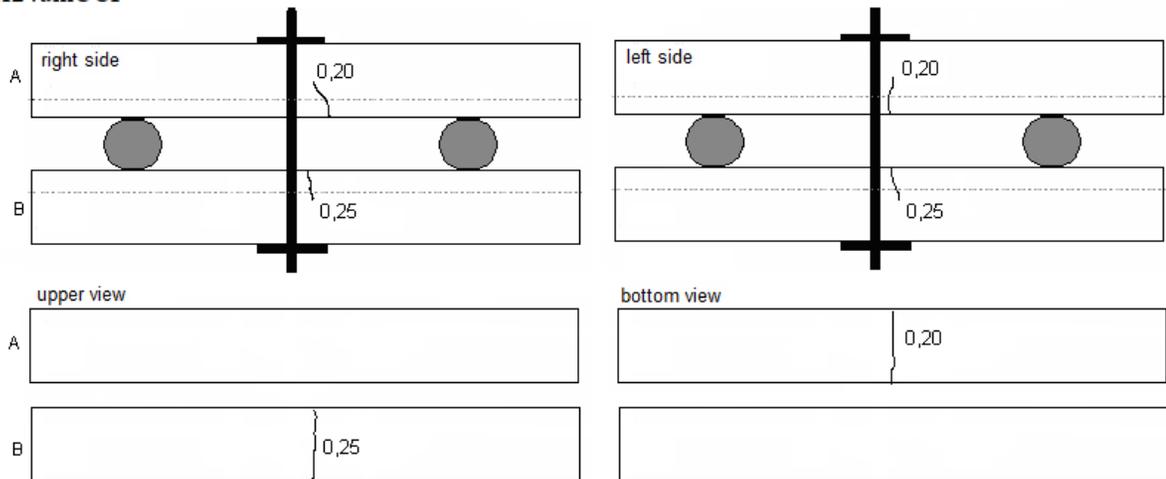
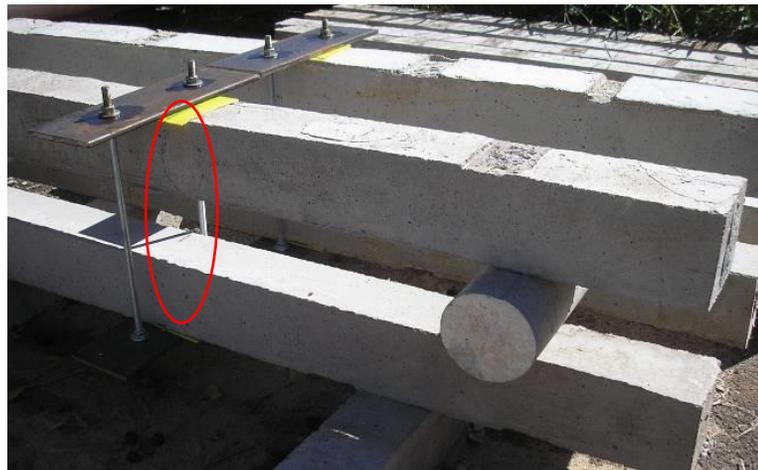
Figure 8. Mapping of cracks in concretes that have been under permanent central loading for 24 months (M24umCCP).

The cracks in the M24umCCP prismatic specimens (subjected to wet curing) had openings ranging from 0.20 mm to 0.25 m. At 24 months, the behavior of the fissures was like that of other ages. The initial openings were from 0.2 mm to 0.25 mm, reaching 0.4mm at the test ages.

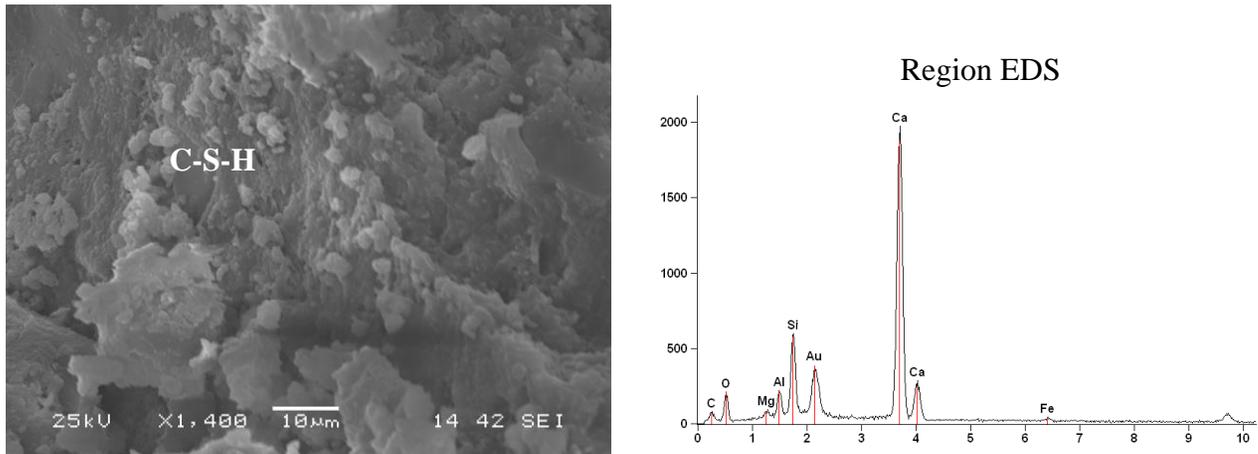
Figure 9. Concrete subjected to wet curing, without loading, at six months of age.

Figure 9 shows an area with dense and amorphous morphology (C-S-H Type III or IV), which is more common in this case because it is a sample at older ages. Cheng et al. (2005) observed in the concrete micrographs with different levels of blast furnace slag in high percentages, a denser structure, with few ettringite needles and with capillary pores smaller than 50 nm, which may have been filled by products like CSH. The Au peak appeared in the EDS in the region of Figure 9 may be due to metallization with gold.

At six months of age, only two types of samples were selected for microstructure tests. These samples were taken from the traction region of the prismatic specimens without loading (SC) and subjected to Permanent Central Loading (CCP). Both were in wet cure for 7 days before undergoing shipments. Figure 9 shows a sample without loading.

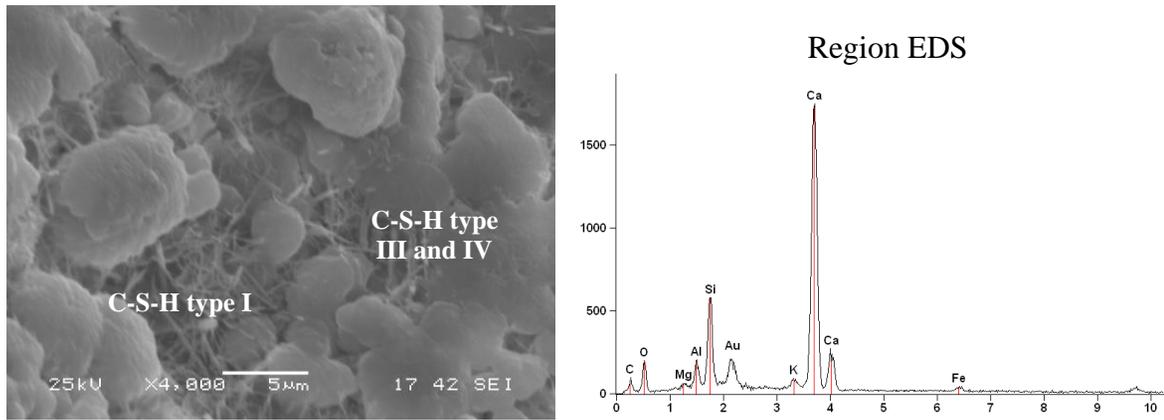
Figure 10. Concrete subjected to wet curing for 7 days and permanent central loading, at six months of age.

In the image of Figure 10 some needles are observed, but in the EDS the element sulfur (S) is not present to configure an ettringite. In this case, they can be C-S-H needles, with fibrous morphology (Type I) (Taylor, 1997; Ghosh, 2002). Phases C-S-H type III and type IV are also observed. In blends using blast furnace cement, the C-S-H fibrillar morphology of Portland cement without additions (Portland clinker) is gradually replaced by a different morphology, which Richardson (1999) calls “sheet” or “sheet type”. This author reports that this change in morphology is responsible for the better performance and greater durability of mixtures with this addition. Morphologies not yet observed at the age of 6 months of testing.

Figure 10 shows the microstructure of the concrete subjected to permanent central loading in wet curing for 7 days, at six months of age; and Figure 11 shows the microanalysis in three points of this same concrete.

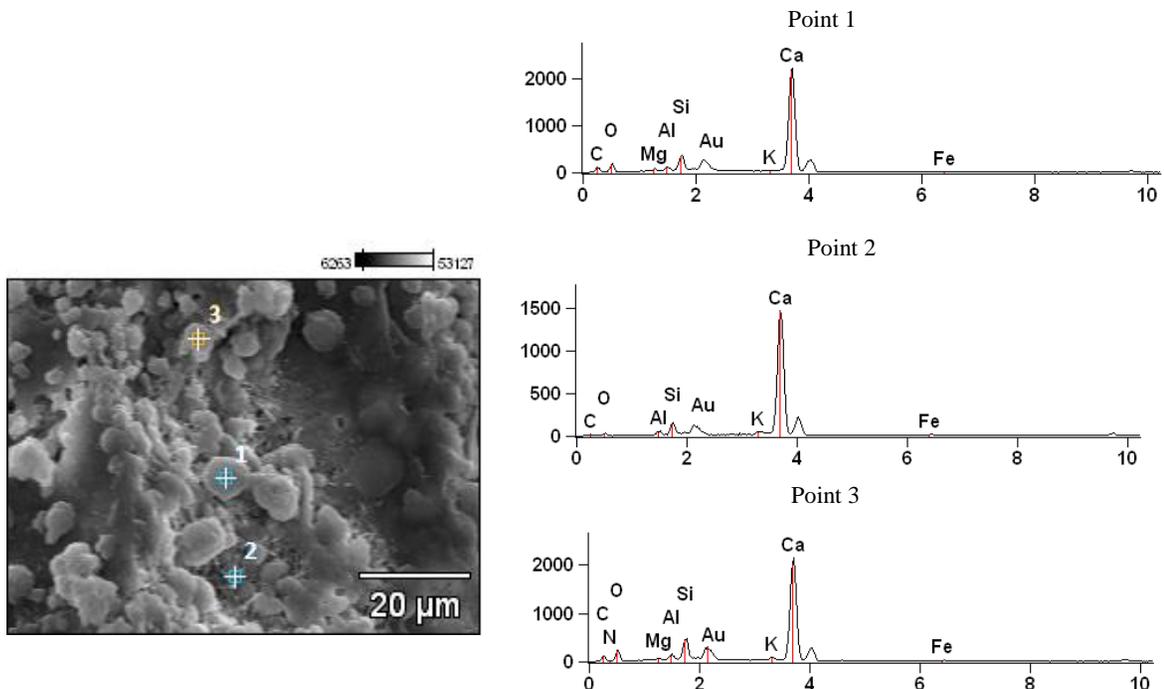
Figure 11 shows three selected points of the concrete subjected to wet curing for 7 days and permanent central loading. In the elementary composition by the EDS of the three points, the same elements Ca, Si, Al and Mg are found.

Figure 11. EDS microanalysis at three points of the concrete under permanent central loading (CCP).

In the microanalysis, we detected the presence of the elements Ca, K, Si, Al, Mg, O and C, which are typical of cement hydration products.

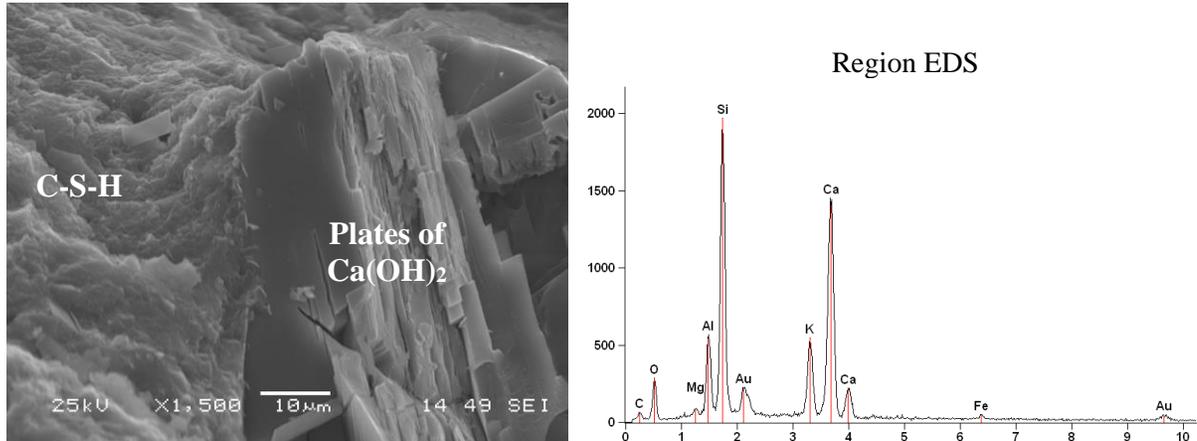
Figure 12. Micrograph and microanalysis of the unloaded concrete sample, at 24 months of age.

Figure 12 shows the presence of possible Ca(OH)<sub>2</sub> and C-S-H plaques. As verified by Baroghel-Bouny (1994) Mehta and Monteiro (2008), the phase corresponding to Ca(OH)<sub>2</sub> maintains the high alkalinity of the system, preserving the stability of the C-S-H and the concrete cover.

In Figure 12, a micrograph of a sample of unloaded concrete is presented, submitted to moist curing for 7 days, at 24 months of age.

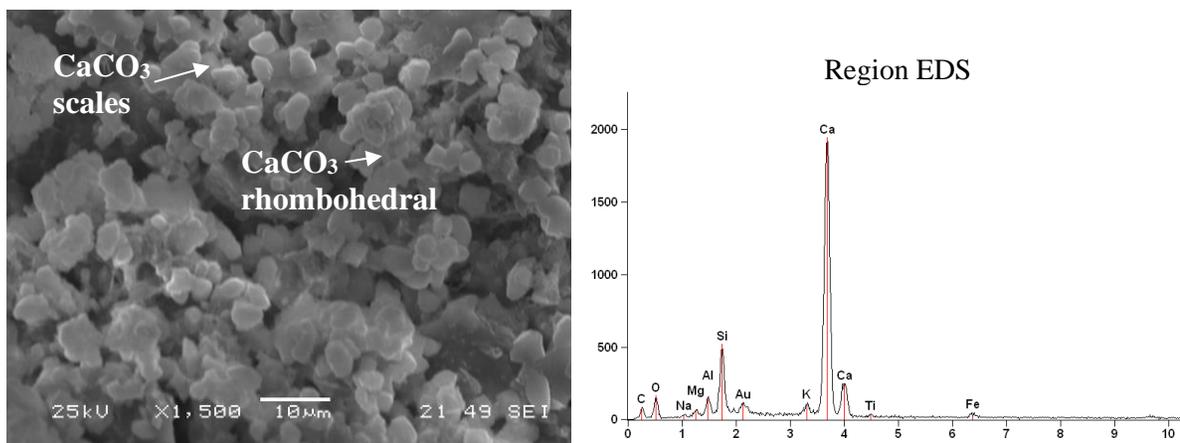
Figure 13. Micrograph and microanalysis of the concrete sample submitted to short-term central loading, at 24 months of age.

In Figure 13, it is possible to observe the formation of calcium carbonate in the form of rhombohedral crystals and in the form of scales, on a porous and possibly carbonated C-S-H. It is observed in the hydrated compounds formed, the presence of calcium carbonate ( $\text{CaCO}_3$ ), with different morphologies on C-S-H, which may also be in the process of being modified by the action of time, and due to its porosity. The porous C-S-H phase and the formation of  $\text{CaCO}_3$  indicated in Figure 13 was also observed by Sakar et al. (2001) in their study, with  $\text{CaCO}_3$  in the form of scales, however, in large quantities.

Figure 13 shows the micrographs and EDS of the concrete subjected to short-term central loading, at 24 months of age.

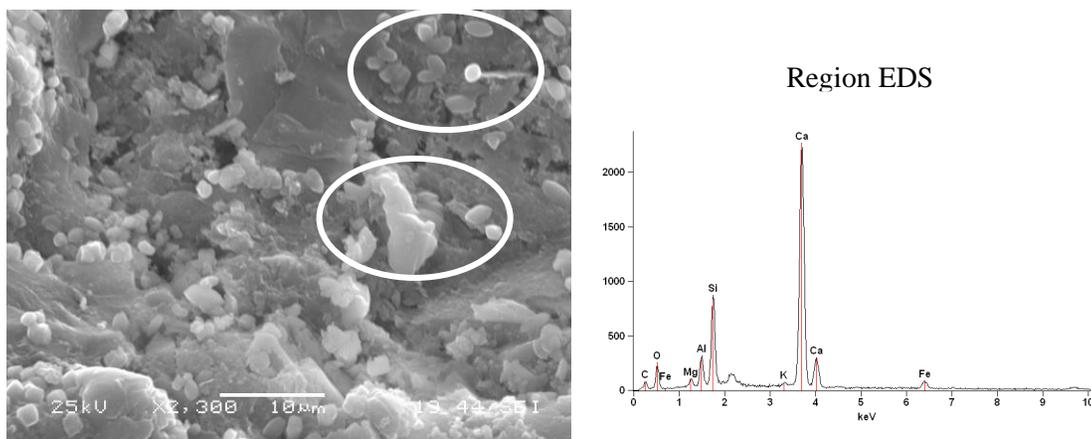
Figure 14. Micrographs and microanalyses of concretes with permanent central loading.

The sample in Figure 14 shows an area with a denser microstructure, with different  $\text{CaCO}_3$  morphologies. Some products that attracted attention, and that are highlighted in this micrograph, due to their morphology, can configure organic matter, probably microorganisms (Ribas Silva, 1996). However, to confirm this hypothesis, a microbiological analysis would be necessary, which was not performed because it was not the object of this study. In this case, the loading-induced cleft could have led to the entry of these microorganisms, since they were not observed in the SC and CCCD concretes.

Figure 14 shows the micrograph and microanalysis of the concrete subjected to permanent central loading (CCP), at 24 months of age.
