Concrete degradation by the formation of biogenic sulfuric acid in a Sewage Pumping Station

This work presents the study carried out in a Sewage Pumping Station after severe degradation was observed. The attack by biogenic sulfuric acid in sanitary sewage systems is widely studied in the literature, however, data on real work situations are still quite limited. Analyzes of the concentration of H₂S in the air, carbonation depth, compressive strength, petrography, SEM/EDS, XRD and chemical determinations were carried out in concrete cores extracted above the effluent level. The products identified on the surface were Gypsum, Jarosite, Ferrous Hydroxide, Ferrous Chloride and possibly Hisingerite. The results demonstrate the presence of products on the surface, from the dissolution of cement paste as well as from the 16 mm steel bars located in the attacked region.

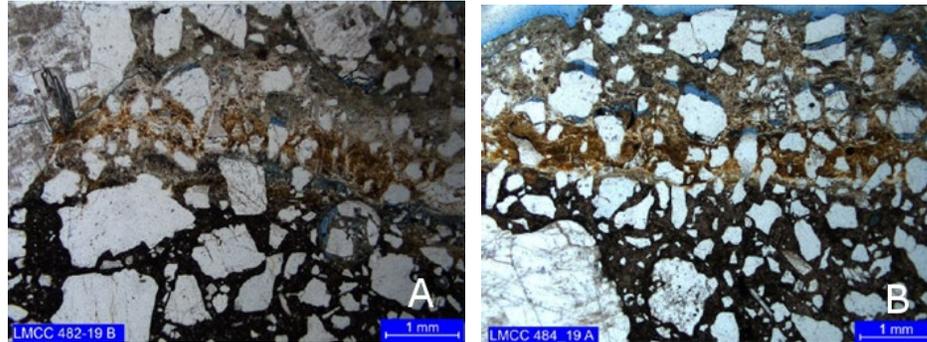
The identified thickness of the attacked region in the prepared slides corresponds to 1.6 mm to 4.1 mm for core 1 and 500 μm to 3.7 mm for core 2. Figure 5 shows the interface location between the attacked region (above) and the apparently unaffected region (bottom) for both cores. Note, in blue tones, the presence of microcracks and microporosity. The attacked region of both cores presents three zones of distinct alterations, namely:

Figure 5. Interface location between the core regions (a) 1 and (b) 2. Simple polarization with capacitor.

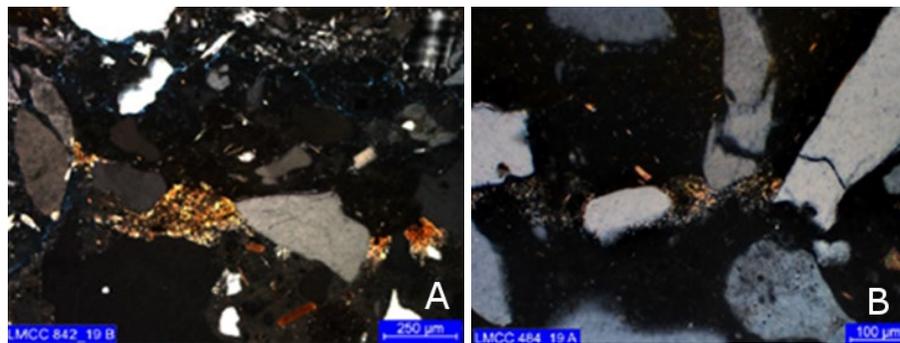
Tertiary zone: this is a discontinuous carbonation zone at the interface with the apparently unattacked concrete (Figure 8).

Figure 8. Presence of carbonation (yellowish tones) at the interface between the attacked regions (top) and apparently not attacked (bottom) cores (a) 1 and (b) 2. Cross polarization with capacitor.

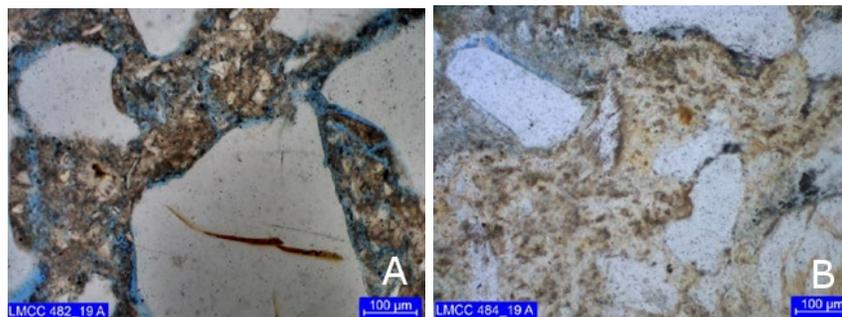
In both cores (Figure 9), the three zones show abundant microcracks, unfilled or partially filled by low birefringence crypt to microcrystalline material, gypsum.

Figure 9. Microporosity zones in the paste associated with microcracks in blue tones (a) 1 and (b) 2. Simple polarization, with capacitor.

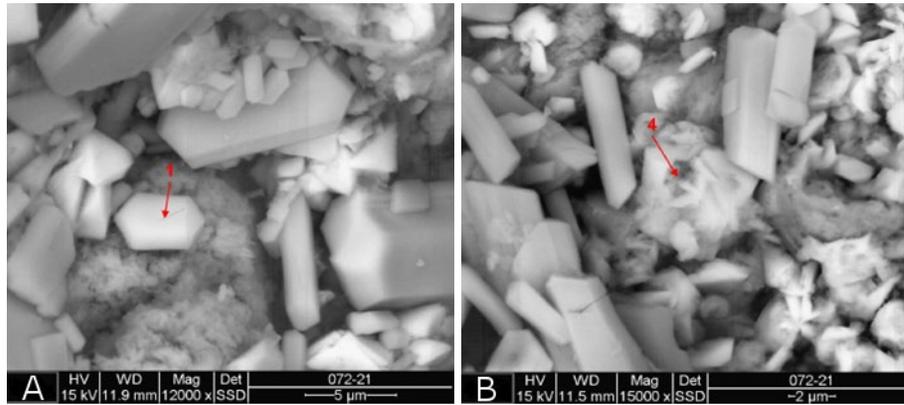
Microstructure analysis revealed considerable mineralogical changes on the attacked surface (Figure 10). Crystals of crystalline sulfoaluminosilicate phases were identified in the sample, containing Ca, Fe and K. In figure 10, the arrows point out to the locations of analysis by energy dispersive system (EDS – Figure 11).

Figure 10. SEM scraped material - sulfoaluminosilicate crystalline phases, containing Ca, Fe and K.

In the micrograph of the scraped material, the presence of portlandite crystals was not identified, indicating that it has completely dissociated. Also, the acid has reduced the matrix to a more porous material, consisting of smaller particles.

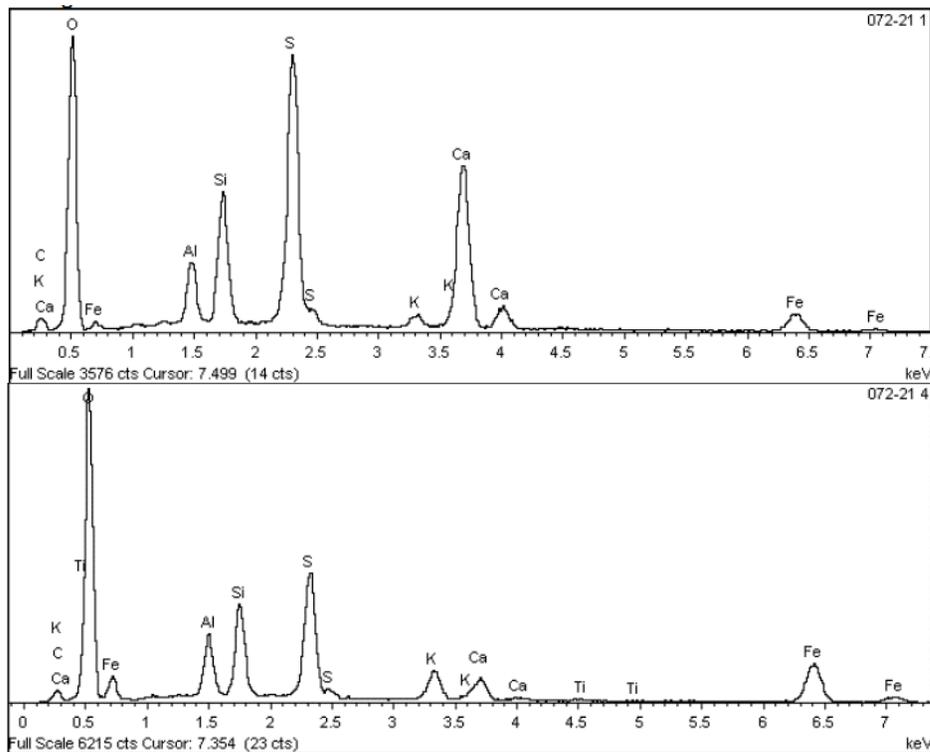
Figure 11. EDS spectra indicated in figure 10 (a) and (b)

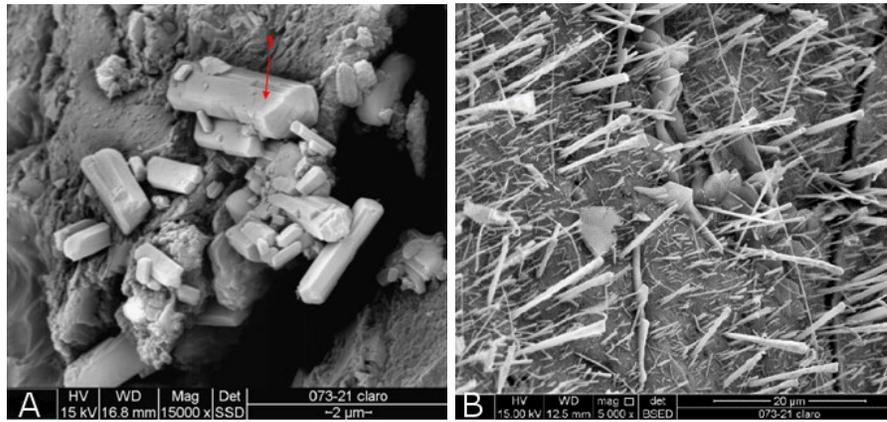
In the intermediate sample, two fragments of the light and dark portions were analyzed. In the lighter portion, crystals of rectangular morphology of hydrated calcium sulfate were identified (Figura 12.a), according to the EDS spectrum (Figure 13) with strong S and Ca signals, suggesting gypsum as the main component and ettringite crystals (Figure 12.b).

Figure 12. SEM intermediate sample - fragments of the clear portion (a) hydrated calcium sulfate and (b) ettringite crystals.

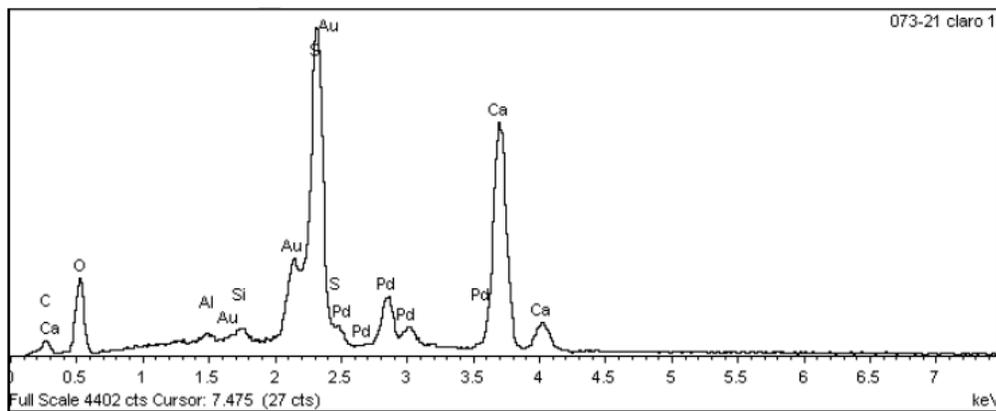
Figure 13. EDS spectra indicated in figure 12.a

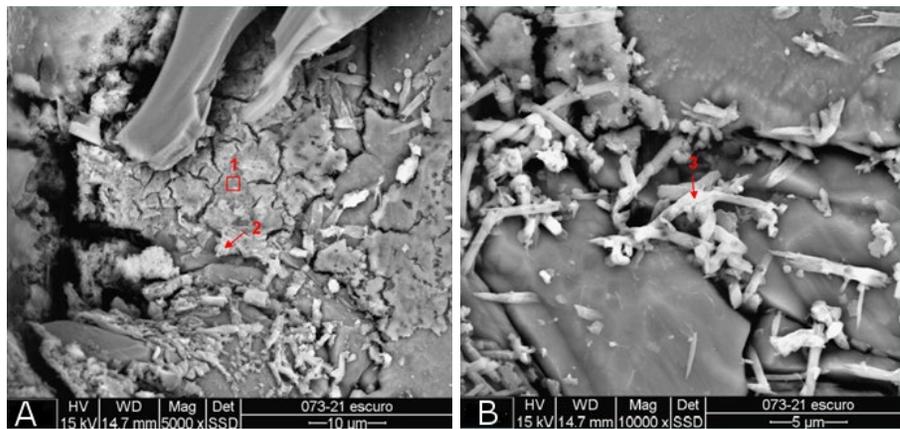
In the analyzed fragments of the darker portion of the intermediate sample, crystals of calcium aluminosilicate with sulfur or calcium sulfoaluminosilicate were identified (Figure 14).

Figure 14. SEM intermediate sample - fragments of the dark portion calcium aluminosilicate crystals with sulfur or calcium sulfoaluminosilicate.

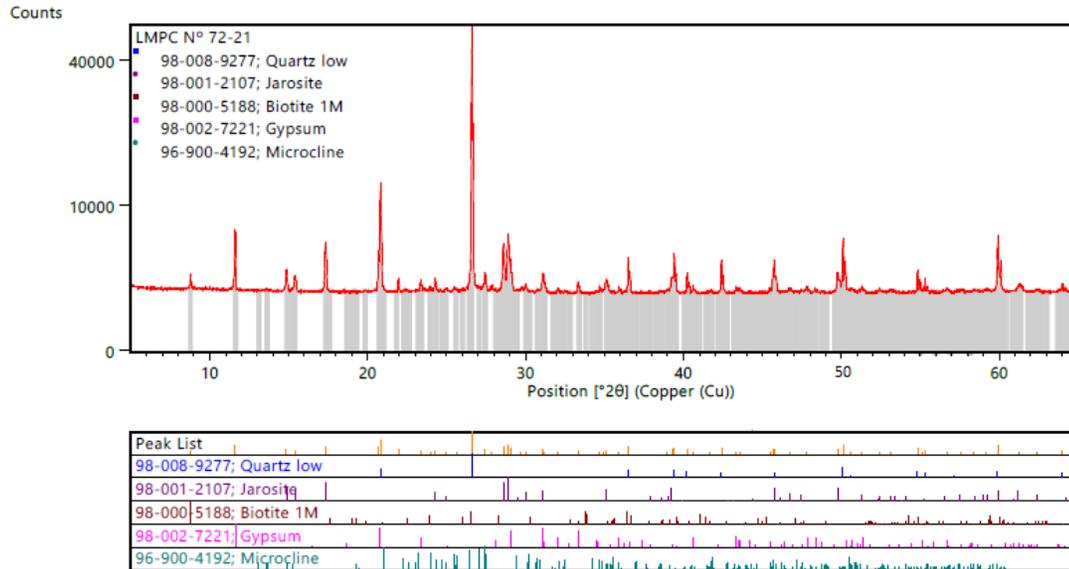
Figure 17. X-Ray diffractogram – scraped material.

In the scraped sample (Figure 17) the presence of Jarosite and Gypsum was identified in a higher concentration. Similar results were found by Tazaki et.al., (1992) in severely corroded concrete pipes. According to the authors, under extremely low pH conditions, bacterial activity can break down Pyrite (iron disulfide, FeS₂) to form Jarosite. Usually, the main microorganisms involved in these reactions are identified as *Thiobacillus ferrooxidans* and/or *Thiobacillus thiooxidans*. In the study by Song et.al., (2020), when the acid attack reaches the surface of the steel bars, the corrosion process of the bars is accelerated by H₂S forming iron sulfide, one of the compounds identified being FeS₂. Thus, it is possible that Jarosite formation comes from FeS₂, formed by the oxidation of the steel bars located in the attacked region. Gypsum was also identified as the most abundant compound on the concrete surface by authors such as Fernandes et.al., (2012), Davis et.al., (1998), Song, et. al., (2018) and Song et. al., (2020).

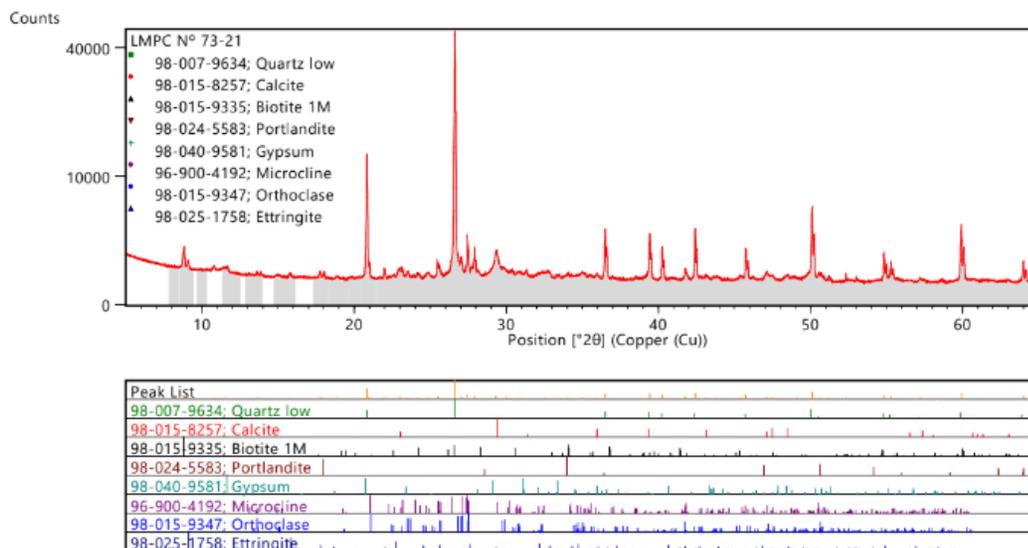
Figure 18. X-ray diffractogram – intermediate sample.
