## Carbonation deep evaluation of a concrete structure subjected to fire soot.

The objective of this study was to verify the influence of moderate heat (< 200°C) and soot from fires on the alteration of carbonation of concrete. Although this fact occurs naturally in all small and large fires, these authors did not find bibliographic references on the subject. An experiment of exposing concrete specimens to moderate temperatures was then performed, followed by soot impregnation for twelve months, with the measurement of carbonation depth every three months. The study was carried out in a laboratory environment and compared the depth of carbonation observed in specimens subjected to moderate temperatures and soot with specimens under laboratory environmental conditions. Despite the natural limitations of an experiment with a reduced time frame and laboratory environment, it was evidenced that even in intact concretes, the moderate temperatures combined with the acidity of the soot accelerate the carbonation depths and can significantly alter the residual service life of the structure if subsequent corrective intervention measures do not consider this risk.

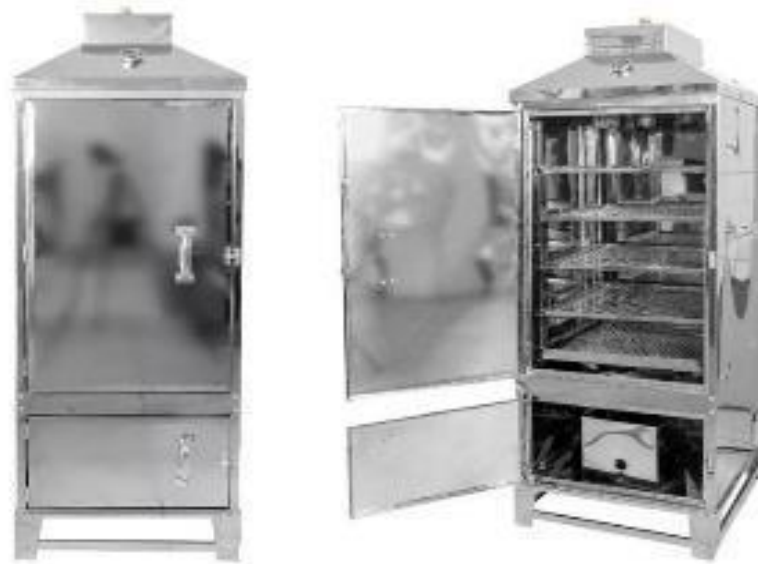
Figure 2. Smoker used as a covering for burning the specimens.

To burn the material, an adapted smoker was purchased, in which the smoke could pass into the upper part where the test specimens were located, but the burning area was isolated in the lower part of the object, therefore, there was no contact between the materials. test specimens directly with the fire.

This smoker, made of stainless steel, had 5 hollow trays in the upper part where the test specimens could be stored, and in its lower part, a smooth plate where the burning products were stored.

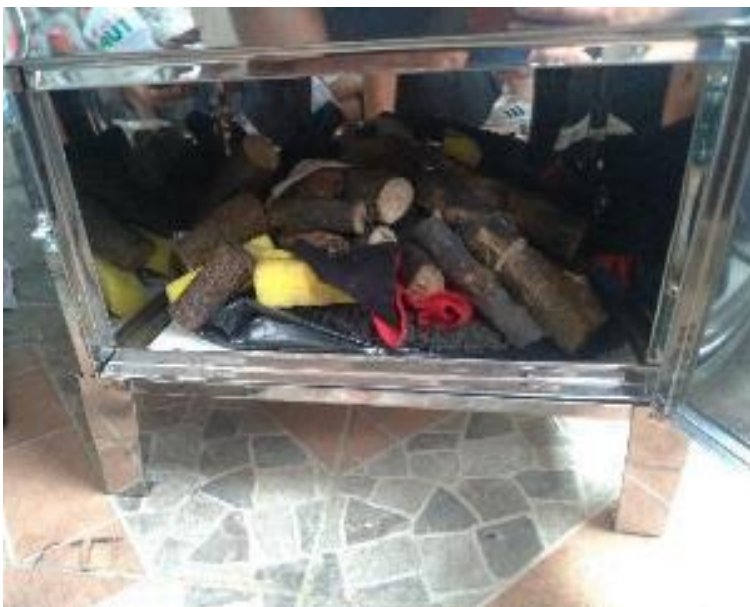
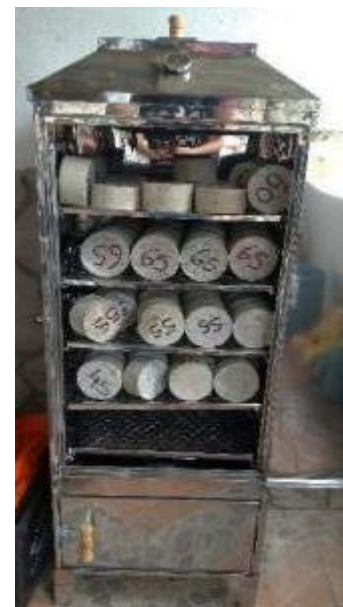
Figures 4 and 5. Left: Materials for burning inside the casing. Right: Test specimens arranged inside the casing, with each trace arranged at one level of the casing.

In the bibliography consulted, no technical standards were found that guide similar tests for soot impregnation in test specimens, without contact with temperature. In this way, the burning criterion consisted of burning the material carried out in the lower part of the casing, as shown in Figure 4, while the test specimens were arranged inside (upper part) of the casing (Figure 5), being equivalent to 20 discs. each trace, which was subjected to smoke without direct contact with the flame, as well as the container with soil arranged in the casing. 20 discs of specimens from each trace and a container with soil were also left outside the casing, which were not subjected to smoke.

The material was burned with the casing closed for 90 minutes, which is determined as the maximum TRRF time (Required Fire Resistance Time [TRRF], Júnior, 2011) as recommended by NBR 14432 (ABNT, 2001), which refers to the fire resistance requirements of constructive elements of buildings for residential buildings of up to 30m (buildings of up to 10 floors).

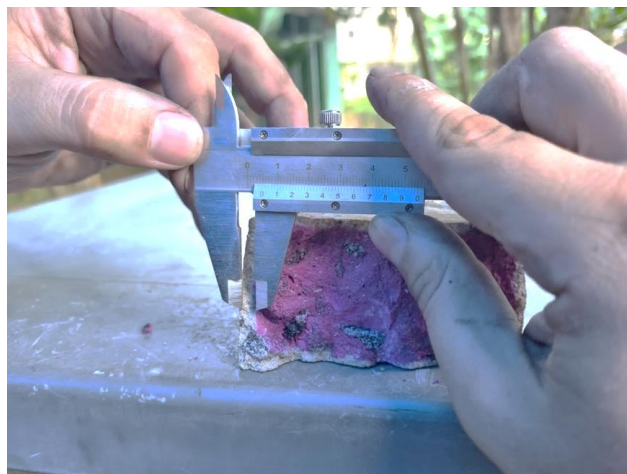
Figure 7. Measurement of the carbonated area

Situación 5- Detail of the procedure form measuring the carbonated área with a caliper. Always measuring the deepesdt área whit "e" being the measurement between the beginning of the phenolphthalein reaction and the fase of the piece.

The measurement of the carbonated area was carried out on the test specimens with and without soot impregnation. The carbonated thickness was measured and at the end of the process a comparative graph was created between the measurements of what was inside the casing and what was left outside the casing, to identify whether there is a change in the carbonation front, thus reducing the useful life of the concrete.

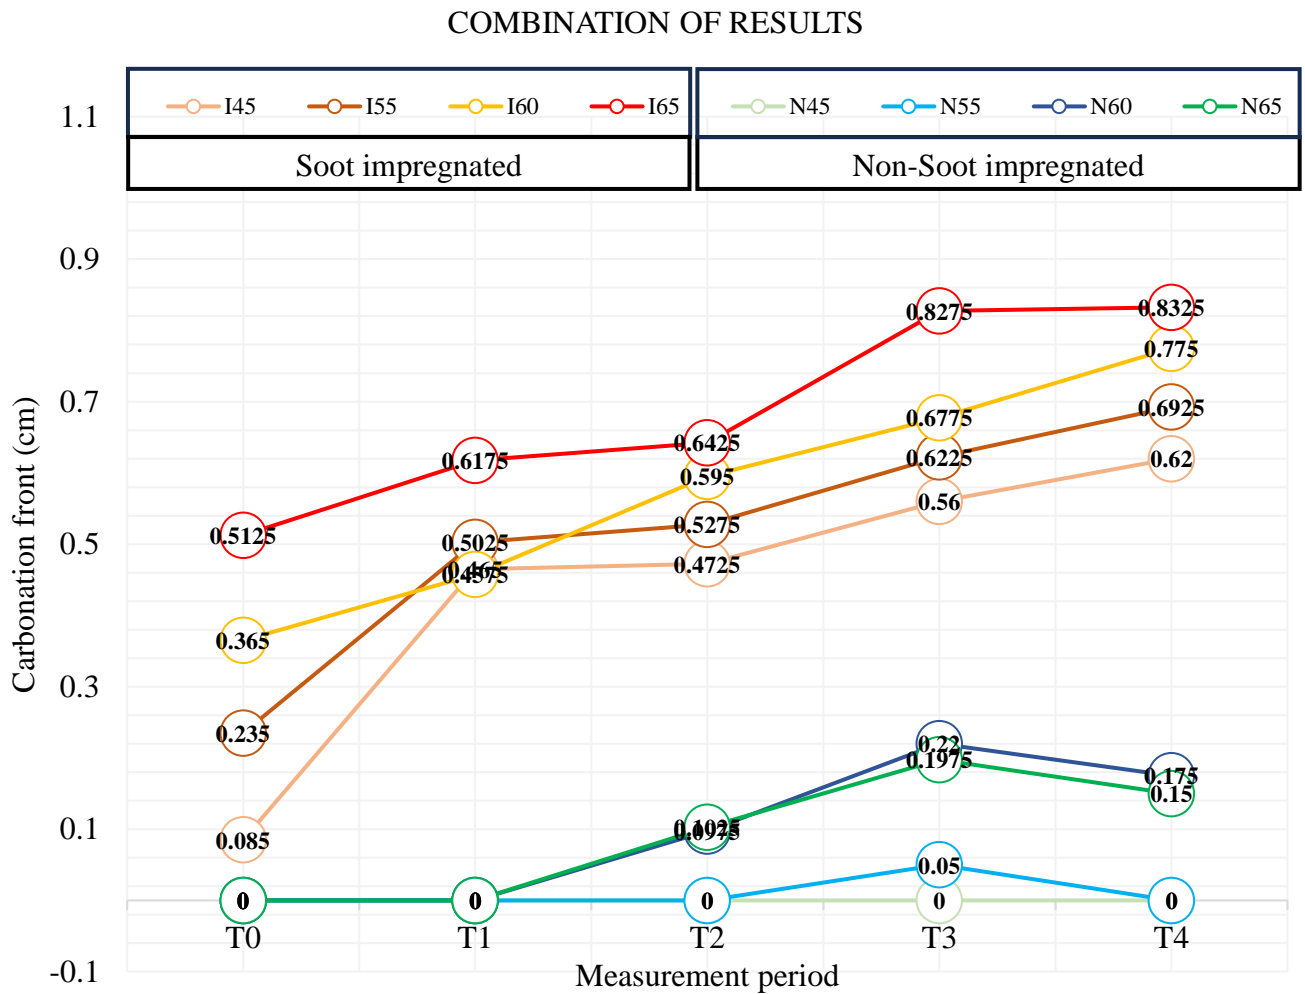
Graph 1. Carbonation front over time among the non-impregnated and impregnated specimens for all concrete mixes.

Graph 1 demonstrates the concrete carbonation front, in different traces, both impregnated (red tones) and non-impregnated (blue tones). Based on these data, it can be observed, in general, that the passage of time (0 to 364 days) is related to the increase in carbonation, both for impregnated and non-impregnated specimens. This demonstrates a natural tendency for carbonation - although relatively slow under natural conditions - due to common environmental conditions, such as exposure to gases present in the atmosphere, as previously described in the literature (Costa, 2012). However, it is possible to verify that the carbonation front advanced at a greater speed in the specimens that were subjected to temperatures of up to 200°C in the burning process and subsequently spent 365 days subjected to intense soot impregnation and an aggressive post-fire environment.

It was immediately possible to observe that the carbonation values present in the T0 column of the graph demonstrate that the advancement of the carbonation front immediately after burning the material and the soot impregnation was 0.085 cm for the w/c trace. 45; 0.235 cm for w/c trace. 55; 0.365 cm for the w/c trace. 60 and 0.5125 cm for the w/c trace. 65.
