Non-destructive evaluation of the wooden beams from the Narciso López building in the Historic Center of Havana for reuse in its restoration

A. Hernández Oroza^{1*}

DOI: <https://doi.org/10.21041/ra.v12i2.585>

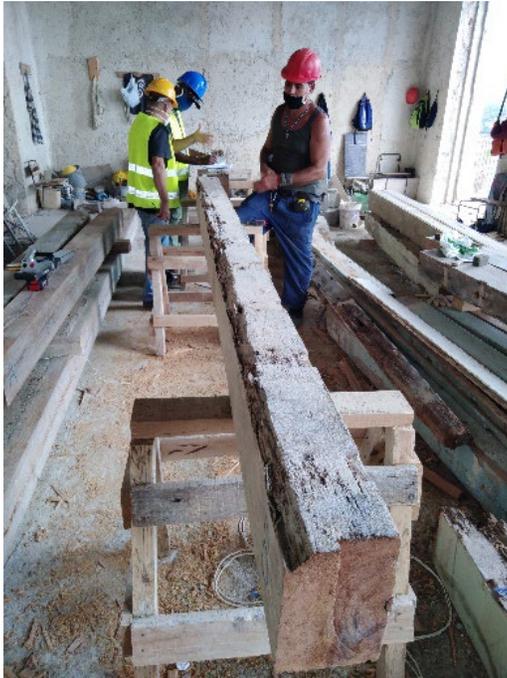
The study began with the removal of the floor and the dismantling of all the beams. This enables detailed inspection on all sides (Figures 3 y 4), fundamentally in the area of the heads, which, being embedded in the walls, show greater deterioration due to rot by increase of moisture inside the joints (Figures 5 y 6). This first stage makes it possible to record the position, length, direction and sense of each fissure, crack, rot and/or defibration present in the beams, for which the distance of the lesion with respect to the head was taken as a reference (Figure 7). Additionally, the test areas that have the ideal conditions for carrying out the measurements were identified. In areas where there are cracks or deterioration due to different forms of rot (brown, soft, etc.) it is not possible to carry out measurements because a correct transmission or confinement of the signal is not achieved from the emitter to the receiver, or the results obtained are altered by the presence of microbial films that affect the physical-chemical composition of the wood, degrading its structure and density. On the other hand, impact or penetration techniques have the drawback that they should not be applied on irregular surfaces that influence the moment of impact of the drill bit, either due to its deformation, alteration in the angle of entry or lack of wood to offer a density value representative of the real properties of the structural element. For the preparation of the test areas, two sections were selected for each beam, free of surface lesions.

Figure 3. Stage of detailed inspection in beam mounted on wood supports

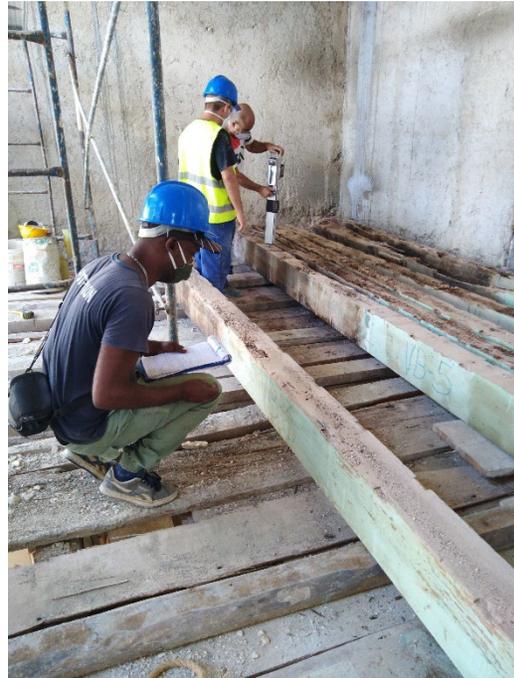
Figure 4. Inspection and visual classification of disassembled beams

Of the 32 beams inspected, eleven of them did not show any type of injury (Table 1). In accordance with the visual classification requirements of the standard (UNE 56544, 2011), 4 beams categorized as ME-1 and 7 as ME-2 (Table 2). The rest of the beams are classified as Rejected considering the recurring damage from cracks and longitudinal fissures, rotting and splintering, mainly in the area of the heads up to a distance of approximately 40 cm. However, as it is a rehabilitation project that intends to use the original beams, with the exception of VA-18, all of them need to be re-evaluated through the proposed tests.

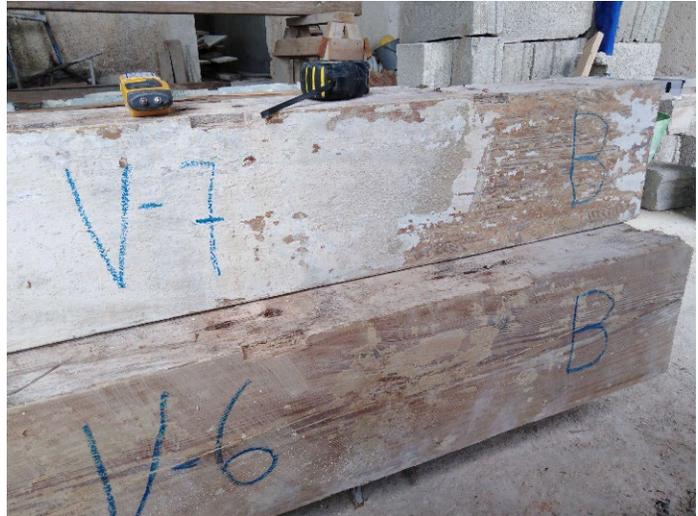
Subsequently, each beam was identified using the code (VA-x), where x represents a consecutive number, starting from 1. The local has a total of 32 wooden beams, which support each other axes 5-6. To determine the dimensions, a tape measure was used, and the measurements of width, depth and length were recorded (Table 1). The heads of the beams were identified with the letters A and B (Figure 8).

Figure 8. Identification of wooden beams

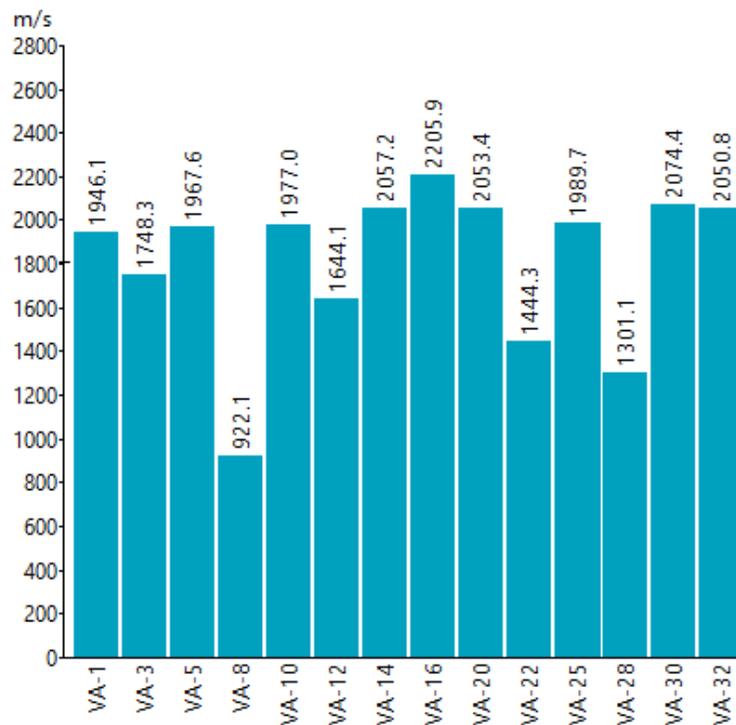
To carry out the penetrometer and UPV tests, two points were prepared on each beam. In each one, 5 readings were recorded, for a total of 10 results for each element. Figure 12 shows a summary of values in some of the beams tested.

Figure 12. Summary of UPV measurements at a test point for wood beams. Data extracted from software Proceq PunditLink

In the UPV results obtained, only two beams (VA-8 and VA-28) show values below the established limit of 1400 m/s, being classified as "deteriorated wood". This may be due to fungal infestation from rotting, softening and spalling in the wood having spread into the beams, which is reflected in the wave transmission velocity output between the transducers. With the years of exploitation of the building it is not possible to determine the causes for which these beams suffered a deterioration considerably higher than the rest. It is possible that its location coincided with that of humid areas such as bathrooms or kitchens, although the registered humidity contents do not show extreme values that support this hypothesis. The statistical analysis of the data (Table 4), in which beams VA-8 and VA-28 were excluded, show a dispersion for UPV of less than 10%, with a reliability of 95%, so that for the rest of the values the population of data obtained is accepted.

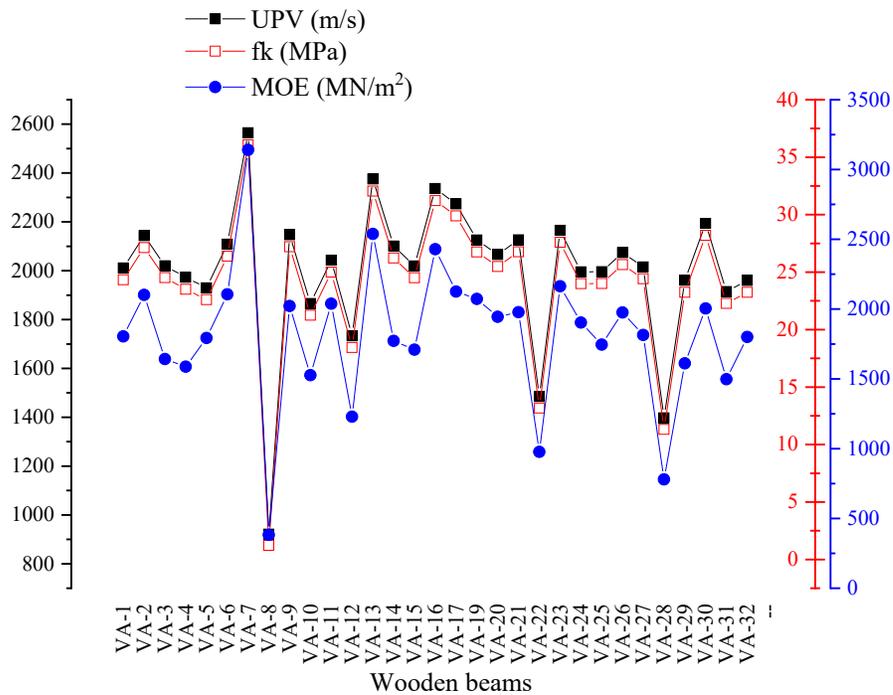
Figure 15. Correlation of results obtained from UPV, fk and MOE for wooden beams
