Restoration of the facade of the church of San Pedro Apostol in Agost, Spain

This work describes the studies and the intervention carried out for the restoration of the facade of San Pedro Apostol in the parish church of Agost. This facade was made at the end of the 18th century in limestone. After an initial inspection and graphic survey of the facade, the lesions, their origin, and the solution to them were identified by using advanced restoration techniques. The stone elements damaged or destroyed by the passage of time are composed of calcite, dolomite and silica, with plaster joints, and have been reconstructed either through the use of new elements or, for the most part, through systems of recovery of the initial volume with the use of a light core of polystyrene, lime mortars, expanded clay, fiberglass and carbon together with infiltrations of resins in the disintegrated areas. After a delicate intervention process using innovative techniques, the facade was completed in June 2023.

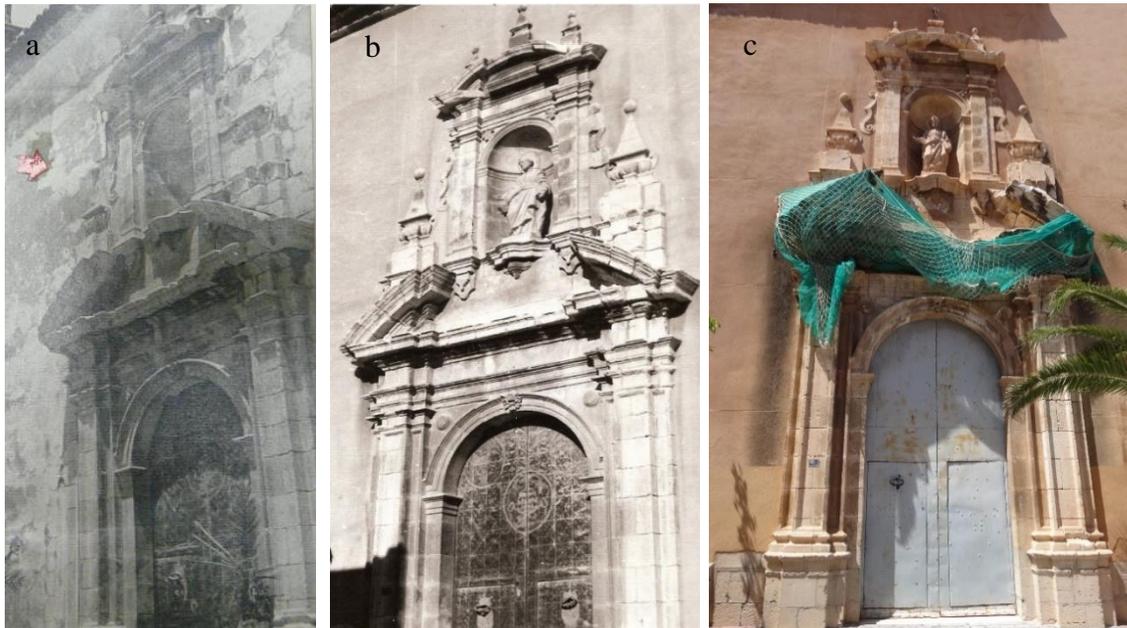
During the Spanish Civil War (1936-39) the building suffered considerable damage and even suffered a fire. The existing images on both facades were destroyed, particularly the image of Saint Peter on this facade (Figure 2a). After a major intervention of the building in the 1960s, there have been no further major structural interventions affecting this facade (Figure 2b). In 2014, some detachments were detected in elements of this facade and a protective net had to be installed, which had to be replaced again in 2021 due to detachments of stone elements (Figure 2c). In 2023, the restoration process began following a study and a project carried out at the University of Alicante.

Figure 2. Photographs of various historic situations (a) 1964, (b) 1973 (c) 2021

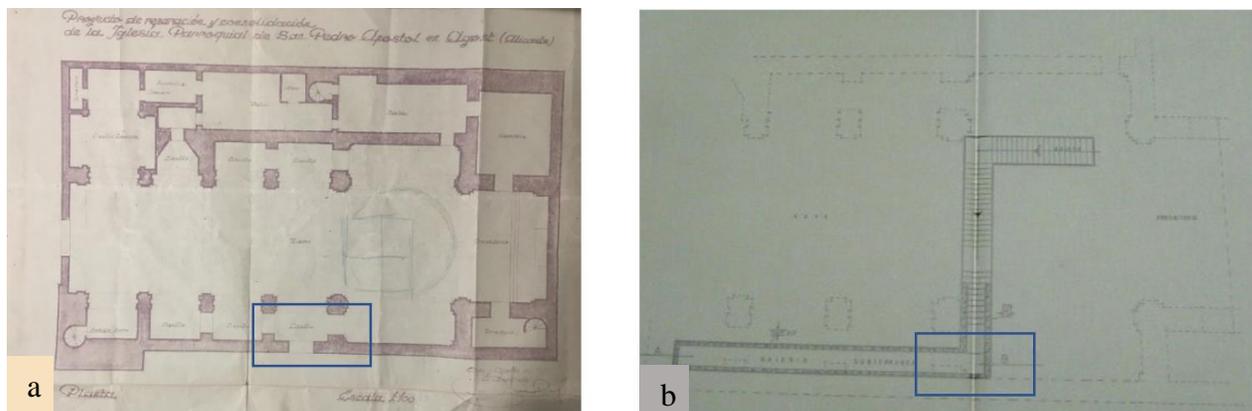
The collection of documentary data has been carried out especially in the parish archive and the Serrano y Valderrama architecture office in Elche, where the studies and project of the architect Antonio Serrano Peral, who worked on the church in the mid-20th century and was the author of the drawing in Figure 3, are kept. Mainly cracks in the interior and facades of the building caused by the excavations carried out inside the church. The damage to the doorway is not described, although the wall that supports it has a crack next to it on the right-hand side, probably due to the same cause as the cracks in the interior. Figure 3b) shows that there is a hollow area next to the facade containing the doorway, which corroborates the origin of the fracture.

Figure 3. a) General drawing of the church made for the intervention carried out in the 1960s by Antonio Serrano Peral. b) Detail of the staircase and excavated area inside the church. The location of the doorway under study is indicated. Source: private archive of the Serrano Peral family.

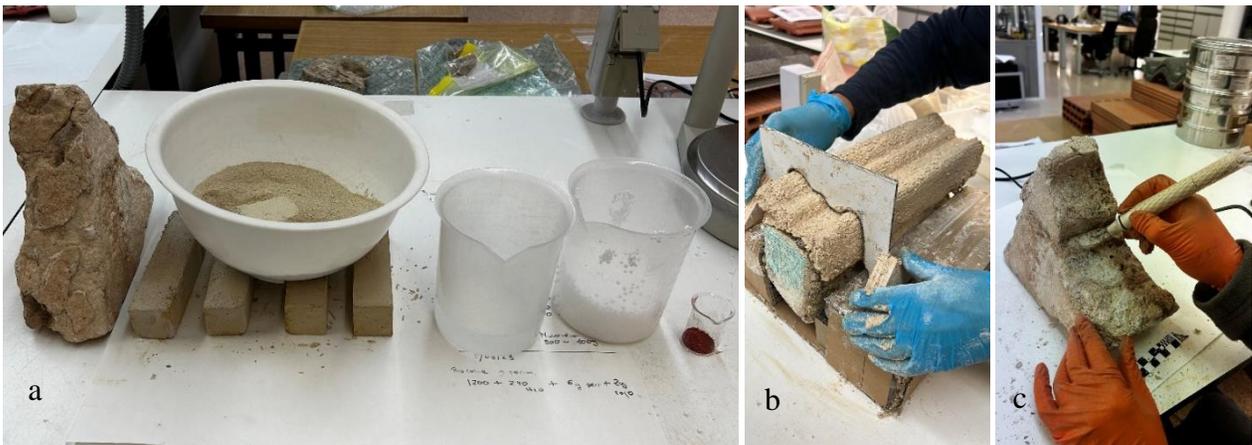
A fragment that had become detached from the facade was taken to the Architectural Constructions laboratory of the University of Alicante and was used as the basis for the study of density and colour, as well as for testing cleaning techniques. Figure 10 shows some of the tasks carried out in the laboratory.

Figure 10. Different aspects of the previous studies carried out for the restoration of the doorway. a) Components prepared to make test specimens for subsequent study together with the fragment of the cornice of the doorway (bio-lime, water, eps beads and natural pigments). b) Detail of the test carried out in the reintegration laboratory with a light polystyrene core and exterior lime mortar. c) Detail of a cleaning test using ultrasound.

For the volumetric reintegration of missing areas, it was decided to use lime mortar. There are various prefabricated mortars on the market whose density is similar to that of the stone to be replaced, but in this case the stone of the facade on which the material forming the missing volume must be anchored is very weak and has micro-cracks. This has led the project team, together with the fine arts restorer Enrique Jordá, to design light volume reintegration systems using lime mortar. The main lesions on this facade are very high levels of stone degradation, especially in the areas most exposed to water, such as the upper finials and cornices. In the masonry to the right of the doorway there are some cracks in the facade that coincide with other cracks in the interior of the building. In a report carried out in 2020, it was diagnosed that the building suffers from differential settlement towards the tower area, so that the cracks mentioned are due to this origin. This movement may also have influenced the slipping of the voussoir in the arch of the doorway.
